# High Cascade Complex – East Spruce Lake & Blanket Creek Fires July/August/September/October 2017

**BURNED-AREA REPORT**

**PART II - BURNED-AREA DESCRIPTION****A. Fire Name:** High Cascade Complex

**B. Fire Number:** OR-RSF-000636 (High Cascade Complex); OR-RSF-000371 (Blanket Creek); OR-CLP-000453 (Spruce Lake)**C. State:** Oregon**D. County:** Jackson and Klamath**E. Region:** R6 Pacific Northwest**F. Forest:** Rogue River-Siskiyou National Forest**G. District:** High Cascade Ranger District**H. Fire Incident Job Code:** P6K75A**I. Date Fire Started:** July 26, 2017**J. Date Fire Contained:** October 31, 2017 (Tentative)**K. Suppression Cost\*:** Blanket Creek Fire: \$17,700,000; \*Costs as of September 26, 2017 (ICS 209)

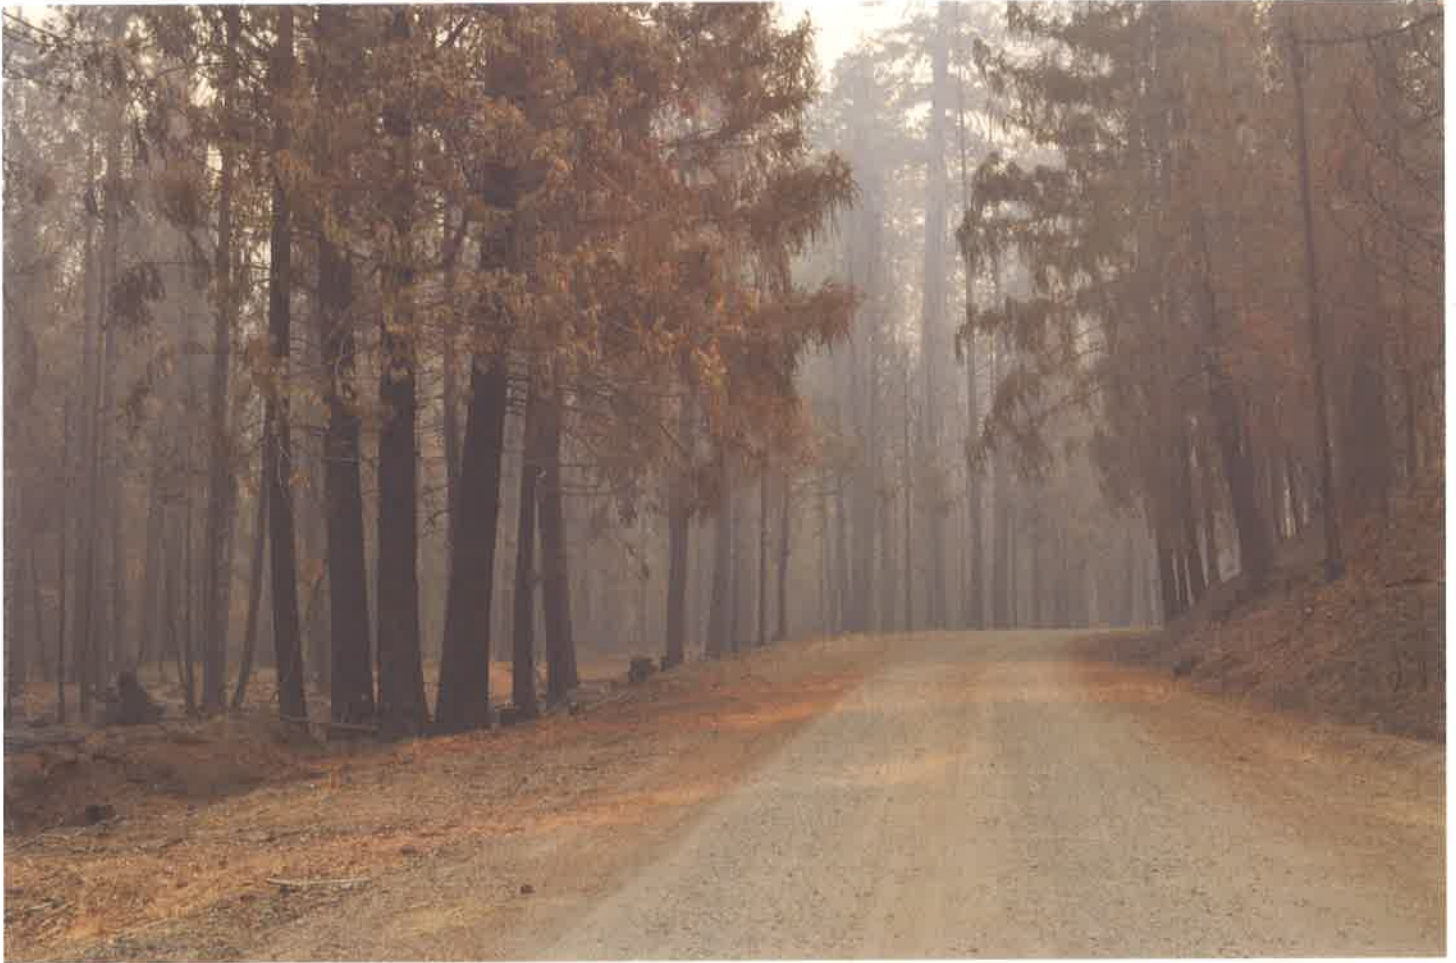
Forest Service Road 6205 within the Blanket Creek Fire

Property	FSR 6205	Very Likely	Major	Very High	<p>Storm patrol, install 5x rolling dips, 3x locations of ditch cleaning, 20x culverts to clean, log jam removal at stream crossing</p>	<p>ML3 road. Road traverses the base of steep (50-100%) compacted glacial till through wall mountainside, and is downhill from and through the burned area. Debris flows are anticipated to reactivate in historic flow paths &amp; potentially come from new sources. Road includes culverts and ditches. Varmint Creek crossing has a log jam that has not been threatening road with normal annual flow; with potential for debris flows from burn, jam has potential to prevent function of the culvert and exacerbate road damage and potential crossing blow out.</p>
Property	FSR 6205-100	Very Likely	Moderate	Very High	<p>35x culverts to be cleaned, storm patrol</p>	<p>ML2 road. Road travels upslope and near the ridgeline. Treatments focus on the road miles that travel through areas dominated by moderate and high severity burn; road grade has potential to carry flows down road surface if ditchlines and cross-drains plug.</p>

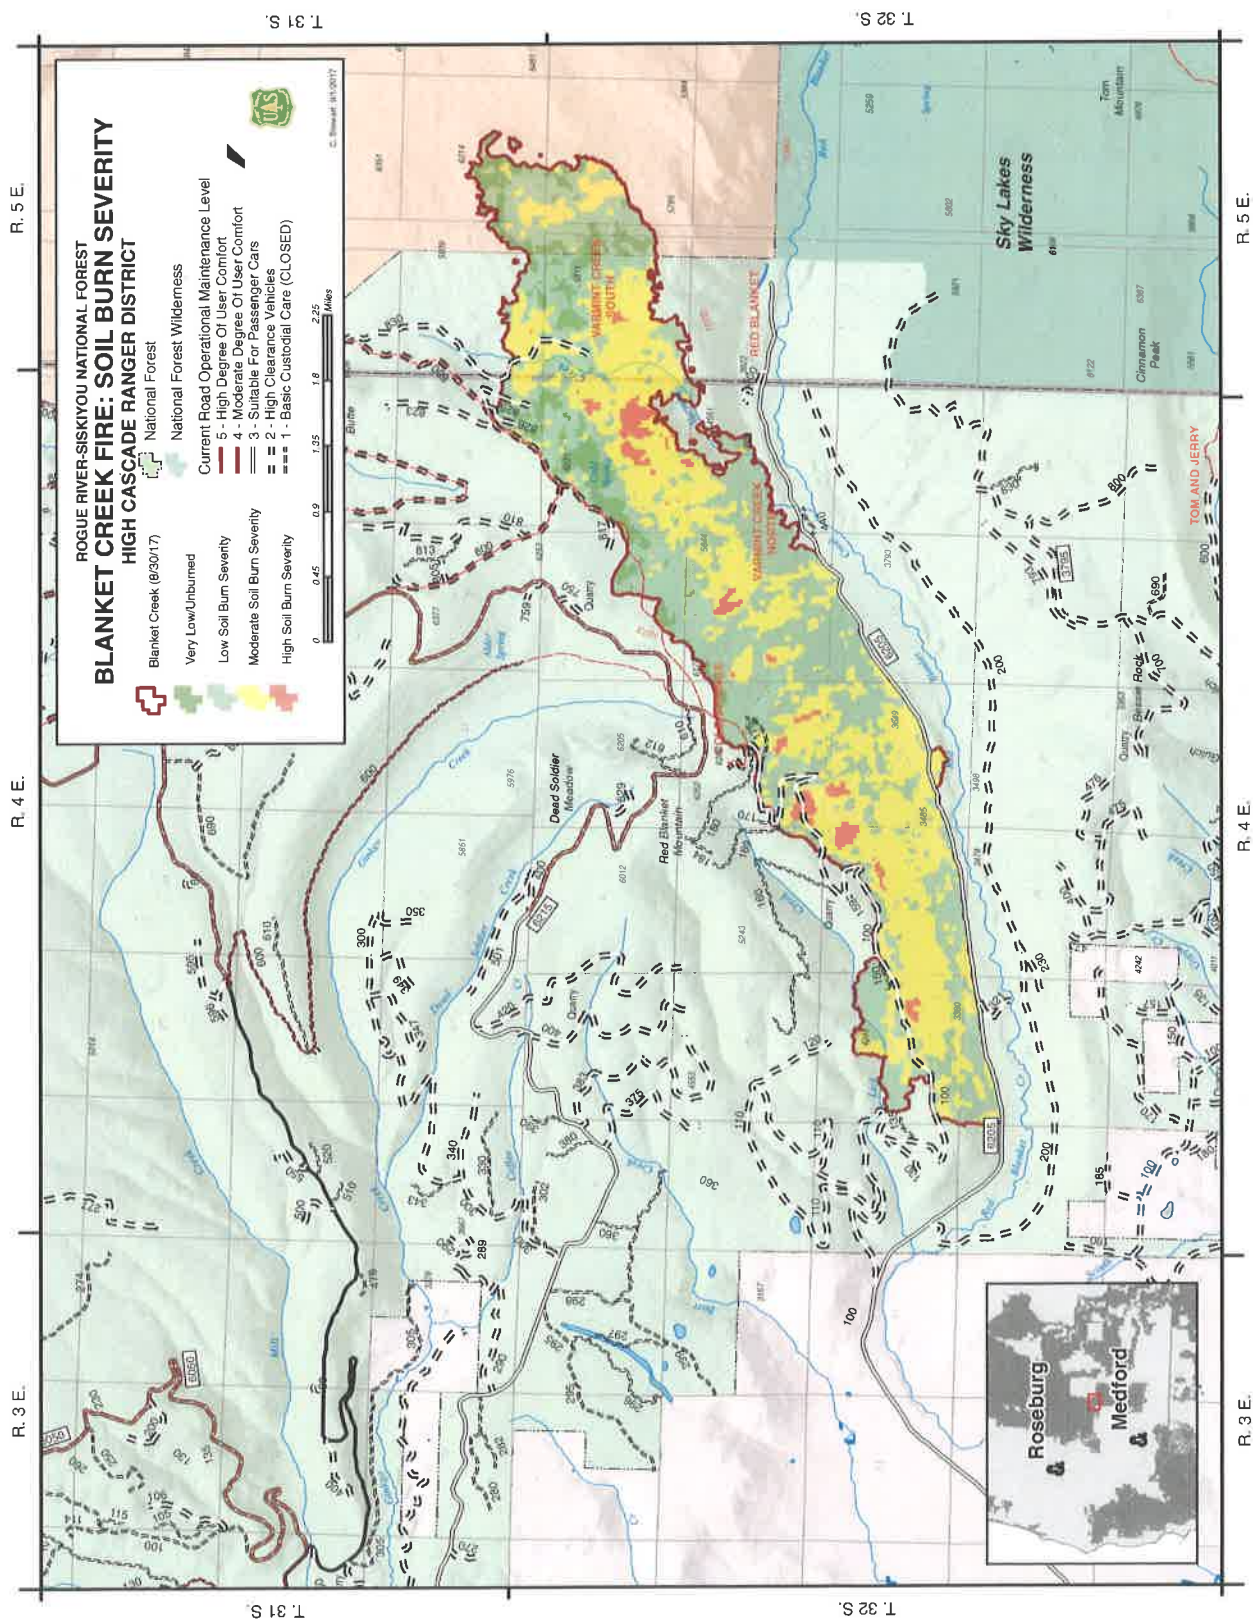
Appendix A: Maps and Figures  
 Figure 1: Blanket Creek Soil Burn Severity Map

Blanket Creek Fire: 8,847 acres (Very Low/Unburned), 9,447 acres (Low), 10,399 acres (Moderate), and 4,445 acres (High)

The soil burn severity (SBS) map shows approximately 45% burned at high and moderate soil burn severity. The rest of the fire was either low soil burn severity or unburned. It is very important to understand the difference between fire intensity and burn severity, and soil burn severity as defined for watershed condition evaluation in Burned Area Emergency Response BAER analyses. Fire intensity or burn severity as defined by

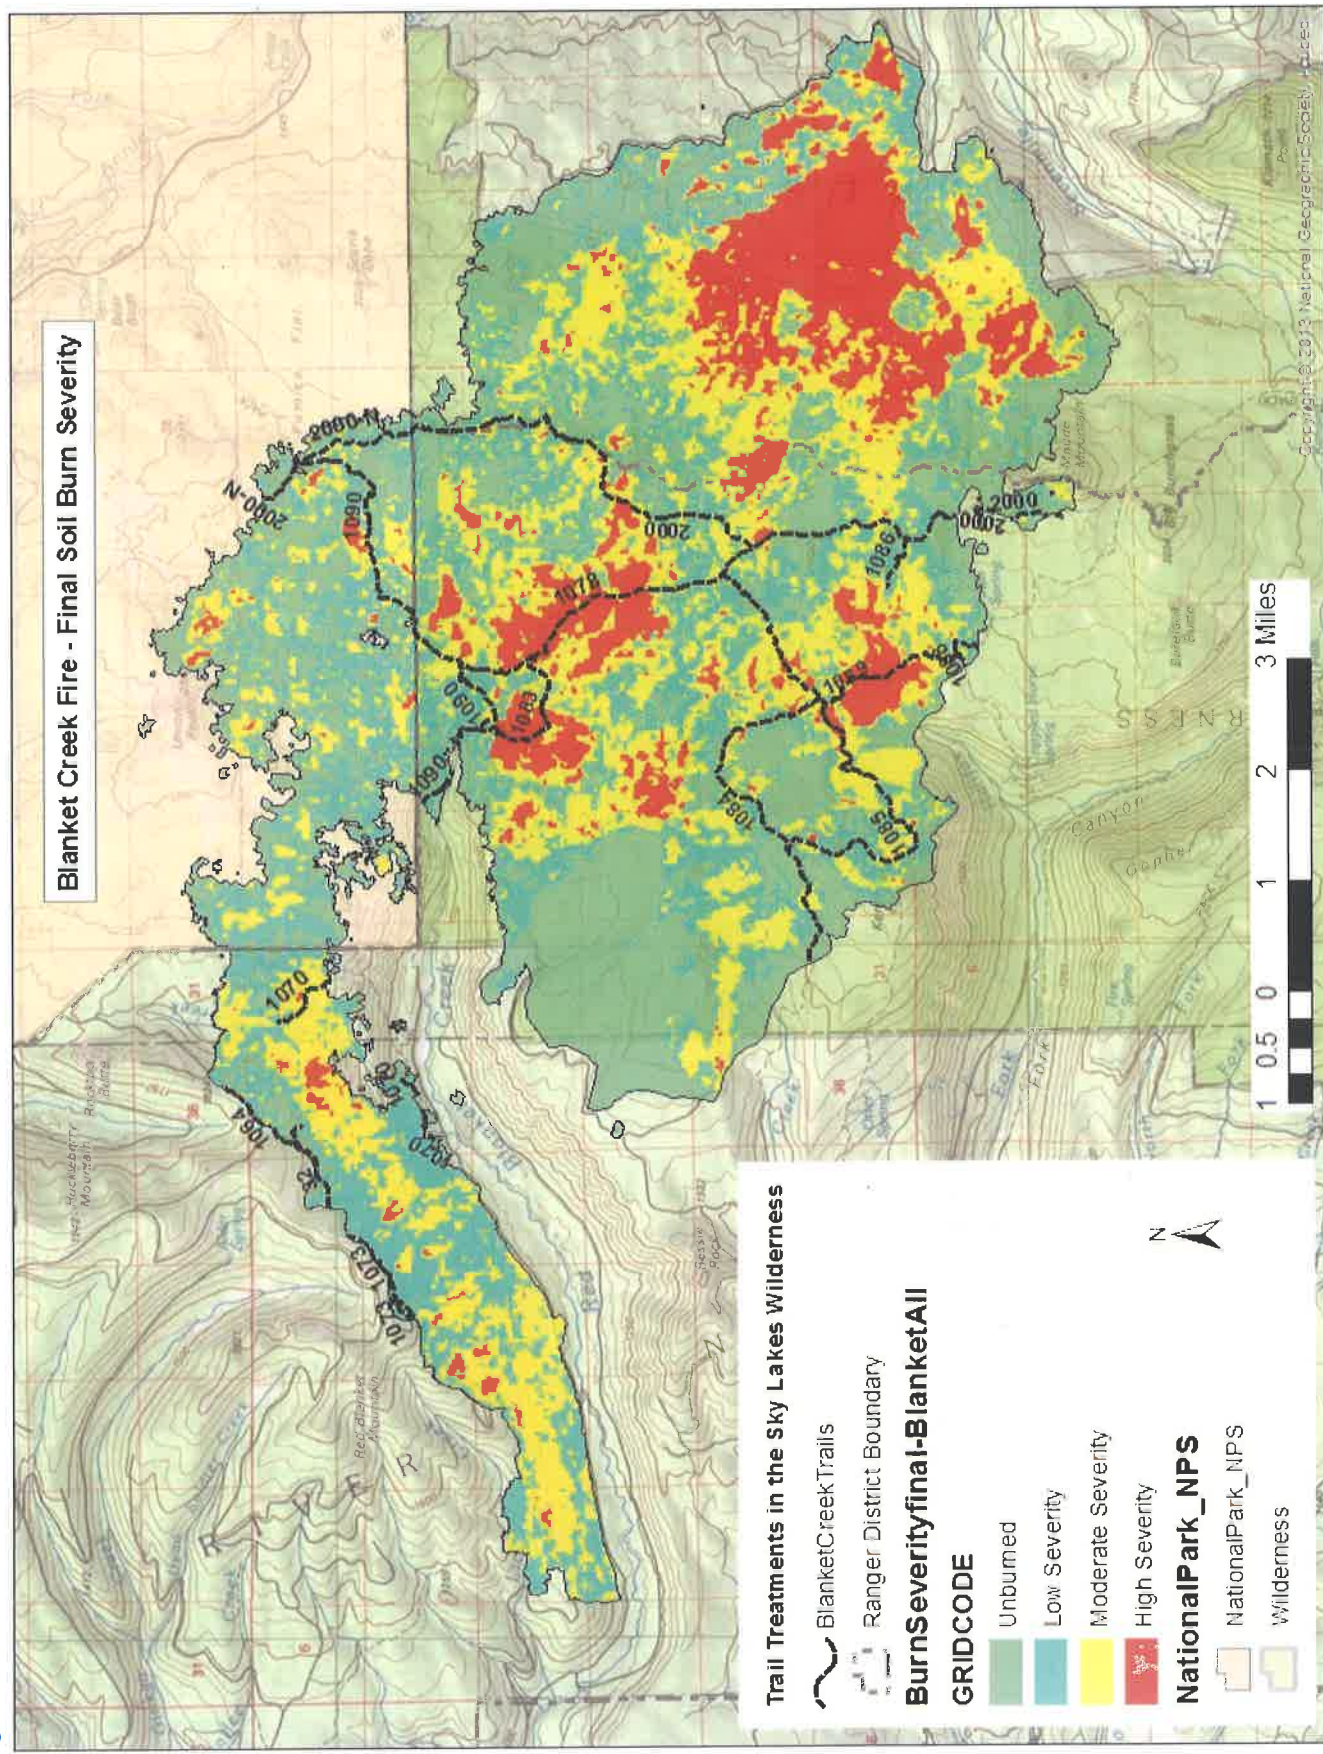
Figure 5. Blanket Creek – Final Burn Severity, and Proposed Trail Treatments in Sky Lakes Wilderness, Rogue River-Siskiyou NF

After the Initial BAER assessment, the Blanket Fire made large runs into the Sky Lakes Wilderness, burning over an extensive wilderness trail system, including a section of the Pacific Crest Trail. The following trail sections on the Rogue River-Siskiyou NF within Moderate and High SBS would be treated:

<b>Table 14: Trail Storm Proofing Treatments in Sky Lakes Wilderness through mod &amp; high soil burn severity</b>				
<b>Trail Name &amp; Trail No.</b>	<b>Units</b>	<b># of Units</b>	<b>Unit Cost</b>	<b>Total Cost</b>
Halifax Trail #1088	Miles	0.12	\$4,000	\$480
Lucky Camp Loop Trail #1083	Miles	1.31	\$4,000	\$5,240
McKie Camp Trail #1089	Miles	2.45	\$4,000	\$9,800
Mudjekeewis Trail #1085	Miles	1.98	\$4,000	\$7,920
Pacific Crest Trail – Wilderness #2000	Miles	2.0	\$4,000	\$8,000
Red Blanket Trail #1090	Miles	1.38	\$4,000	\$5,520
Stuart Falls Trail #1078	Miles	2.17	\$4,000	\$8,680
Tom and Jerry Trail #1084	Miles	1.45	\$4,000	\$5,800
<b>Total Miles and Cost</b>		<b>12.86</b>		<b>\$51,440</b>
