Date of Report: 05/01/2003**BURNED-AREA REPORT**
(Reference FSH 2509.13)**PART I - TYPE OF REQUEST**

- A. Fire Name: Cave Gulch Fire B. Fire Number: MT-HNF-027
C. State: MT D. County: Lewis and Clark
E. Region: R1 F. Forest: Helena NF
G. District: Helena
H. Date Fire Started: 7/23/00 I. Date Fire Controlled: 10/15/00 (estimated)
Date Fire Contained: 9/15/00 (estimated)
J. Suppression Cost: \$18,500,000 as of 9/14/00
K. Fire Suppression Damages Repaired with Suppression Funds (to date)
 1. Fireline waterbarred (miles): 15
 2. Fireline seeded (miles): 15
 3. Other (identify): 0.0
L. Watershed Number: 100301011401
M. Total Acres Burned: 29,187

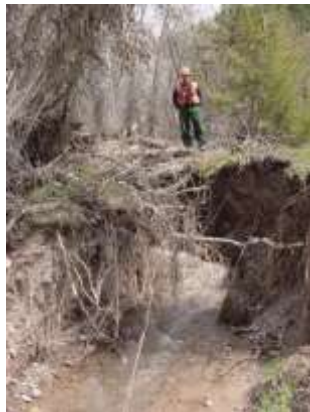
Headcut #3

These flooding events have created several large, unstable headcuts in Cave Gulch stream channel, and have completely washed out or eroded deep gullies in segments of Forest Road 4156. This forest road has in places become the lowest point in the valley, and will continue to carry runoff water and erode fine-textured soil in the road bed. Stream headcuts and road gullies have, and will continue to erode and deliver sediment to downstream private properties, unless stabilization treatments are implemented.

Channel Treatments: Construct 4 stream headcut stabilization structures in lower Cave Gulch with class IV rip rap. Headcut structures will be four to six feet in height, and constructed with wings to prevent stream avulsions from going around the structures. Structures will be keyed at the top and the bottom. Grade control structures will require dewatering of stream during construction.

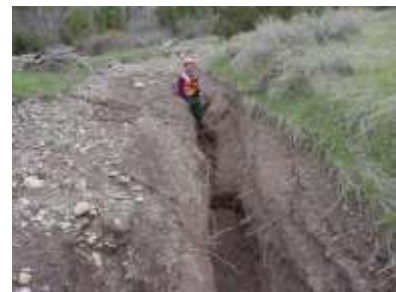
Gully in Forest Road 4156

Road Treatments: Reshape 900 feet of gullied road and armor with class II riprap. The objective of this treatment is to prevent further road downcutting, minimize sediment delivery to the stream and reduce sediment transport to restoration treatments being implemented on private properties downstream.
