**BURNED-AREA REPORT**  
(Reference FSH 2509.13)**PART I - TYPE OF REQUEST****A. Type of Report**

- A. Fire Name: Happy Camp Complex      B. Fire Number: CA-KNF-005956  
C. State: CA      D. County: Siskiyou  
E. Region: 5      F. Forest: Klamath  
G. District: Happy Camp/Oak Knoll/Scott River      H. Fire Incident Job Code: 0505-P5JB1F14

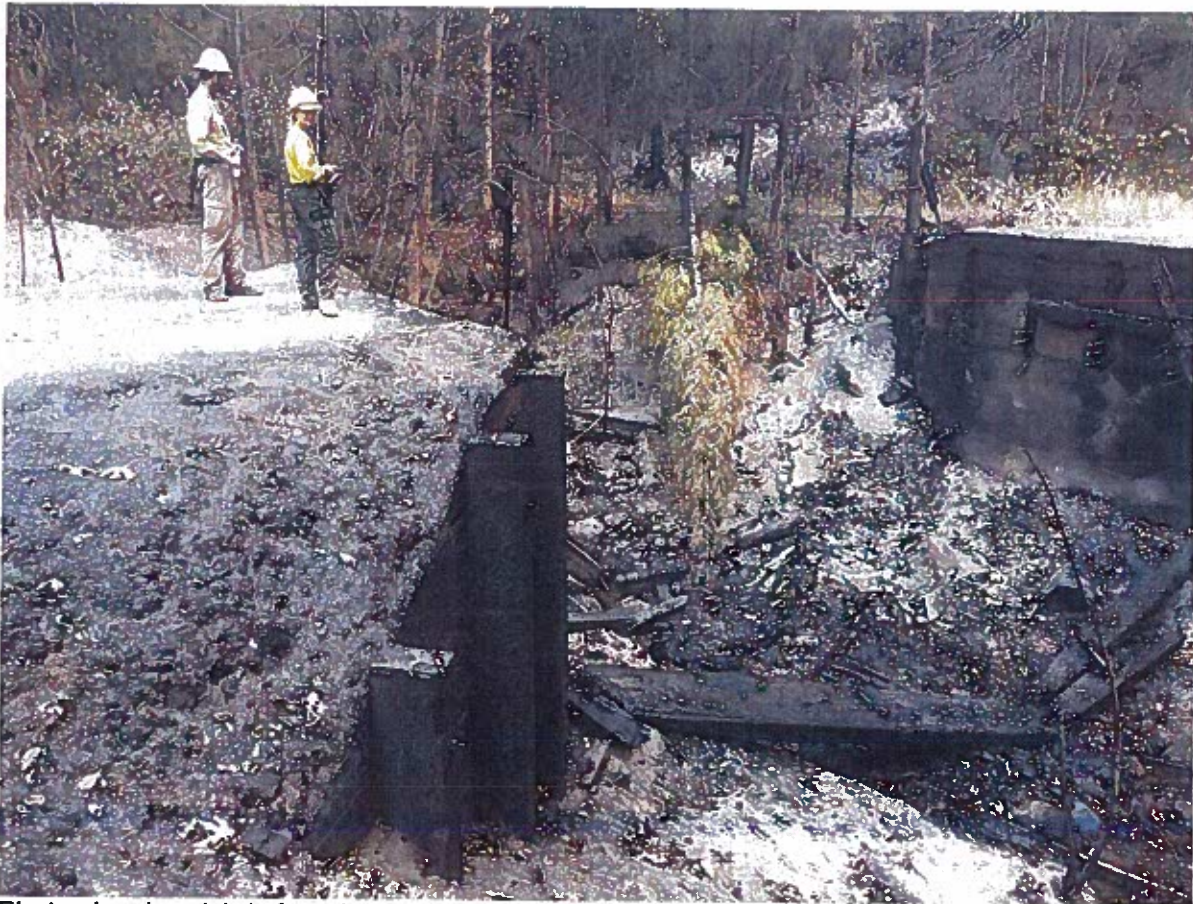
Photo showing debris from burned and collapsed bridge on the 15N02 road over EF Elk Creek.

Removing the burned trail bridge debris from Grider Creek would be accomplished with a California Conservation Corps Crew. The implementation of this project would occur as soon as practical before winter. The cost is **\$27,642**.
