BURNED-AREA REPORT
(Reference FSH 2509.13)

A. Fire Name: Sims

BAER IMPLEMENTATION ACCOMPLISHMENTS

Herringbone Log Dams: Purpose, Installation, and Effectiveness

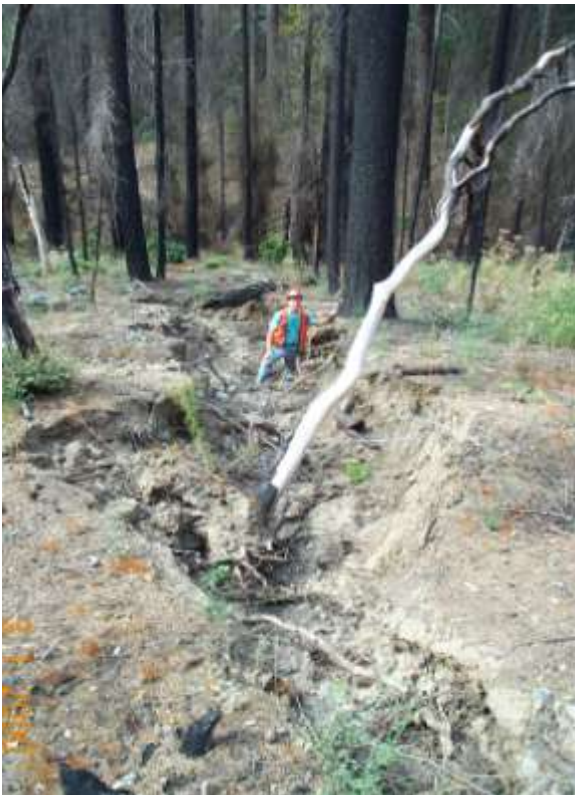
Picture 1. Post fire channel response 46 acre subwatershed. Pre-fire the width to depth of this channel was 1.5 x 0.5 feet. Three years post-fire this channel was 6.5 x 3.8 feet. The winters following the fire were normal to below normal.

Monitoring of post wildland fire impacts on source and transport stream channel types shows that there can be a substantial increase in drainage network efficiency and debris flux causing increased channel width and depth downstream (Picture 1). Increased runoff and debris flux can destabilize the stream network causing inner gorge debris flows, rock flows, dry ravel, and downstream sediment delivery.

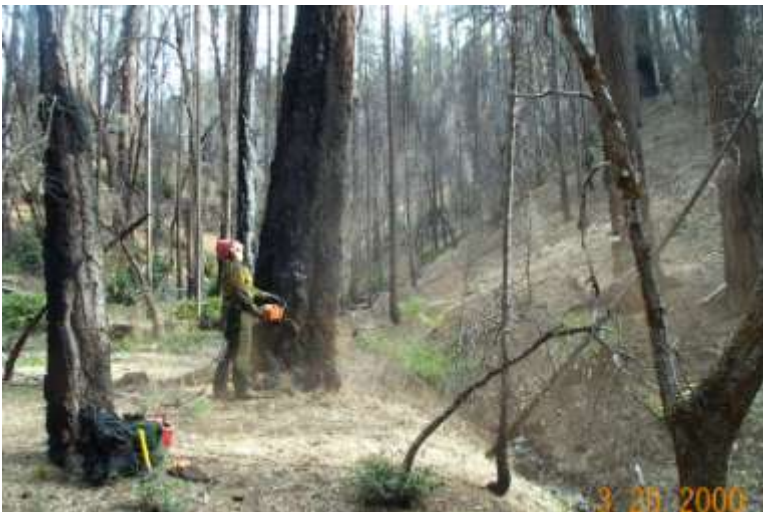
Picture 2. Falling the primary tree across the stream channel.

Herringbone Log Dams are designed to treat steep drainages where woody debris and riparian zone vegetation have been consumed by fire and there is a high risk of debris flows and channel destabilization. The dams are constructed using the existing trees adjacent to the channel. Herringbone Log Dam treatment effectiveness monitoring shows that these dams, when placed and spaced correctly, can substantially reduce the risk of debris flow bulking. These dams immediately stabilize the pre-fire instream bed-material and trap and store the post-fire debris delivered from the hillslope (Picture 2).

Herringbone Log Dams are constructed using existing dead or dying trees adjacent to the stream channel. Trees are strategically fallen with a “primary” tree to plug the channel, and “secondary” tree(s) to buttress the primary tree. The main tree is fallen across the channel and bucked so that either the tree butt of main log touches the channel bottom (Picture 2 and 3). Secondary trees are subsequently fallen to support and/or buttress the primary tree (Picture 4). Cut trees are designated based on their diameter, length, and position relative to the channel. The trees need to be large enough to hold the expected runoff and debris load. Typically, the trees need to be greater than 16 inches in diameter and at least 15 feet long.

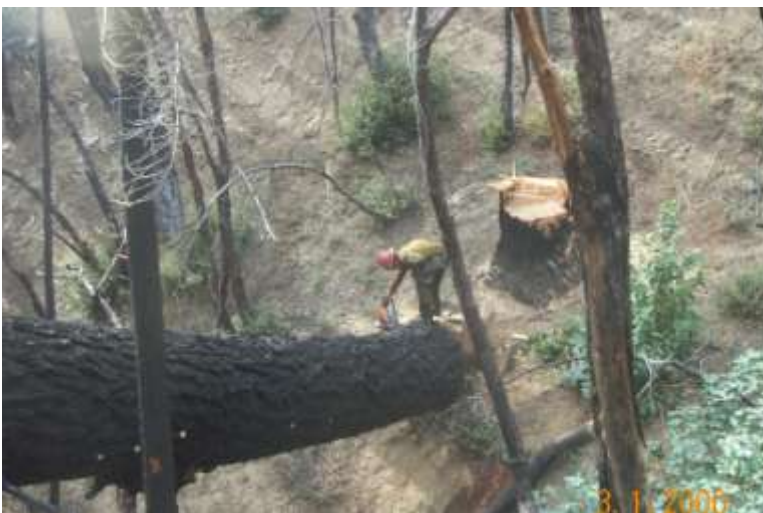
Picture 3. Placing primary tree into channel bottom.

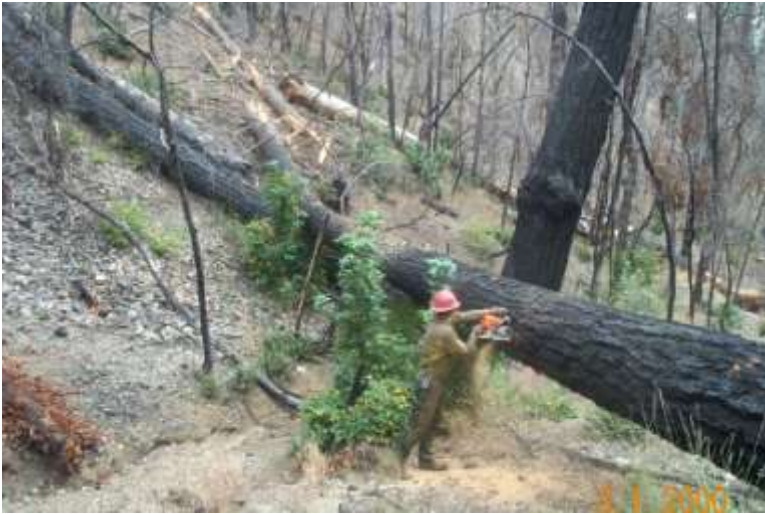
Picture 4. Placing secondary tree into channel to support the primary tree.

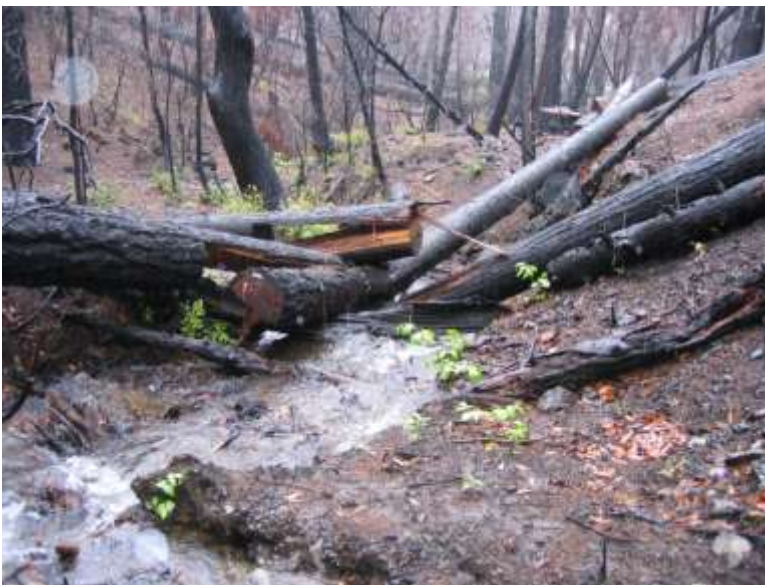
Picture 5. Ideal configuration of finished dam.

The final dam configuration will vary based on site conditions. The final dam though should hold the expected bed-material load and work in concert with the other dams upstream and downstream (Picture 5). Where possible, existing in-channel logs that were not fully consumed by the fire should be used (Picture 6)

Herringbone Log Dam spacing should be a function of channel gradient and the bed-material texture. In steep (i.e., $> 10\%$), coarse grained channels (i.e., $D_{50} > 32$ mm), the dams should be about 75 feet apart. The dam spacing will also depend on the number of available trees. Monitoring has shown that it is critical to place at least one dam directly below the confluence of headwater tributaries and below large instream bed-material deposits.

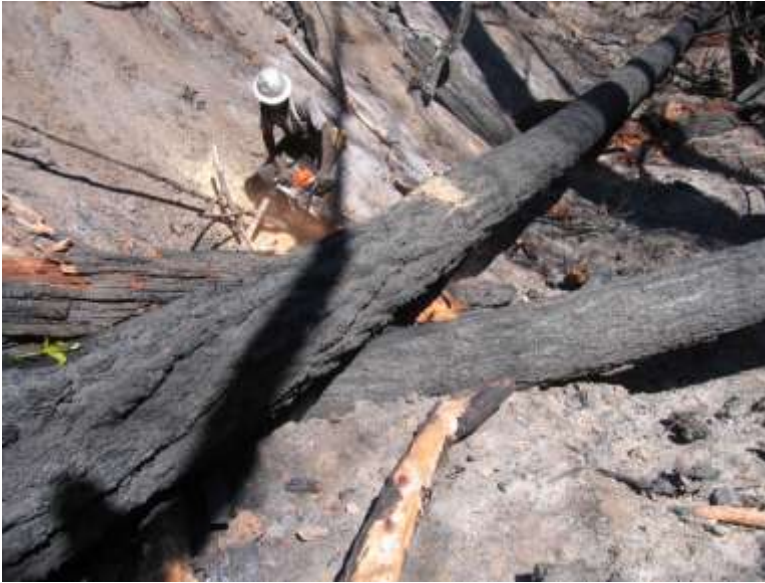
Picture 6. Use of existing in-channel log.

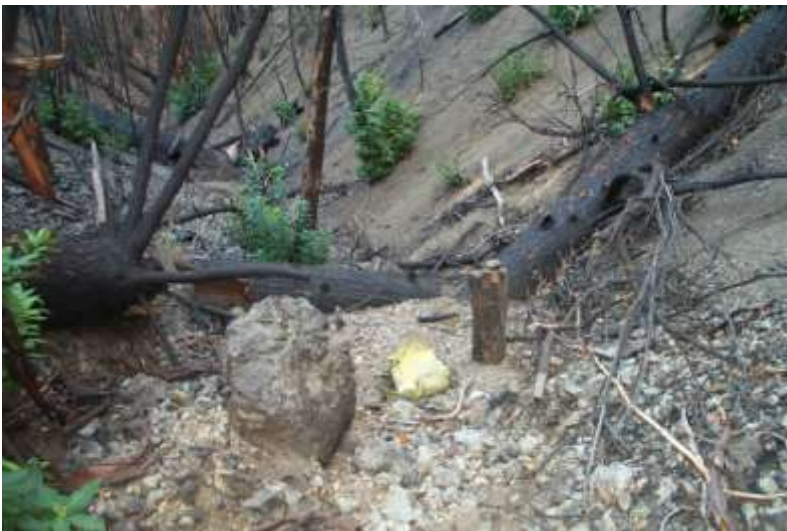
Picture 7 Looking downstream at Herringbone Log Dam after first winter post fire. Dam has trapped about 5 yd³ of debris.

The Shasta Trinity National Forest has been monitoring the effectiveness of Herringbone Log Dam treatment for five water years. This monitoring indicates that these dams, when placed and spaced correctly, can substantially reduce the risk of debris flow bulking and stream channel destabilization (Picture 7). These dams immediately stabilize the pre-fire instream bed-material and trap and store the post-fire debris delivered from the hillslope.
