BURNED-AREA REPORT
(Reference FSH 2509.13)**PART I - TYPE OF REQUEST****A. Type of Report**

- A. Fire Name: Chips Fire B. Fire Number: CA-PNF-1001
C. State: California D. County: Plumas
E. Region: 05 F. Forest: Plumas and Lassen
G. District: Mount Hough (PNF) and Almanor (LNF) H. Fire Incident Job Code: P5G32E

BURNED-AREA REPORT
Chips Fire: Plumas and Lassen National Forests

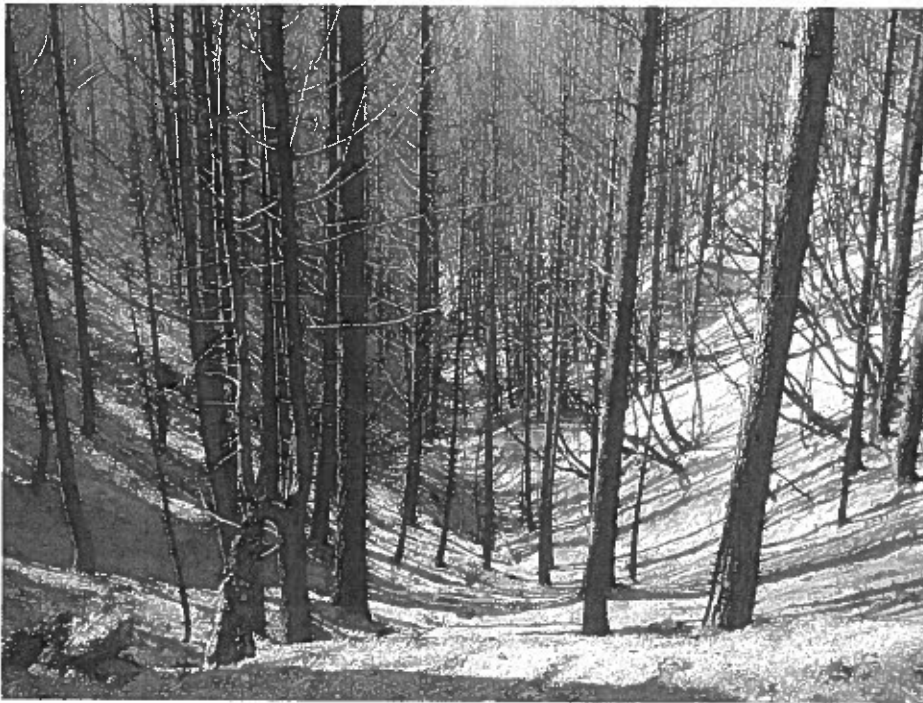
An area along a tributary to Mosquito Creek. This area was indicated to be high burn severity by BARC imagery but was revised to moderate severity after on-the-ground visits. However, due to complete consumption of ground cover and vegetative canopy, watershed response is expected to be extreme in these areas, with increased runoff and higher debris delivered to stream channels.
