BACKBONE FIRE BURNED-AREA REPORT
(Reference FSH 2509.13)

| A. Fire Name: <u>Backbone Fire</u> | B. Fire Number: <u>CA-SRF-1131</u> |

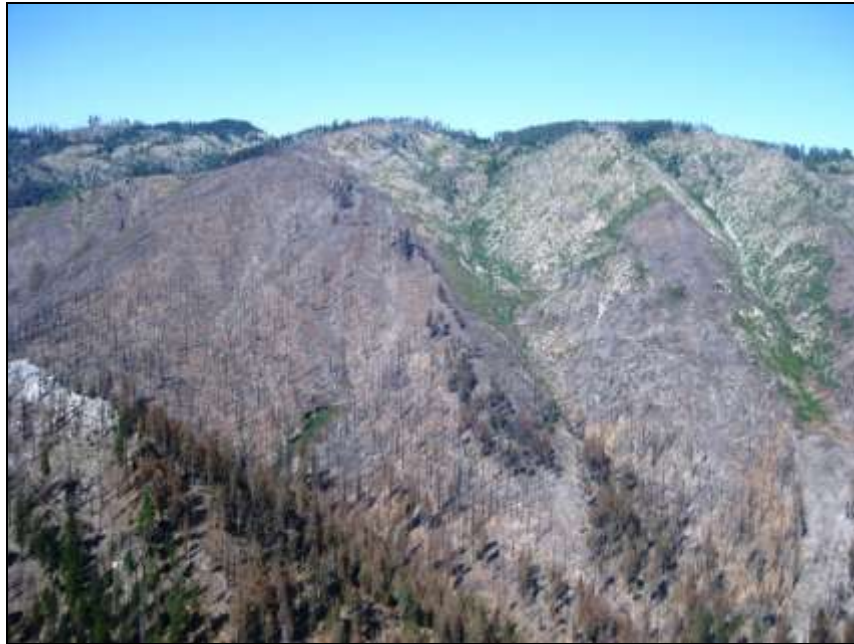
Backbone Fire looking into Soldier Ck. watershed above Paul Gibson Cave and trail 6E01
