USDA-FOREST SERVICE

BURNED-AREA REPORT
(Reference FSH 2509.13)

PART II - BURNED-AREA DESCRIPTION
(East Harker Complex)

- A. Fire Name: Trojan # 2 B. Fire Numbers: 48070
- C. State: UTAH D. County: Utah
- E. Region: 04 F. Forest: UINTA
- G. District: SPANISH FORK
- H. Date Fire Started: 9/10/94 I. Date Fire Controlled: 9/15/94

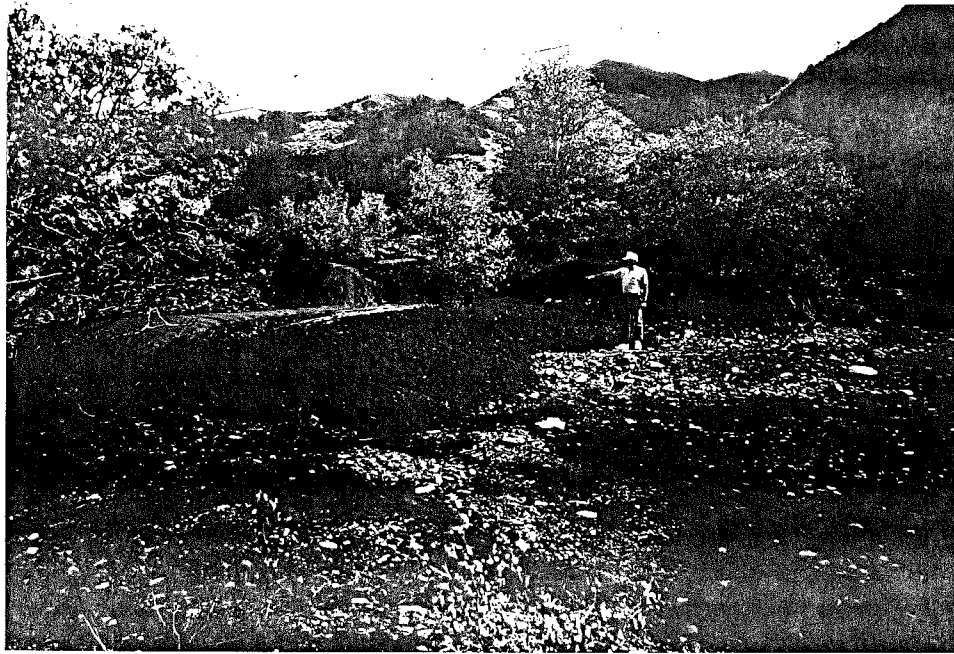
PHOTO 15 Doug Wheeler of Mapleton City inspects more flood debris deposited on the powerline road upstream about 100 yards from previous photo and at the same location which Photo 10 was taken. This flood event occurred the previous evening around 9:30 p.m. following a high intensity burst of rain amounting to .35 inches in a 20-minute period. 9/30/94 P.H.S.

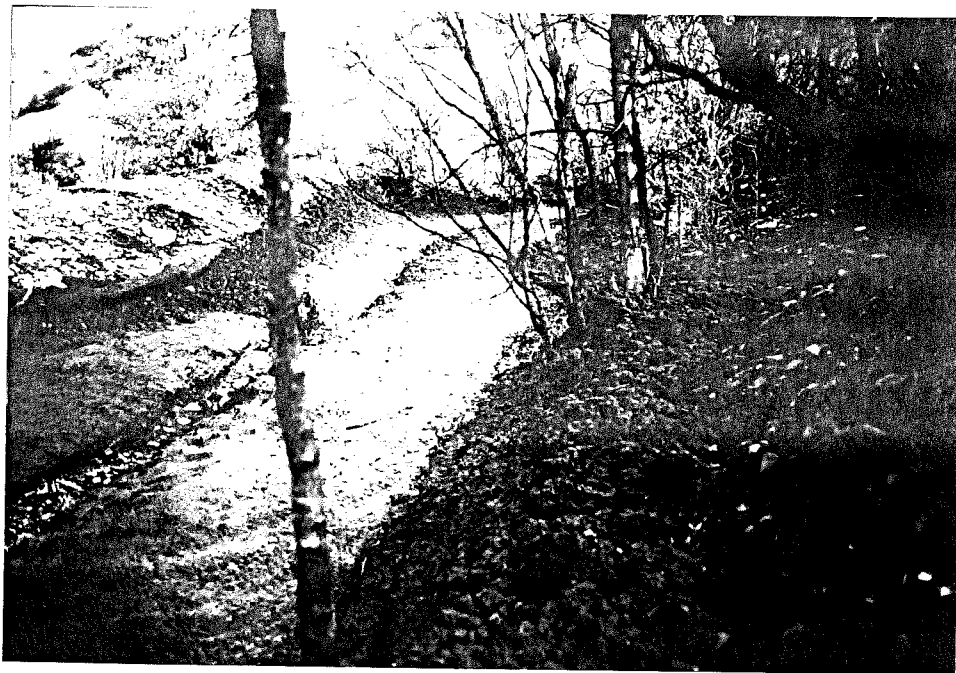
PHOTO 16 Channel of Big Slide Canyon just upslope from the powerline road has been coated with a deposit of concrete-like flood debris. Compare to Photo 6 and 7 in Middle Slide Canyon 1989 Flood Report. 9/30/94 P.H.S.
