BURNED-AREA REPORT
(Reference FSH 2509.13)**PART I - TYPE OF REQUEST****A. Type of Report**

| A. Fire Name: Brittle Fire | B. Fire Number: MI-HMF-210172 |
| C. State: MI | D. County: Iosco |

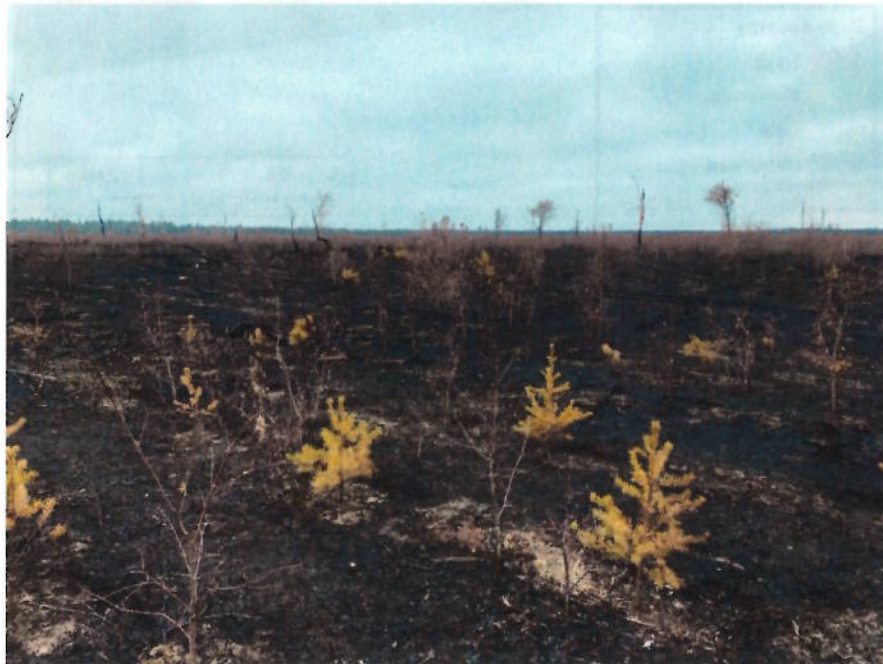
Figure 3: Level glacial lake plain characteristic of the Brittle Fire burn area.

The Brittle Fire occurred in Iosco County Michigan and started on Friday, April 23, 2021 (Figure 1). The footprint of the fire occurs on a level glacial lake plain characterized by deep, infertile, sands with very high infiltration capacity (Figure 3). Much of the area is managed for Kirtland's warbler habitat and was forested with newly established to approximately 10 year old jack pine planted for nesting habitat (Figure 2). Other timber types were mostly older jack pine, red pine, or mixtures of the two species.

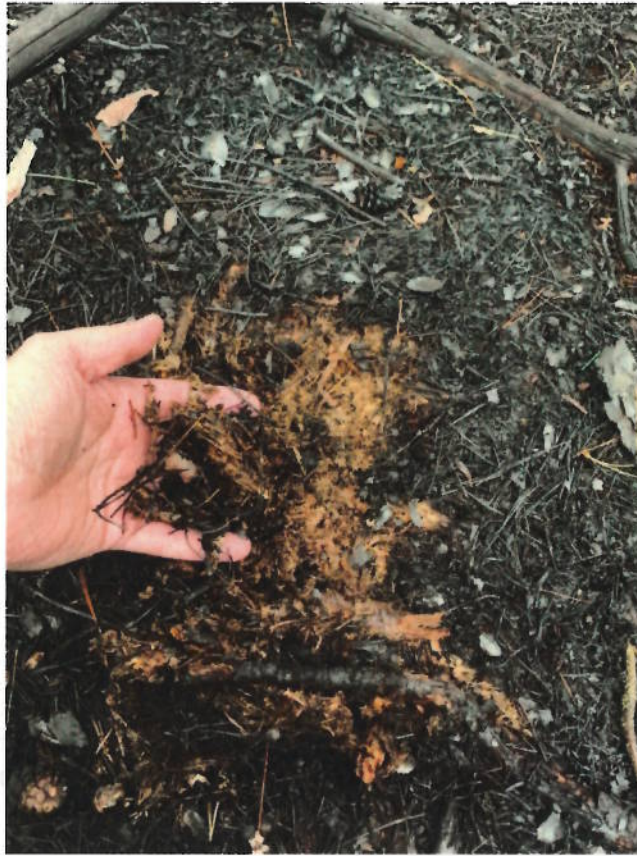
Figure 5: Forest floor debris was not consumed by the low intensity Brittle Fire. Soils retain a high degree of infiltration capacity and no overland flow was observed or is expected.

The fire was mostly low to moderate intensity (Figure 4) and the forest floor was not observed to be completely consumed at any location within the burned area (Figure 5). No occurrence of hydrophobic soils was observed.

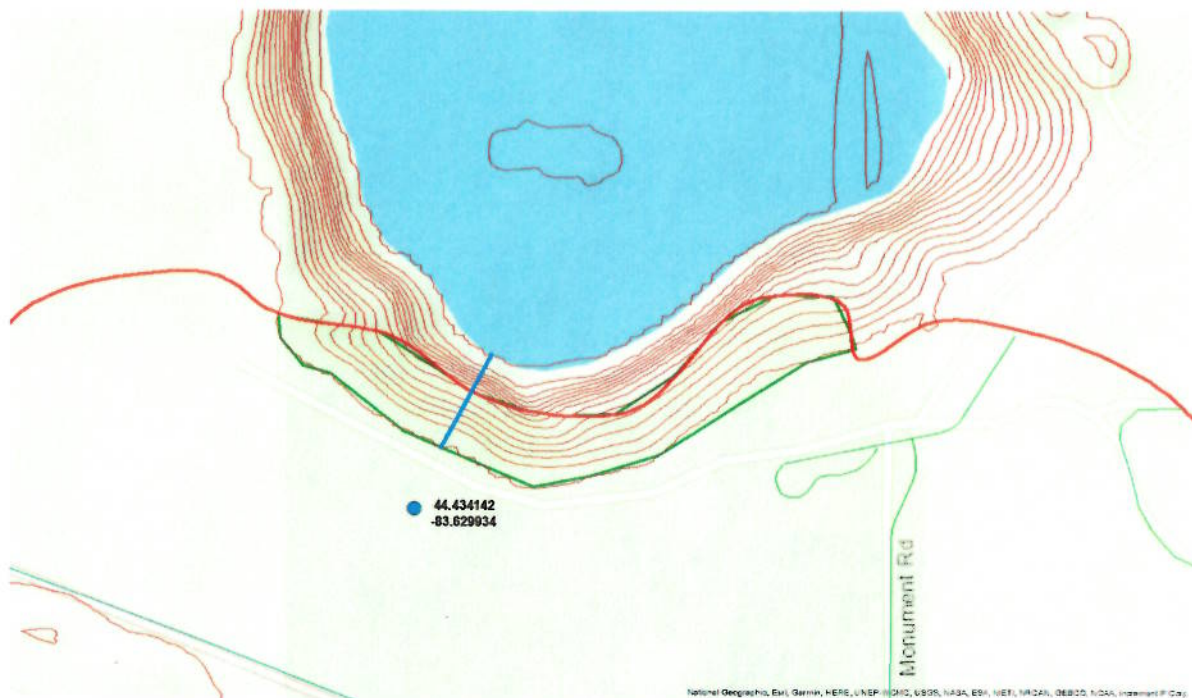
Figure 7. Close up of slope leading to Cooke Dam Pond on the Au Sable River (site "A" from Figure 6 above). Green shaded area is zone of potential soil erosion and blue line shows transect for WEPP analysis (see Appendix A).

Few aquatic resources exist within the burned area and were identified as shown in Figure 6. At point "A" the fire burned the upper 35 to 50 feet of an approximately 330 foot slope leading to Cooke Dam Pond on the Au Sable River (Figure 7). The fire was low intensity at this location and extensive surface cover from forest litter and dead woody vegetation remained after the fire with intact, unburned vegetation on the lower slope (Figure 8). Onsite observation suggested little potential for greater than background levels of soil erosion. This was supported by the fact that at least two post fire rain events resulted in no evidence of gully formation or overland flow in the area. Further, Disturbed WEPP analysis, which assumed low severity fire on the upper 197 feet of slope (the fire only occurred on the upper 35 to 50 feet of slope) predicted mean annual average of 0.013 t ac^{-1} soil erosion and no sediment leaving the profile (Appendix A). Accordingly, no BAER remediation is recommended at this location.

**APPENDIX A: WEPP ANALYSIS OF SLOPE TO COOKE DAM POND
(Refer to Figures 7 and 8)**

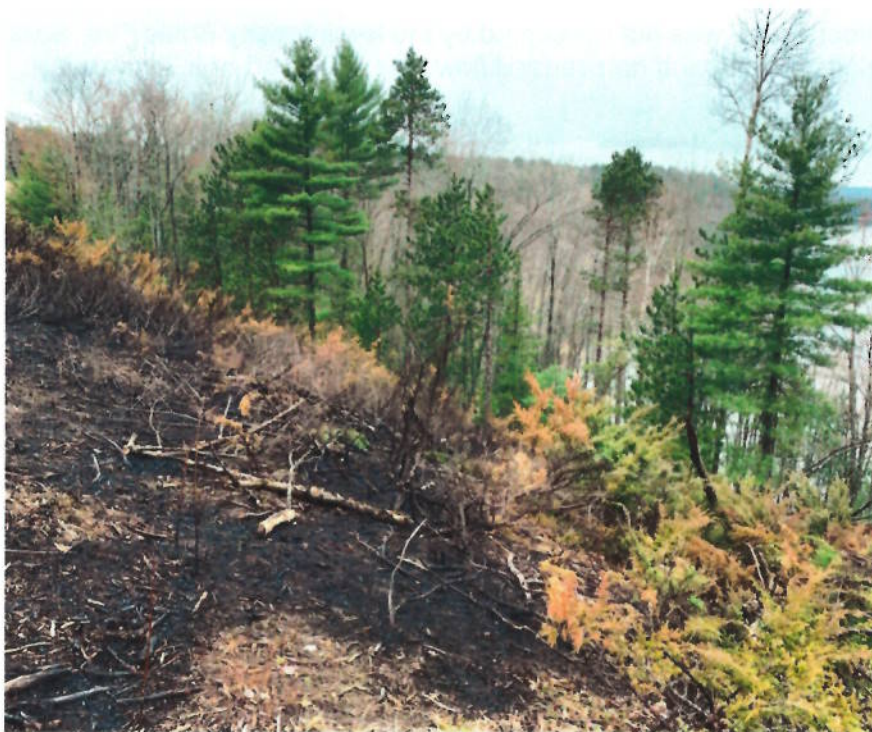
Figure 8: Photo of slope from Figure 7 above. Vegetation on most of the slope leading to the Au Sable River was not burned in the fire.
