SACATA FIRE BURNED-AREA REPORT
(Reference FSH 2509.13)

The Sacata Fire 2018

A. Fire Name: Sacata Fire

B. Fire Number: CA-SNF-002370

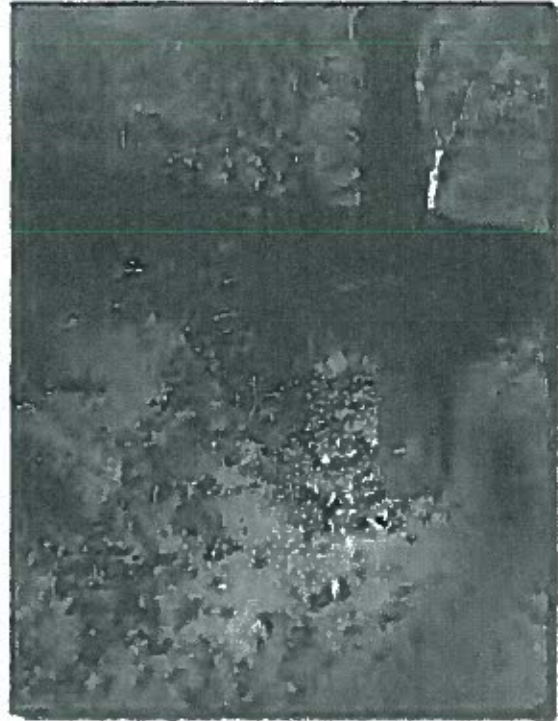
Photo 1: Low soil burn severity

Only a low soil burn severity was observed throughout the burned area with sparse areas of higher severities not large enough to be properly mapped, see Photo 1 for a visual representation of the conditions observed in the field. Minimal evidence of significant soil heating was observed. Very little vegetative consumption occurred throughout the burned area leaving a charred look in patches, all of

the pre-fire canopy was still intact. Ground cover was recognizable with little to no effective cover loss. Ash was generally white to black in areas of total consumption. Very little organic matter was consumed resulting in an unaltered soil texture, very fine roots were still present in the upper soil profiles. Water repellency was low to non-existent. The seed source within these areas would still be present in most of the topsoil and natural understory revegetation is expected to progress without delay.

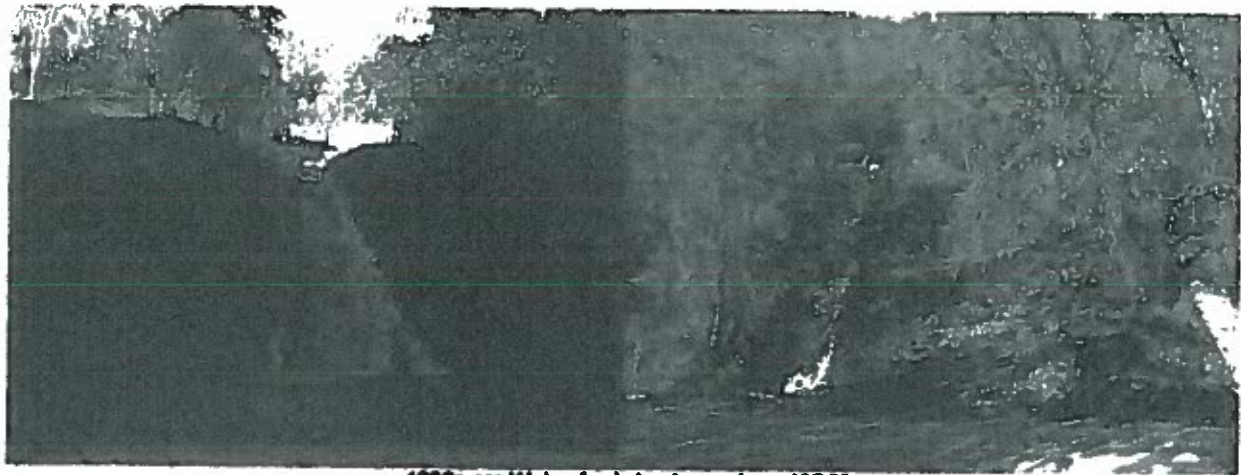
On October 21, the author visited the dams/watershed study structures and the old roadbed along Road 10S69 on the east side of the fire.

Consequences of the fire on values at risk: None of the properties was at risk for adverse effects from the fire and post-fire erosion events, or any other actions, due to the low intensity of the burn and the limited potential for damaging post-fire erosion. The watershed structures are somewhat more exposed to the public, increasing the potential for vandalism, but their existence is in the public domain, as there are published photographs of them available via Google Earth and other websites. The old roadbed above and parallel to 10S69 appears stable, although parts have washed out where it crosses drainages. Within the fire perimeter are 2 previously recorded prehistoric related archaeological sites. Only one site, a lithic scatter camp, was damaged by suppression activity.

1930s-era Watershed structures along 10869
