BURNED-AREA REPORT
(Reference FSH 2509.13)

A. Fire Name: Hale Gulch

F. Forest: Salmon-Challis N.F.

G. District: North Fork

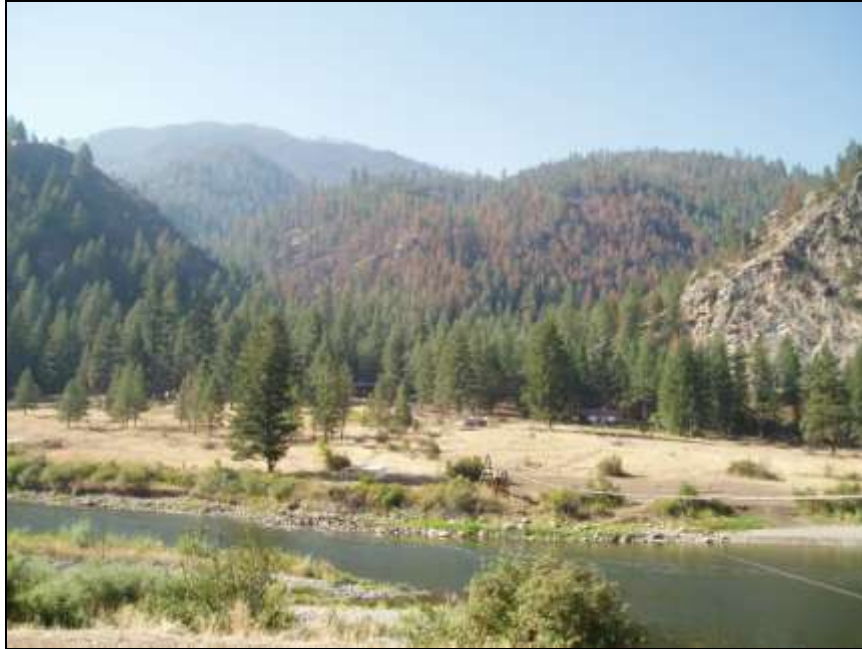
The Cadagan Complex Fire burned 2,643 acres in several small watersheds tributary to the Salmon River. A privately owned High Adventure Boy Scout Camp is located on the large fan at the mouth of Hale gulch (Figure

Figure 1. Overview of Cadagan Complex and High Adventure Scout Camp.

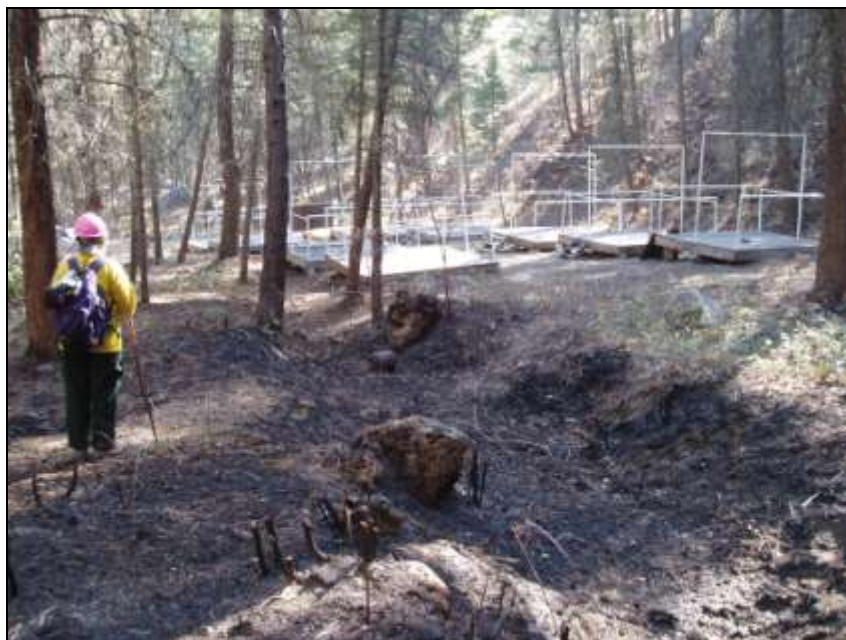
Figure 2. Hale Gulch channel and Upper tent platforms.

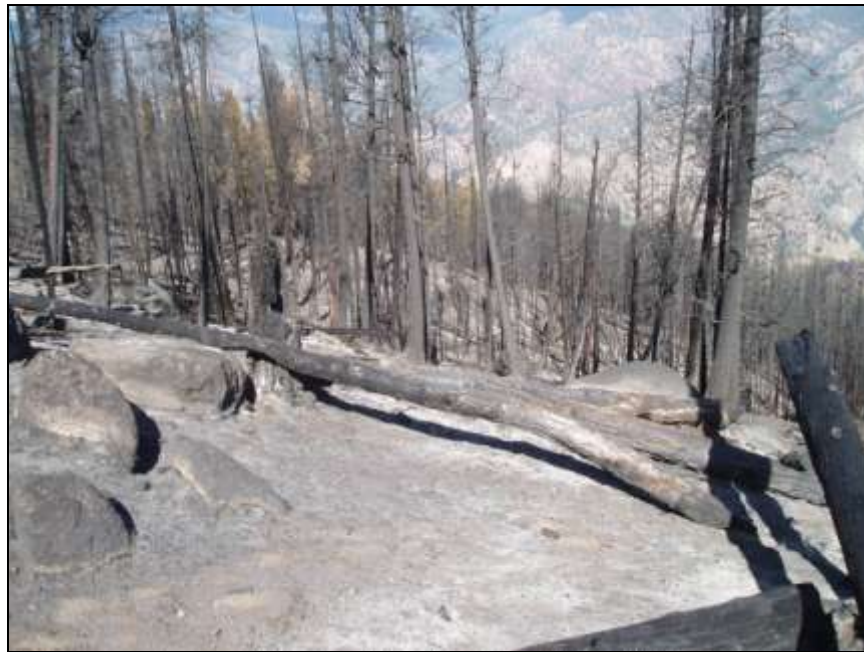
1). The boy Scout Camp is seasonally occupied during the summer months. Additionally there are four seasonally occupied homes in the Rivers Edge subdivision and one year-round residence on the Gazebo property. An assessment of the threats to life and property has been conducted based on a review of fire maps and a field review of the fire area. The only property that is considered to at risk of flooding is the High Adventure Boy Scout Camp. This camp is usually occupied from June through early August during the period of high intensity summer thunderstorms. Hale Gulch is an ephemeral stream with a defined channel. (Figure 2) Evidence of past debris flows was observed along Hale Gulch during the field review. This drainage is located in a high intensity storm track along the Salmon River. High intensity storms are frequent in this area and produce frequent debris flows in both burned and unburned drainages. The majority of the fire area (approximately 90%) is either unburned or a low severity burn. Approximately 10% of the burned area, located in the headwaters of Hale Gulch and Sawlog Gulch, has a moderate fire severity. The moderate fire severity areas are located on steep slopes (50 – 70%) with erosive granitic soils. (Figure 3)

Figure 3. Moderate burn severity near the head of Hale Gulch.

Land treatments are recommended on the moderate severity burn areas (Figure 3) located at the head of Hale Gulch to reduce the risk of flooding and debris flows at the Boy Scout Camp. The objective of the requested RAWS station is to provide an early warning system to be used in conjunction with a flood evacuation plan for the Boy Scout Camp

Land Treatments: Hand Application of Long-Strand Erosion Control Material from Forest and Urban Wood. Wood strand material would be spread on moderate severity burn areas in the headwaters of Hale gulch and an unnamed tributary of Hale gulch. The placement of these materials would increase rainfall infiltration and reduce soil erosion and the risk of flooding at the Boy Scout camp.
