Subject: Corral Fire BAER 2500-8 request

Date of Report: 10/18/2013

**BURNED-AREA REPORT**  
(Reference FSH 2509.13)**PART I - TYPE OF REQUEST**

**A. Fire Name:** Corral Fire

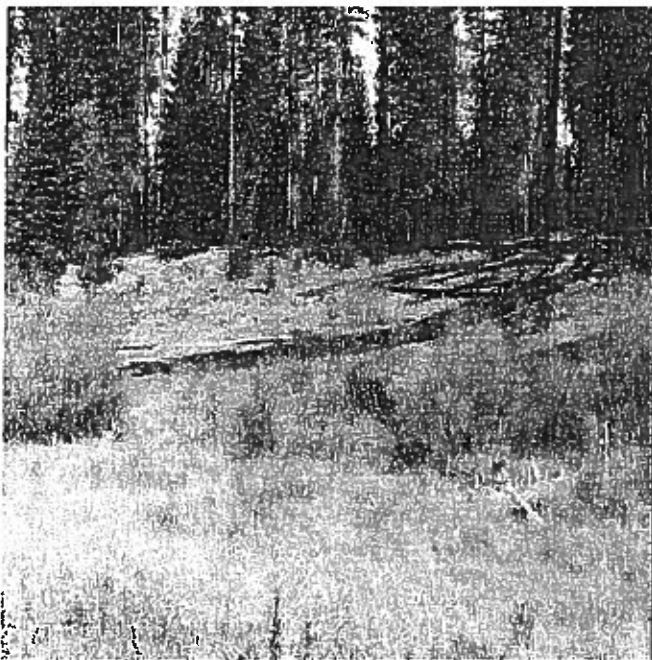
**Low soil burn severity**

severity the surface litter is only partially consumed and the shrub or canopy is still partially green.

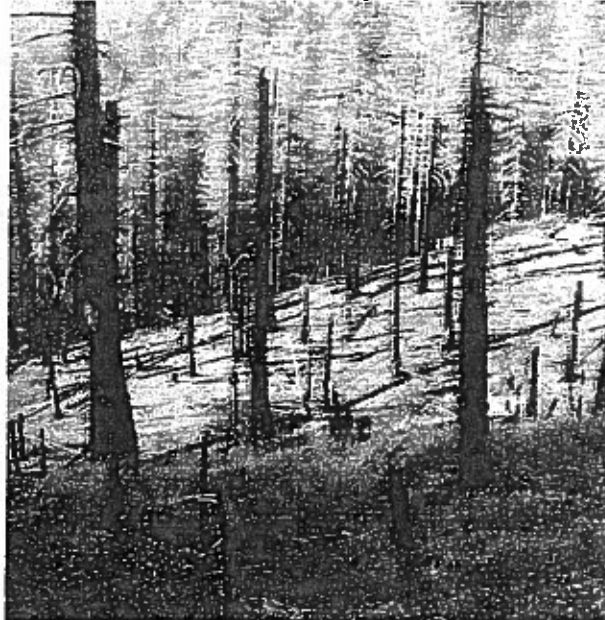
**Moderate soil burn severity**

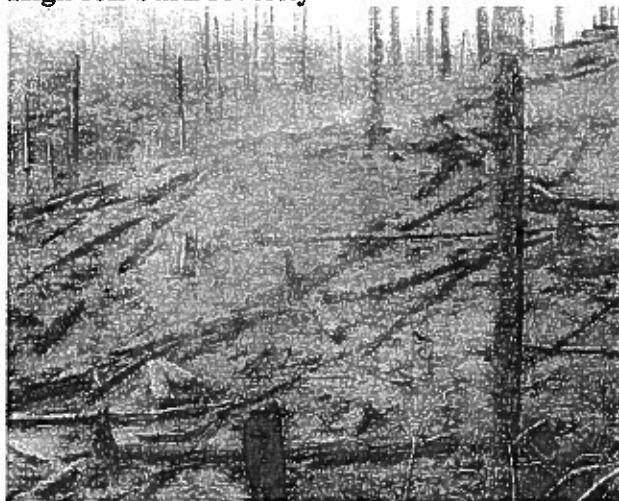
**High soil burn severity**

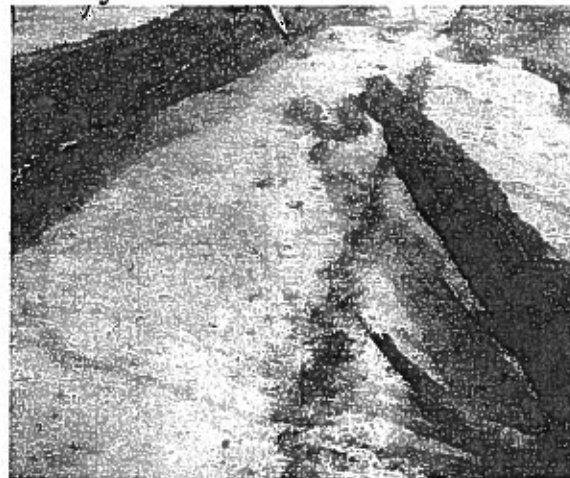
**Charred mineral soil in high soil burn severity**

Soil burn severity is assessed by looking at above ground cover and surface cover, soil char (depth of soil burning), soil structure, destruction of soil organic matter, destruction of fine roots, and water repellency strength and depth. Areas of high soil burn severity typically had nearly all surface organics removed and char depths of up to 1 in affecting soil structure and fine roots. Water repellency in high soil burn severity is running from 2 to 4 inches deep depending on soil texture and vegetation that was burned. In moderate soil burn severity most of the surface organics are consumed but fine roots and soil structure are unaffected. Water repellency is low or non-existent and scorched needles and leaves provide for potential soil cover. In low soil burn
