Rough Fire – South Zone
Sequoia National Forest
2500-8 BAER Assessment Report
October 24th, 2015

**Rough Fire – South Zone
Sequoia National Forest
2500-8 BAER Assessment Report
October 24th, 2015
Executive Summary**

BURNED-AREA REPORT
(Reference FSH 2509.13)**PART I - TYPE OF REQUEST****A. Type of Report**

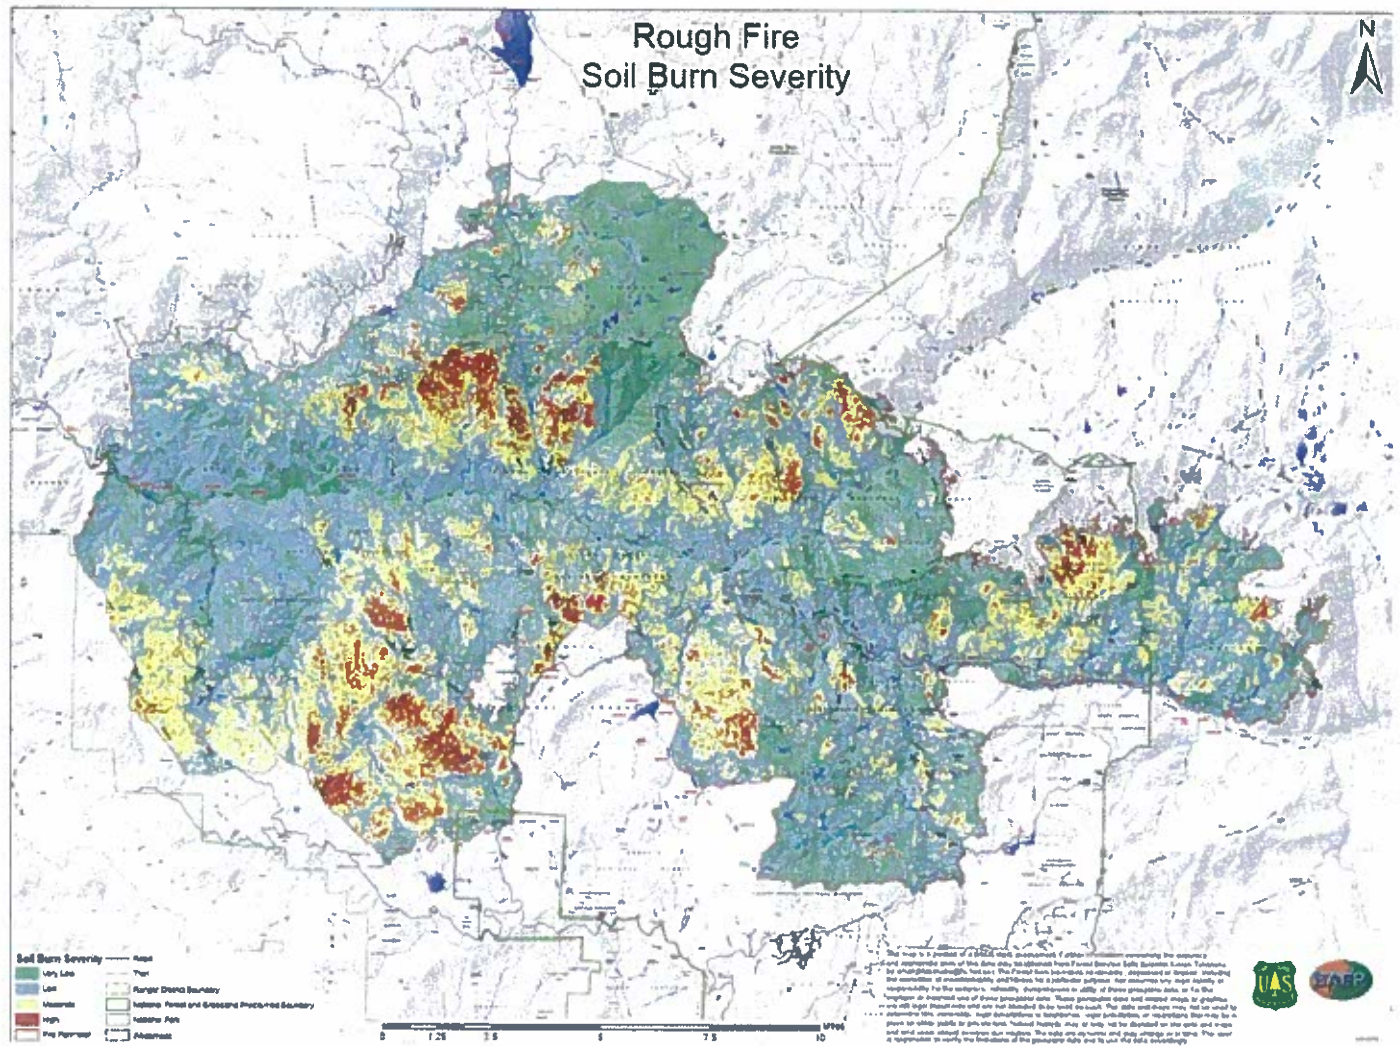
Figure 1 Soil Burn Severity Map for the Round Fire

A. Burn Severity (acres): unburned/very low – 36,631 (24%); low – 66,497 (44%); moderate – 41,943 (28%); high – 6,031 (4%)
