**Date of Report: 9/28/2021**

**BURNED-AREA REPORT**  
**Mud Lick Fire 2021**  
**Salmon-Challis National Forest**

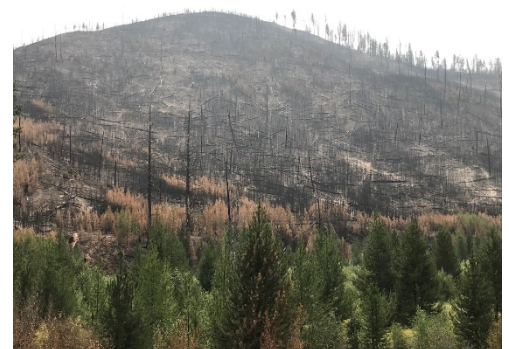
- Because most of the burned area previously burned in the 2000 Clear Creek Fire, a heavy component of large downed trees exists in many portions of the burned area. High intensity burned areas tend to be located on steeper slopes that contain thick regrowth from the Clear Creek Fire as well as a heavy downed log component. In these areas, white-colored soils where downed logs were completely consumed are indicative of high soil burn severity. Areas of high burn intensity generally showed these characteristics, and the assumption was made that all high intensity areas burned at high severity.

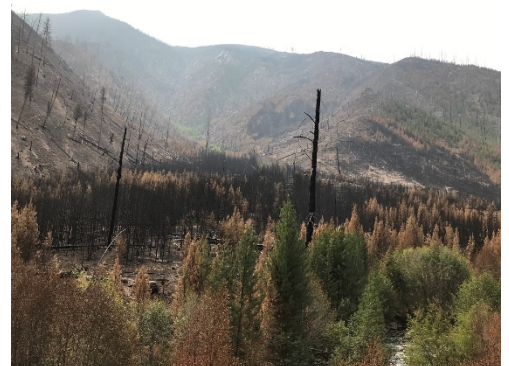
- Many lower gradient slopes with thick regrowth from the 2000 Clear Creek Fire but a lesser component of downed logs tended to burn at moderate intensity, sometimes with pockets of high intensity where downed logs smoldered. The assumption is made that these moderate intensity burned areas burned at moderate soil burn severity.

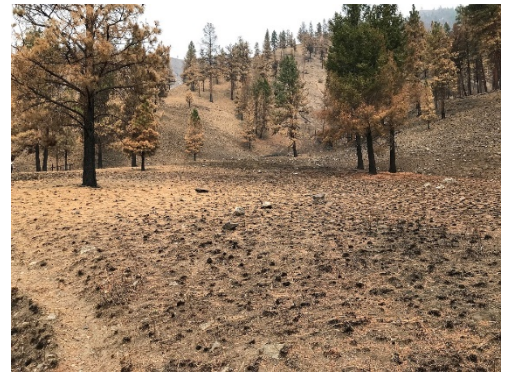
- Low intensity burn occurred in areas of thick regrowth from the 2000 Clear Creek fire where the fire backed down the slope, as well as on most of the South-facing open ponderosa pine forests. Soil burn severity testing on 8/17/2021 confirmed that open ponderosa pine forests burned at low severity, with the bunchgrass root masses still intact and regrowth occurring just a few weeks after the fire.

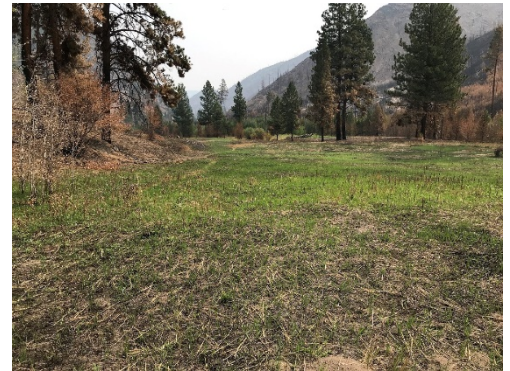
- The adjusted BARC data showed a mixture of unburned, low intensity, and moderate intensity burn in riparian areas along Big Deer Creek. Grassy meadows in the valley floor that burned at moderate intensity show signs of low soil burn severity, with new growth occurring just weeks after the fire. With the assumption that severity is equivalent to intensity, the accuracy of the BARC severity mapping in these areas is mixed as a result of large pixel size, but suitable for this analysis.

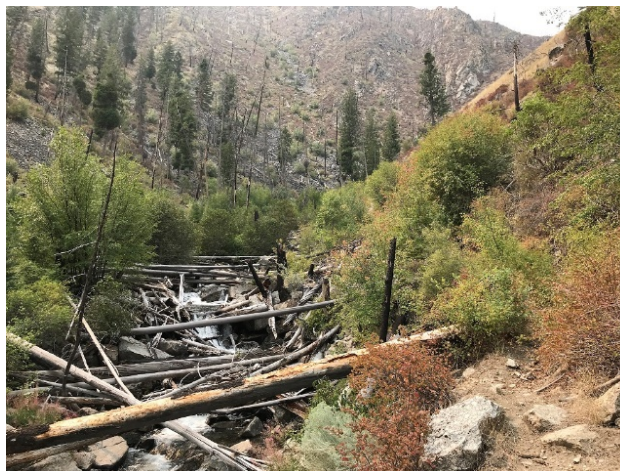
Any high flow events or debris flows within the Big Deer Creek drainage are likely to mobilize sediment and woody debris. Because of the large amount of woody debris already in the channel as a result of the 2000 Clear Creek Fire, a high potential exists for the formation of large debris jams. Debris jams in Big Deer Creek would have the potential to store sediment that could be easily mobilized during subsequent high flow events. It is likely that post-fire flood events in Big Deer Creek will increase delivery of sediment and woody debris to Panther Creek. While an extreme consequence of this could include temporary high turbidities and the loss of portion(s) of the Panther Creek Road, the delivery of sediment and woody debris to the channel of Panther Creek would ultimately provide the materials for improved aquatic habitat.

*Woody debris in Big Deer Creek, approx. ¼ mile upstream of mouth.*

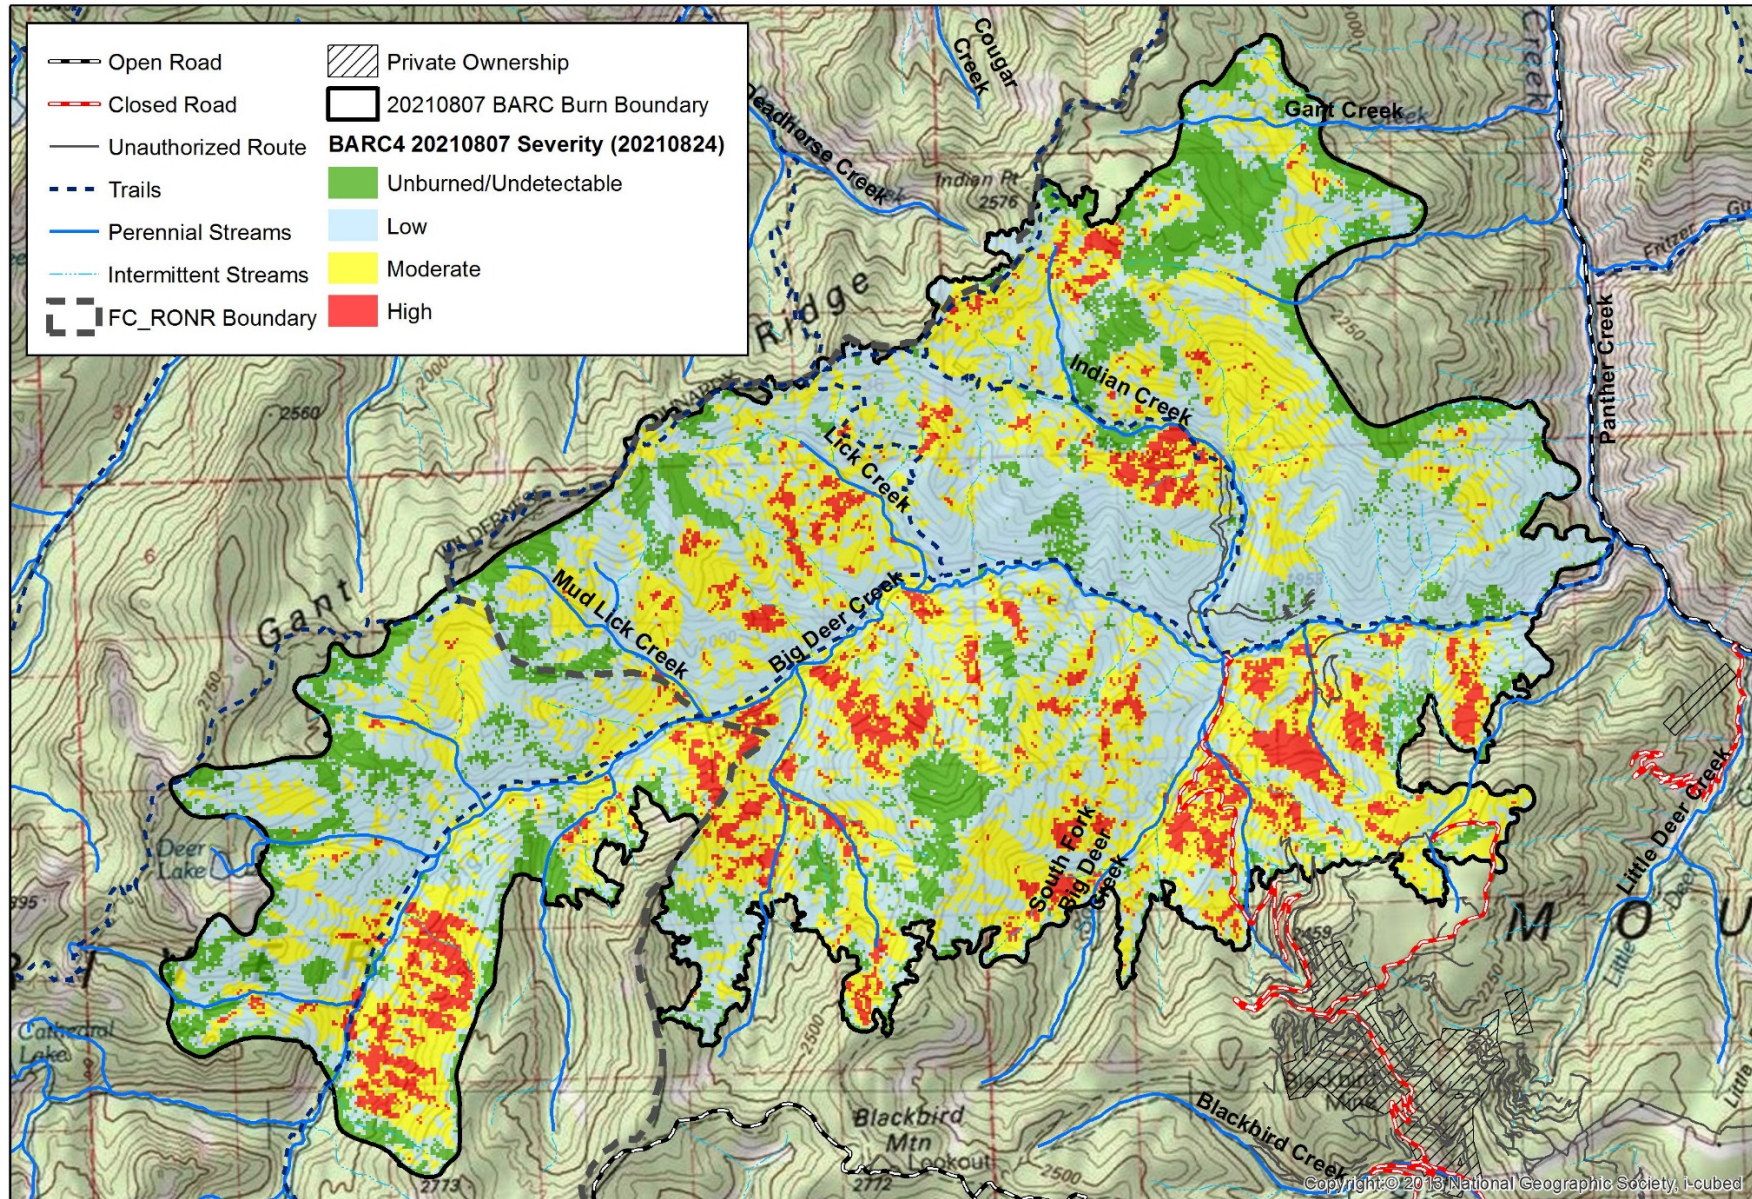
### Burn Severity Map for the Mud Lick Fire, Salmon-Challis National Forest

Map created 8/25/2021 by the Salmon-Challis National Forest Mud Lick Fire BAER Team. BARC Data and Fire Perimeter from analysis of Landsat 8 OLI satellite data, by USDA Forest Service, Geospatial Technology and Applications Center, BAER Imagery Support Program. BARC data field verified 8/17/2021, and burn severity data adjusted to match field data/observations.

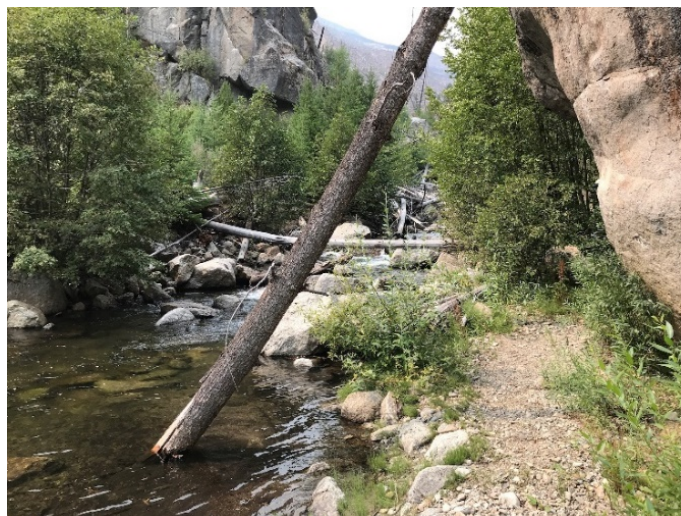
**Comments:** The most commonly used trail in the burned area is the Big Deer Creek Trail (#6029), which follows the length of Big Deer Creek. This trail is commonly used by hunters and horse packers during the fall hunting season. Other trails in the trail network within the burned area include the Indian Creek Trail (#6026), the Lick Creek Trail (#6010), and the Gant Ridge Trail (#6028), which are used to a lesser degree. A primitive hunting camp exists along the Big Deer Creek Trail at the mouth of Indian Creek. The Big Deer Creek Trail has a well defined tread as it crosses variable hillslopes adjacent to Big Deer Creek, passes through some floodplain areas, and occupies old bench-cut road beds in other areas. The trail condition is good, although drainage structures are not incorporated into the trail, and some sections of trail cross eroding slopes. Post-fire hillslope runoff is not likely to have a large effect on the Big Deer Creek Trail because most of the trail crosses through low severity burn on South-facing slopes of ponderosa pine, in which groundcover is likely to recover quickly. The greatest risk to this trail is from post-fire debris flow events in the Big Deer Creek drainage. The portions of this trail in the floodplain directly adjacent to Big Deer Creek would likely experience the greatest effects, but bank cutting could also induce erosion that could undermine portions of the trail that are on the slope adjacent to the channel. Portions of the trail that become blocked or damaged where the canyon is constricted may become impassible. The hunting camp at the mouth of Indian Creek is in a flat, grassy meadow and is at low risk. The Indian Creek, Lick Creek, and Gant Ridge Trails pass through mostly low and moderate severity burn, although a portion of the Indian Creek Trail passes through or adjacent to an area of high severity burn. Isolated portions of these trails may be at risk from increased post-fire hillslope runoff/erosion and/or debris flows. However, these trails receive less use and maintenance, with little in the way of drainage structures and deadfall being the major issue since the 2000 Clear Creek Fire. Increased deadfall as a result of the Mud Lick Fire is likely to be a concern for at least 5 to 10 years along this trail system, and potentially much longer. Increased deadfall has been a major issue impacting access to this area for the past 20 years following the 2000 Clear Creek Fire.

*Big Deer Creek Trail along Big Deer Creek*

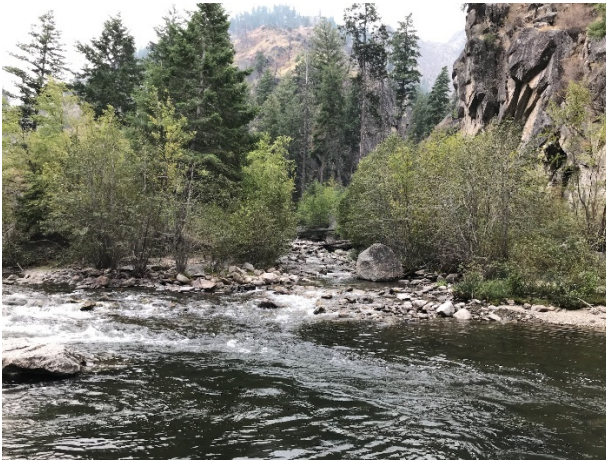
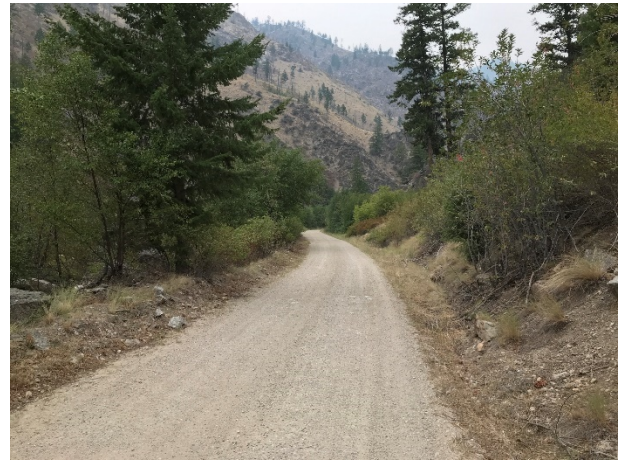
**Comments:** The Panther Creek Road (FR60055) is not within the burned area, but it is adjacent to the burned area at the mouth of Big Deer Creek. The risk of debris flows impacting this location is discussed above under Hydrologic Response. The Panther Creek Road at this location is in the highly confined Panther Creek canyon, with only the channel of Panther Creek separating it from the mouth of Big Deer Creek. The valley width at this location is approximately 100 to 120 feet, and the elevation of the Panther Creek Road is only about 5 feet above the bankfull elevation of Panther Creek. A 20 to 30-foot wide riparian area exists between Panther Creek and the Panther Creek Road. The gradient of Panther Creek just downstream of the mouth of Big Deer Creek is fairly low, providing a depositional environment. This geomorphic configuration presents a risk to the Panther

Creek Road if a post-fire debris flow in Big Deer Creek were to create a fan deposit of sediment, rocks, and/or logs in Panther Creek. Depending on the magnitude of such an event, this could result in erosion along the road embankment, inundation of the road, and/or burial of the road with the Panther Creek channel being pushed onto the location of the road. A temporary closure of the road at this location would impact access to the Forest on this main access road, but it would not prohibit ingress/egress because alternative access routes exist into the Panther Creek corridor. The degree of risk to roads or other Forest Service property along Panther Creek downstream of the mouth of Big Deer Creek resulting from a flood or debris flow event would decrease substantially with distance, as the Panther Creek is a much larger channel than Big Deer Creek (the approximate 100-year flow recurrence interval flow on Panther Creek is 2860 cfs, based on Streamstats modeling).

Left: Mouth of Big Deer Creek at Panther Creek. Right: Panther Creek Road across from mouth of Big Deer Creek.

Panther Creek Road – The SCNF is not proposing any BAER treatments to decrease the risk of damage to the Panther Creek Road as a result of potential debris flow deposition at the mouth of Big Deer Creek. Potential treatments to address this issue could include mulching the high severity burned areas in the watershed or preemptively relocating a portion of the Panther Creek Road. However, these would be very high cost treatments that may not substantially decrease the risk of loss and likely would not be cost effective. Armoring the existing road may provide protection to the road under certain conditions, but would not be beneficial if a large debris flow buried or inundated the road. Because it is not possible to predict the nature or magnitude of effects to the Panther Creek Road if a flood event in Big Deer Creek were to occur, no reasonable preemptive treatment scenario exists. This site will be monitored by road crew and other personnel so that actions can be taken immediately if a flood event results in imminent risks to the road.
