# Rock Mountain Fire December 2016

**BURNED-AREA REPORT**  
(Reference FSH 2509.13)**PART I - TYPE OF REQUEST****A. Type of Report**

**PART II - BURNED-AREA DESCRIPTION****A. Fire Name:** Rock Mountain**B. Fire Number:** GA-CHF-160079**C. State:** Georgia and North Carolina**D. Counties:** Clay and Macon (North Carolina), Rabun and Towns (Georgia)**E. Region:** 8**F. Forest:** Chattahoochee-Oconee, Nantahala**G. Districts:** Chatooga River, Nantahala, and Tusquitee**H. Fire Incident Job Code:** P8KTE7 0803**I. Date Fire Started:** 11/09/2016**J. Date Fire Contained:** Unknown**K. Suppression Cost:** \$11.7 million**L. Fire Suppression Damages Repaired with Suppression Funds:****Chattahoochee NF:**

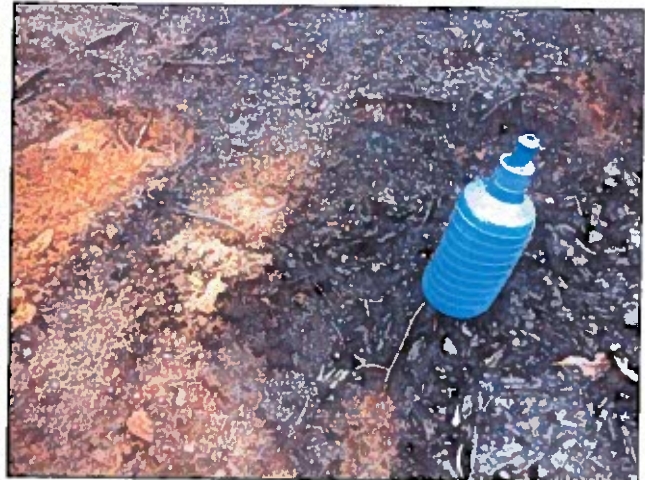
The following photographs on the left show charred but not consumed ground cover, minimally impacted forest duff and fine roots and minimal, if any, impacts on the soil. The following photographs on the right show high consumption of ground cover and forest duff. Impacts on the top ¼ to ½ inch of soil were also observed.

Example of moderate to high burn severity effects on the soil (above)
