BURNED-AREA REPORT

A. Fire Name: Hill Fire

B. Fire Number: CA-BDF-12829

F. Forest: San Bernardino National Forest

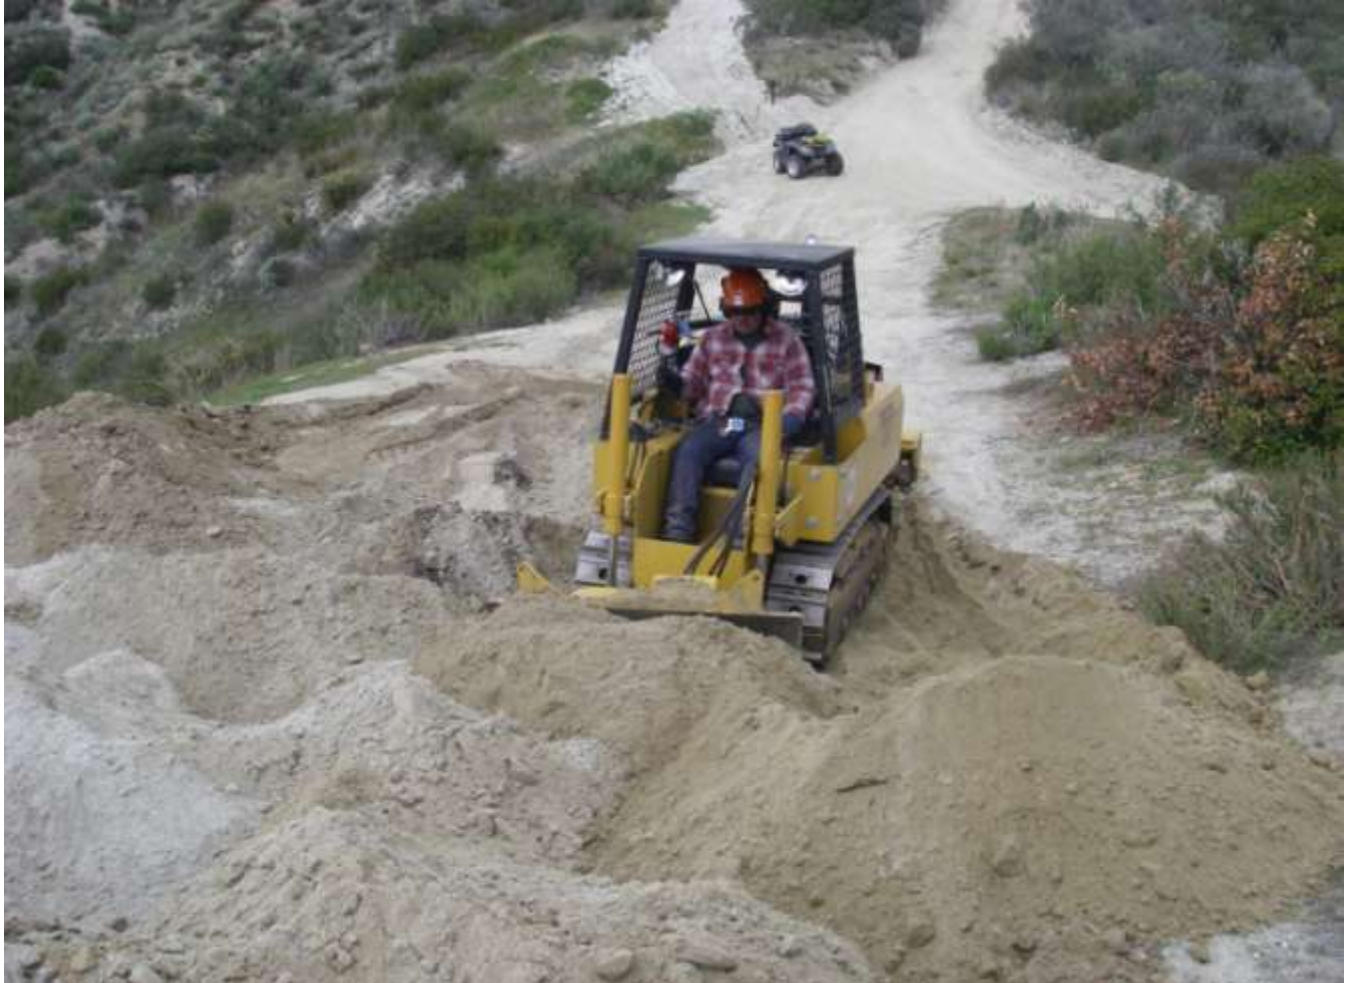
Photo 1: Chunking with a small trail dozer that has an articulating blade.

With the recreational use and vegetation types found in the Baldy Mesa area the Forest found the use of “chunking” with excavators an effective tool in protecting resources after a fire when combined with fencing, signs, and most importantly frequent patrols. Chunking is described as using the bucket of an excavator or articulating blade on small trail dozer to decompact roads/trails by digging into the compacted area and creating divets. These divets act as mini-catch basins (increasing infiltration), require minimal maintenance, and are found to collect seed and promote gemination (See photos below.)

The Hill Fire burned a part of an OHV trail and also exposed some illegal trails from private onto forest lands. The recommended treatment is to use an excavator employing chunking and banked turns to help redirect the OHV trail and forest road recreation use away from cultural resources and out of the Hill burn area. The use of fence lines and fire recovery signage can help support the chunking along the impacted trail and road. Chunking has also proven to help bring vegetation back within impacted burn areas. After the Blue Cut Fire the Forest found vegetation coming back within one year. With high levels of recreational use and the knowledge that we have gained from past fires in the Baldy Mesa area, using these multiple closure methods discussed will have the greatest success on the Hill Fire rehabilitation and resource protection.

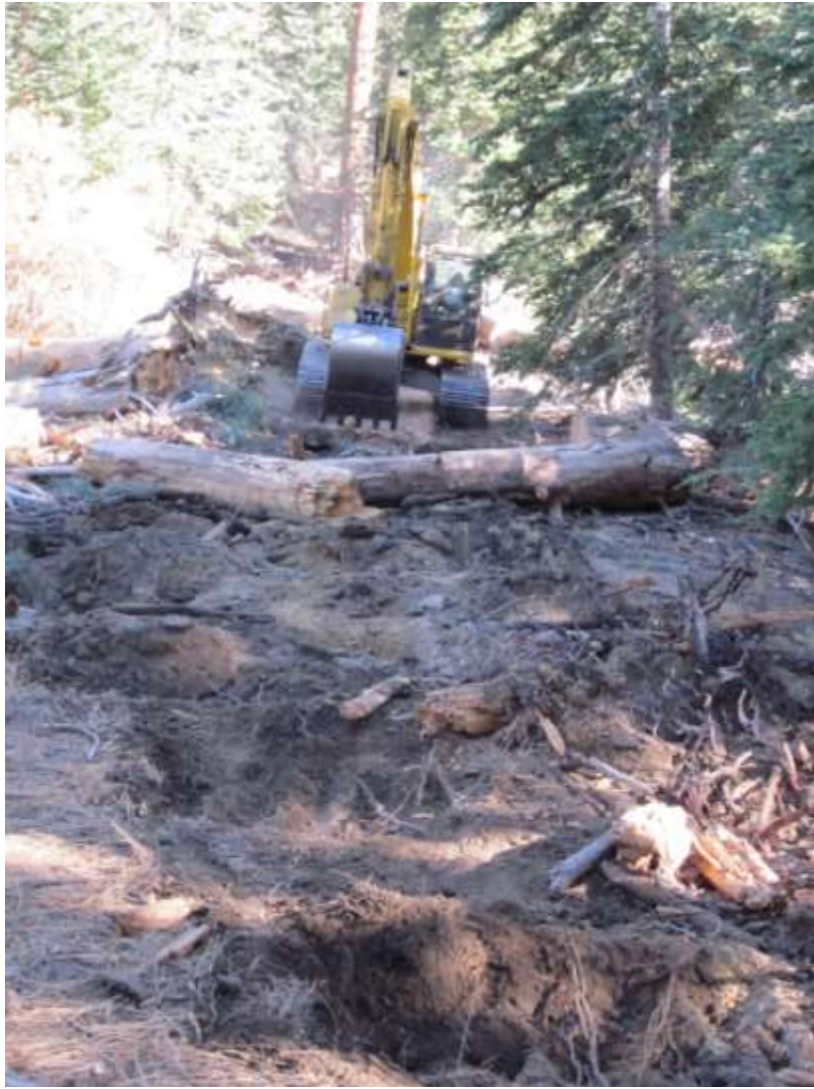
Photo 2: Chunking with an excavator along a dozer line. First chunking occurs, then the equipment spread topsoil and slash from the dozer piles over the treated area.

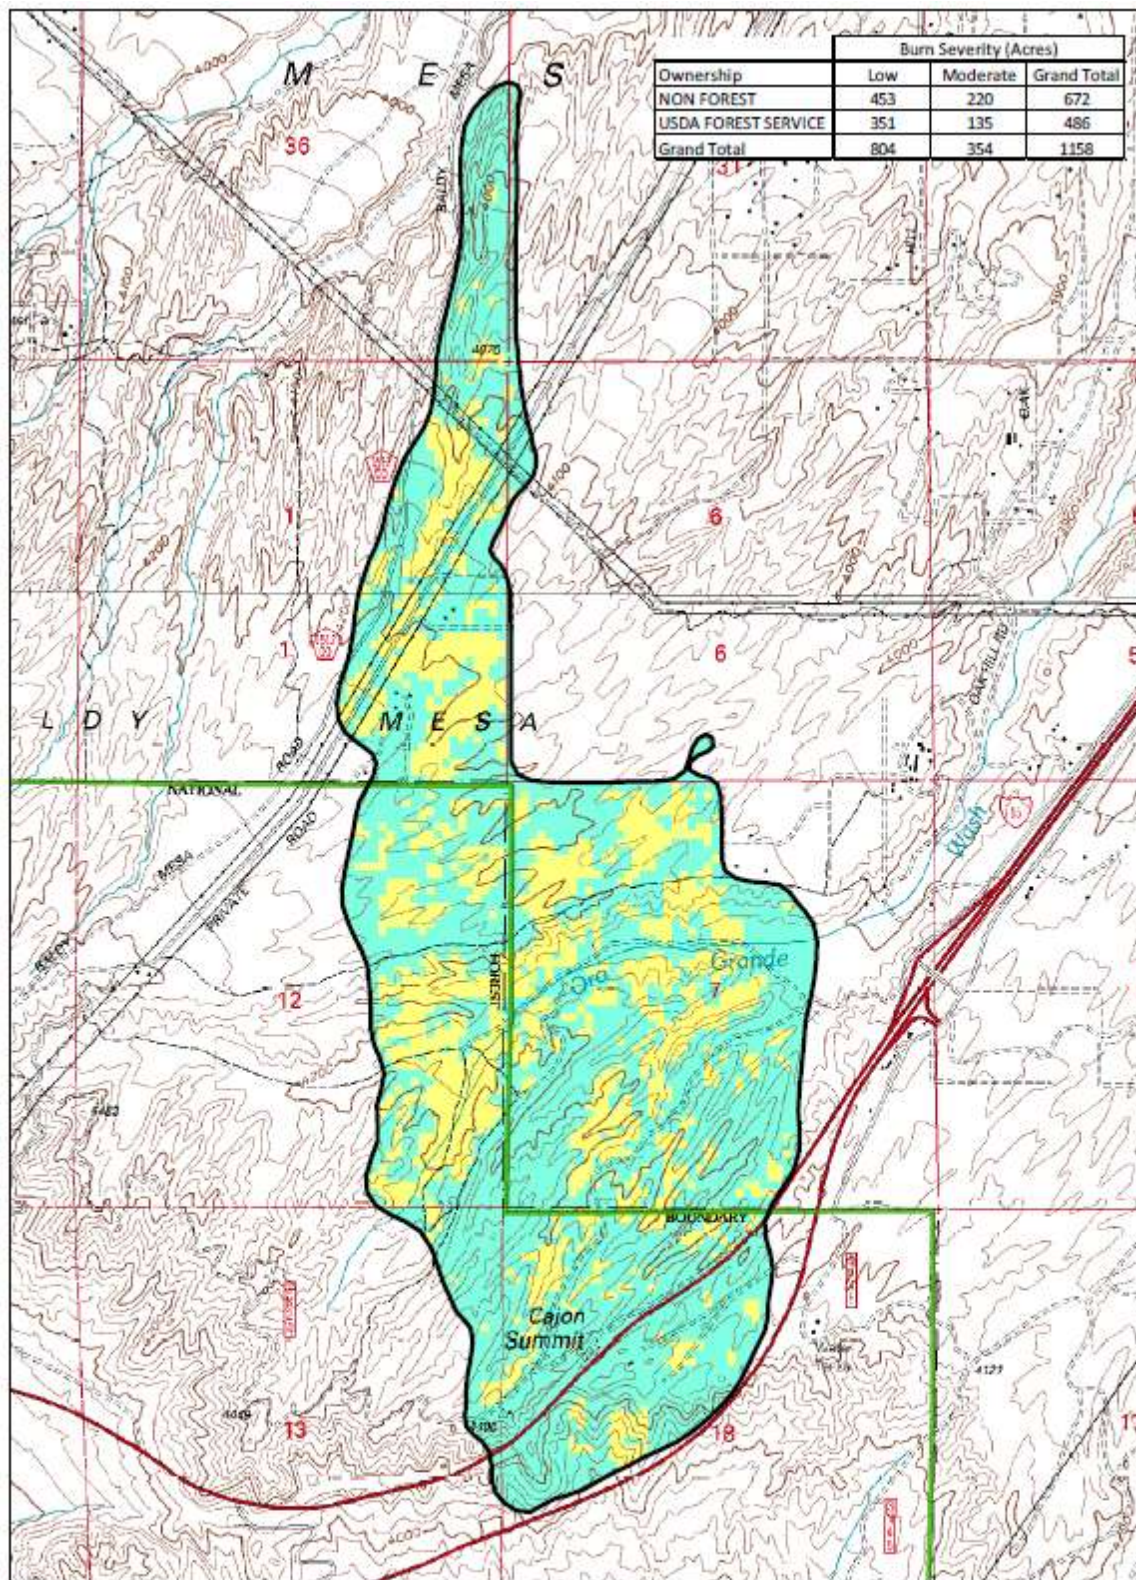
Burn Severity
 Hill Fire
 Sept. 2, 2011

Fire Perimeter

Low Burn Severity (804 ac.)

Moderate Burn Severity (354 ac.)

The BAER Team (Leader, Hydrologist, Hydrologist-trainee, Botanist, Archaeologist) mapped soil burn severity and compared the field findings with the BARC map provided. The BARC map showed a higher initial moderate soil burn severity than was verified in the field. Adjustments were made to the pixels of the BARC map until field observations were more closely represented. The final soil burn severity map shows the overall soil burn severity to be 69% low and 31% moderate. Accelerated hill slope erosion and watershed response is expected on slopes with moderate soil burn severity. Soils with low burn severity still have good surface structure, contain intact fine roots and organic matter, and should recover in the short-term once revegetation begins and the soil surface regains cover. The moderate class has evidence of severe soil heating in isolated patches; these areas could have long-term soil damage and high erosion hazard. Water repellency is present throughout the fire area, including unburned areas, and was only moderately exacerbated by the fire. While a proportion of eroded soil will remain on the hill-slope, delivery of eroded soil, by dry ravel or water erosion, to stream channels is expected to occur. These eroded sediments are a primary source of material for debris flows and sediment laden stream flows.
