BURNED-AREA REPORT
(Reference FSH 2509.13)

Executive Summary

A. Fire Name: Summit Complex Fire

B. Fire Number CA-STF-002655

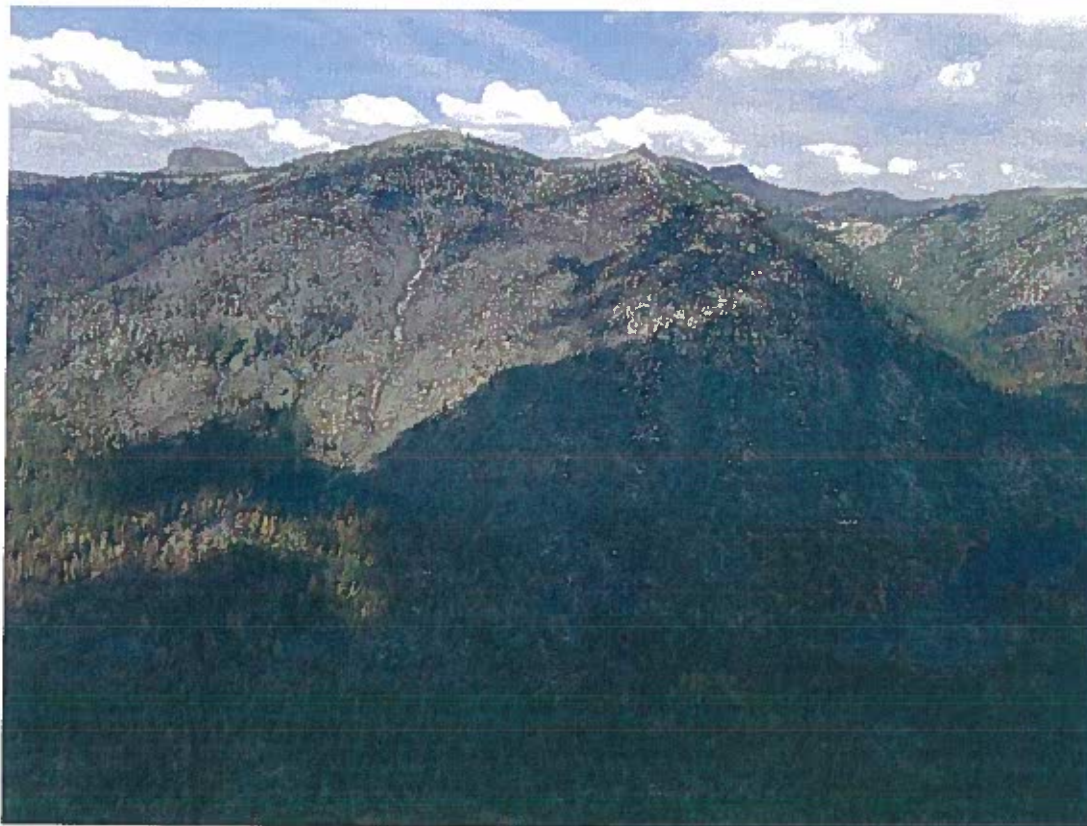
McCormick Fire, looking at No Name Drainage and High Severity Burn

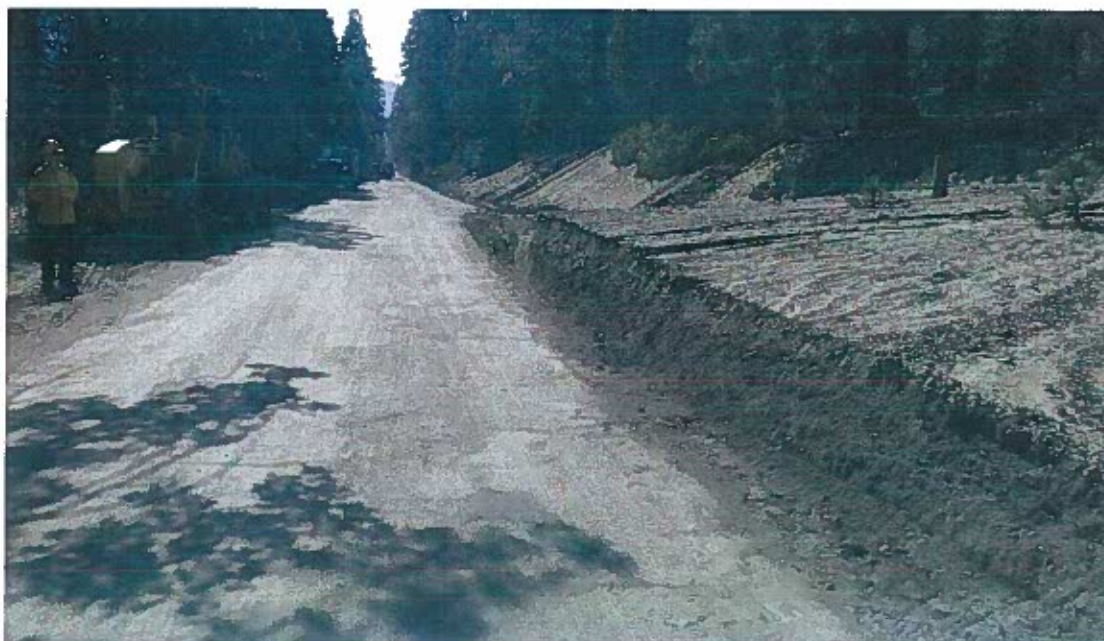
Figure 1: Cleared slide (hyper-concentrated sediment flow) across Clark Fork Road resulted from September 13, 2017 rain event.

An isolated storm hit the burned area on September 13, 2017. This intense, short-duration storm caused erosion and sedimentation within the burn area and is an indicator of the potential for sediment to erode from the hillslopes, and plug culverts and overtop the Clark Fork Road in future storms. One major slide occurred across the road at an unmapped drainage west of Little Teton Creek. This slide was over 3 feet deep and required heavy equipment to clear the roadway (Figure 1).

Treatments include installing critical dips (13), fillslope rip-rap (12 tons), and CMP metal end sections (3). Also included is restoring drainage function (5.5 miles) and storm inspection and response (2.2 miles). Much of this work is focused on the Fence Creek road switchback area on the western end of the McCormick fire where the road is steep and is near/downslope of high soil burn severity. A smaller amount of treatments are on 6N75Y and 6N82Y. See the Roads-Engineering specialist report for details and treatment specifications. See Appendix E for road treatment map.

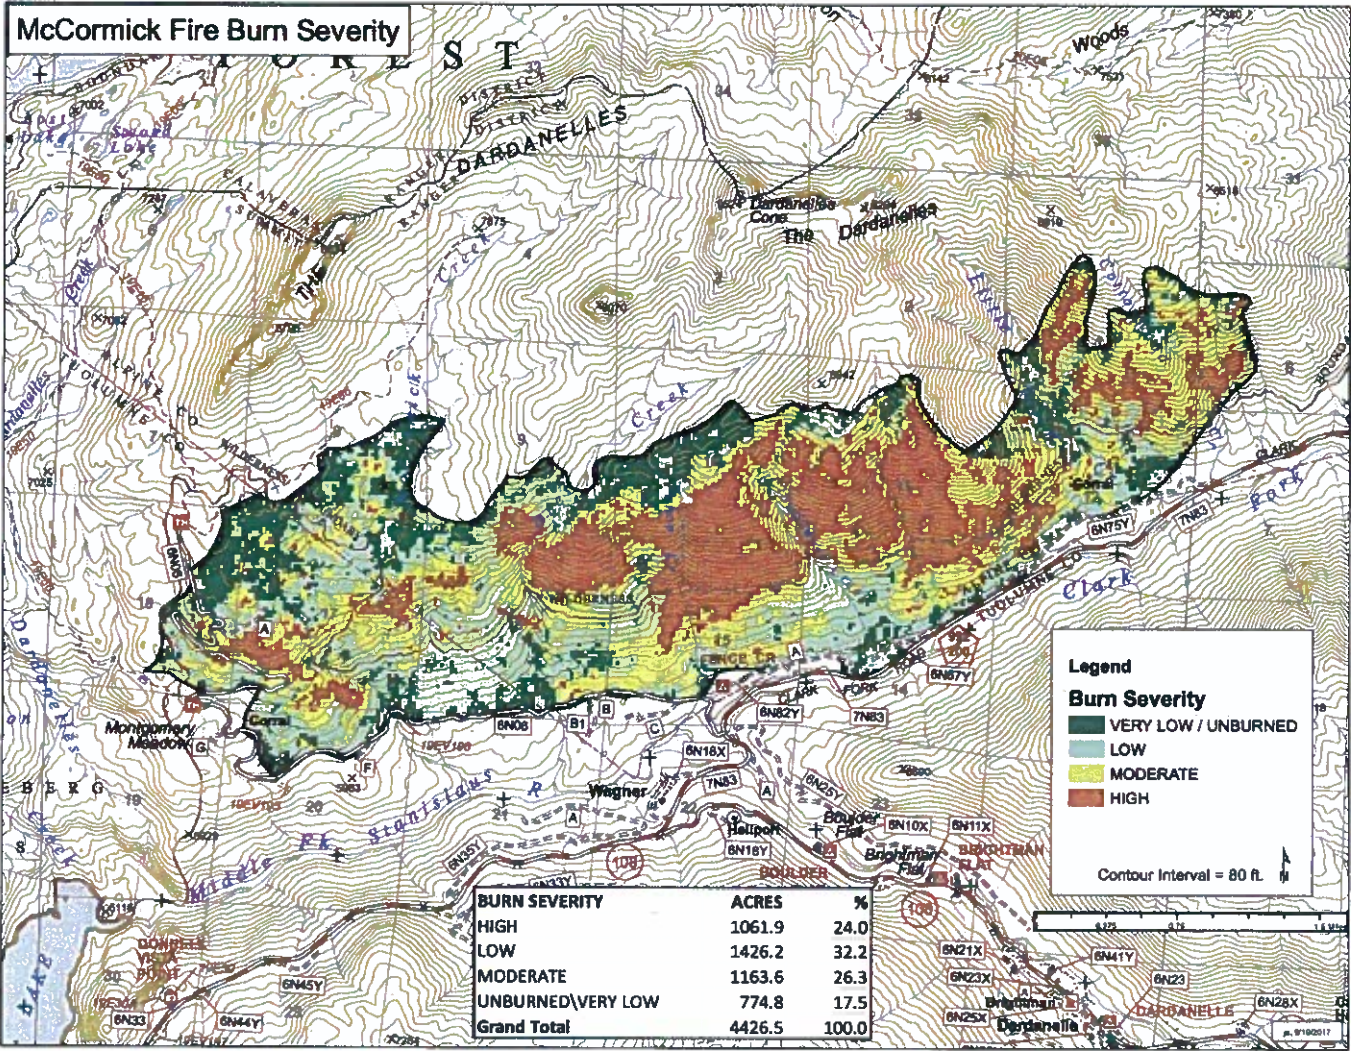
Appendix A: Soil Burn Severity Map:

The McCormick Fire was mapped as 50% moderate to high soil burn severity and 50% low to very low soil burn severity (see Appendix A). McCormick was 24% high, 26% moderate, 32% low, and 17% very low/unburned. The high soil burn severity occurred in large patches of montane chaparral on mid to upper slopes. In general, the eastern end of the McCormick Fire burned hotter than the western end. The Douglas, Willow and Bummers Fires were burned at low severity.

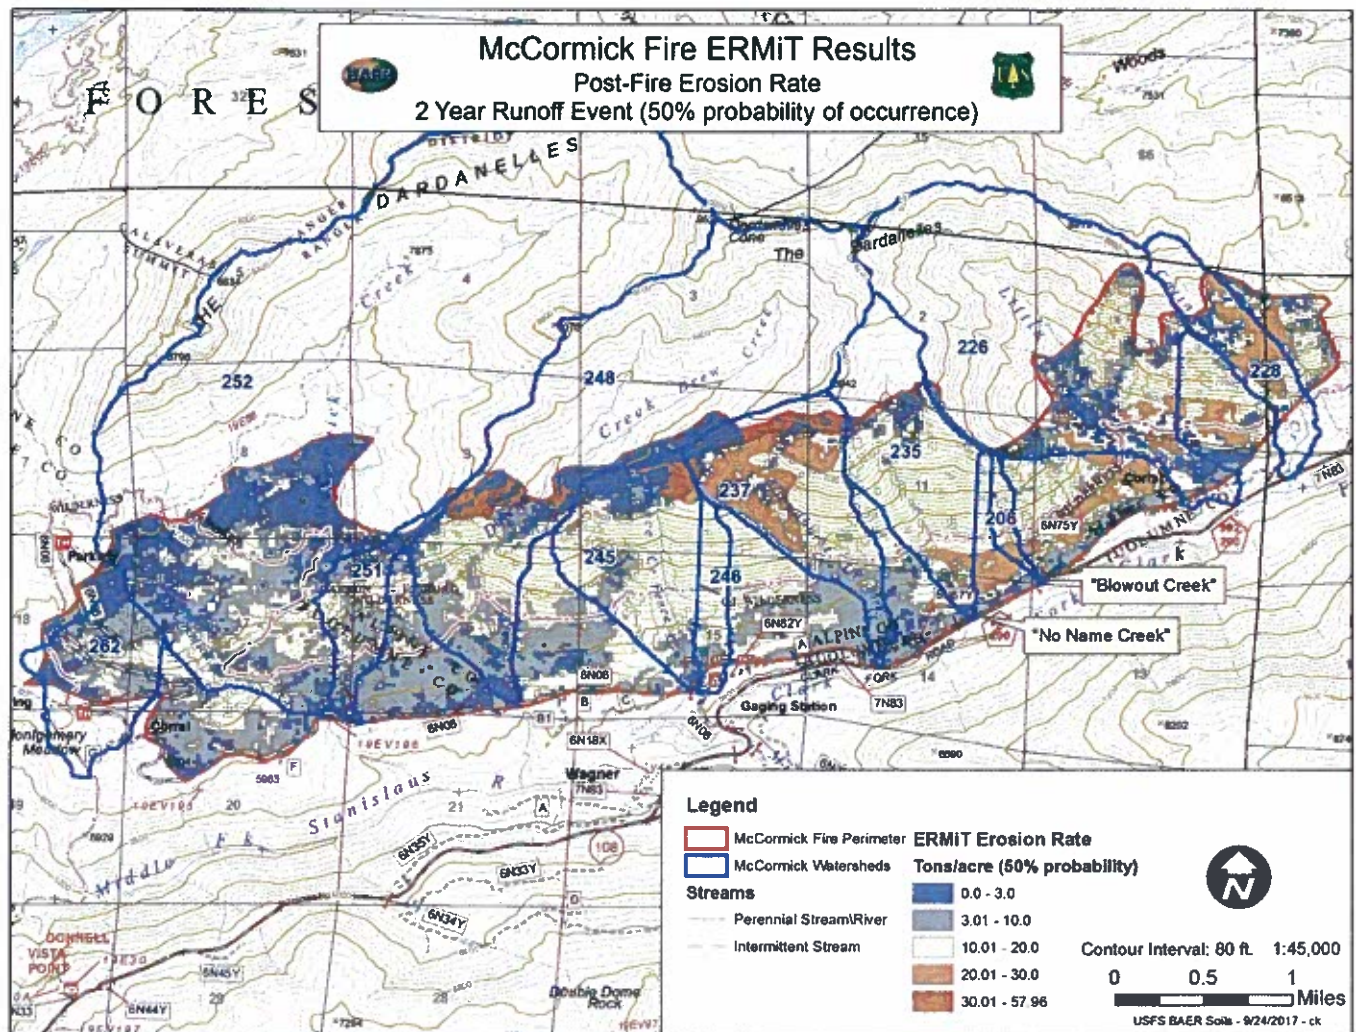
Appendix B- Erosion modeling results

The Erosion Risk Management Tool (ERMiT) was used to predict hillslope erosion and sediment production. (see Appendix B). Fire wide erosion average for the McCormick Fire is as follows:

- 10 tons/acre (range 7.2 – 16.4) for the 2 year runoff event and
- 40 tons/acre (range 35.6 – 68.5) for the 10 year runoff event

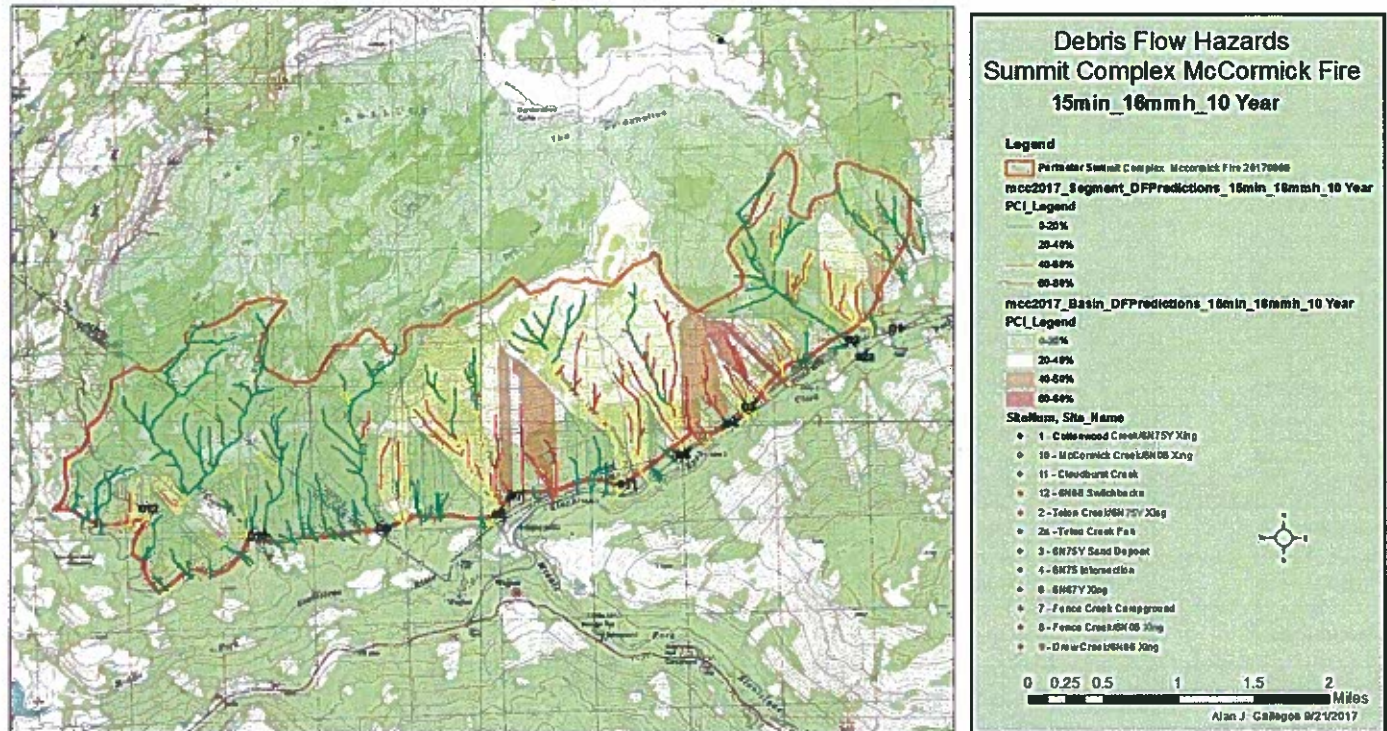
Appendix D: Debris Flow Hazard Map

Geologic Threats to Life and Property– Based on field investigations and modeling of expected post-fire debris flows, there is a substantial risk to critical values (human life and property) along Clark Fork Road within the burn area. Rock fall hazard is present on the upper Fence Creek Road at the switchbacks. An emergency exists at Site 4, Site 7 and Site 12. In addition an emergency may exist at Sites 6, 9 and 11.

- The red colored basin areas and red stream segments on the debris flow hazard map indicate significant risk of debris flows. (see Appendix D).
