1st Ammended Request (post-furlough): October 21<sup>st</sup>, 20132nd Ammended Request (following spring): May 23<sup>rd</sup>, 2014**BURNED-AREA REPORT**  
(Reference FSH 2509.13)**PART I - TYPE OF REQUEST****A. Type of Report**

- A. Fire Name:** Government Flats Complex      **B. Fire Number:** OR-MHF-000697  
**C. State:** OR      **D. County:** Hood River and Wasco Counties  
**E. Region:** 6      **F. Forest:** Mt. Hood National Forest.  
**G. District:** Barlow and Hood River      **H. Fire Incident Job Code:** H6HV1Q 0606 (P)  
**I. Date Fire Started:** 8-16-2013      **J. Date Fire Contained:** 9-9-13  
**K. Suppression Cost** (as of 9/20/2013): Total Fire: \$ 14,237,743, FS Contribution: \$ 2,238,645  
**L. Fire Suppression Damages Repaired\* with Suppression Funds**  
1. Fireline waterbarred (miles):      Dozerline 11.5 miles Handline 7.0 miles  
2. Fireline repaired (miles):      Dozerline 7.0 miles Handline 3.8 miles  
3. Fireline seeded (miles):  
4. Other (identify):

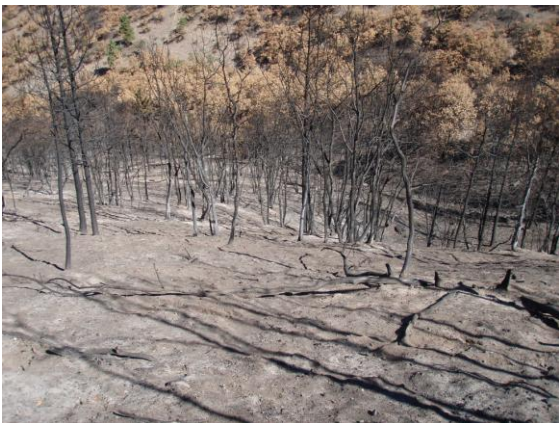
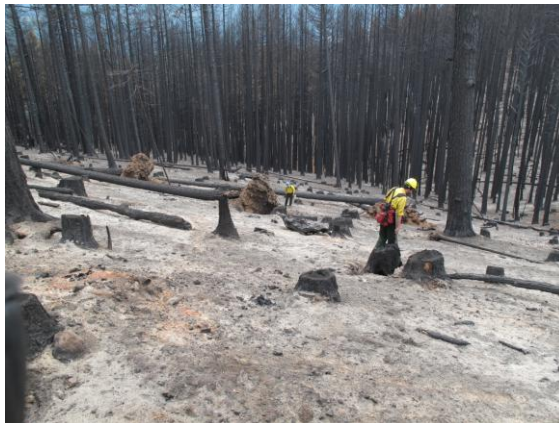
It is estimated that about 30 percent of the Government Flats fire on FS lands is considered to be classified as moderate to high severity. Combustion of the litter and humus layers on the soil surface was complete. Several inches of grayish-white ash cover the ground. Fine roots were consumed within the top ½ to 1 inch below the soil surface, but below that they were wholly intact. Soil color and structure was not altered to depth except in some places a thin layer at the surface, or as mentioned where large fuels in contact with the ground burned for a prolonged period of time. See the Soil Burn Severity map.

Examples of moderate to high severity in the foreground of each of these photos

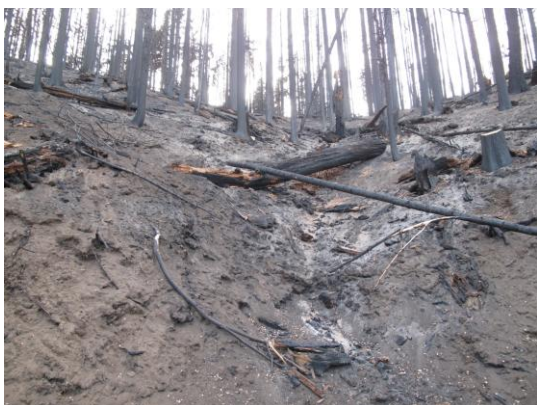
Water accumulation after a light rain in one of the steep draws where burn severity was moderate to high.
