Rough Ridge Fire December 2016

BURNED-AREA REPORT
(Reference FSH 2509.13)**PART I - TYPE OF REQUEST****A. Type of Report**

- A. Fire Name: Rough Ridge B. Fire Number: GA-CHF-160052
C. State: GA D. County: Murray, Fannin, and Gilmer
E. Region: R8 F. Forest: Chattahoochee-Oconee
G. District: Conasauga H. Fire Incident Job Code: P8KR89
I. Date Fire Started: 10/16/2016 J. Date Fire Contained: 12/6/2016
K. Suppression Cost: \$8 million
L. Fire Suppression Damages Repaired with Suppression Funds
 1. Fireline waterbarred (miles): 9.62 miles
 2. Fireline seeded (miles): 9.62 miles
 3. Other (identify): N/A
M. Watershed Number: Jack's River (031501010102) and Headwaters Conasauga River
 (031501010101).

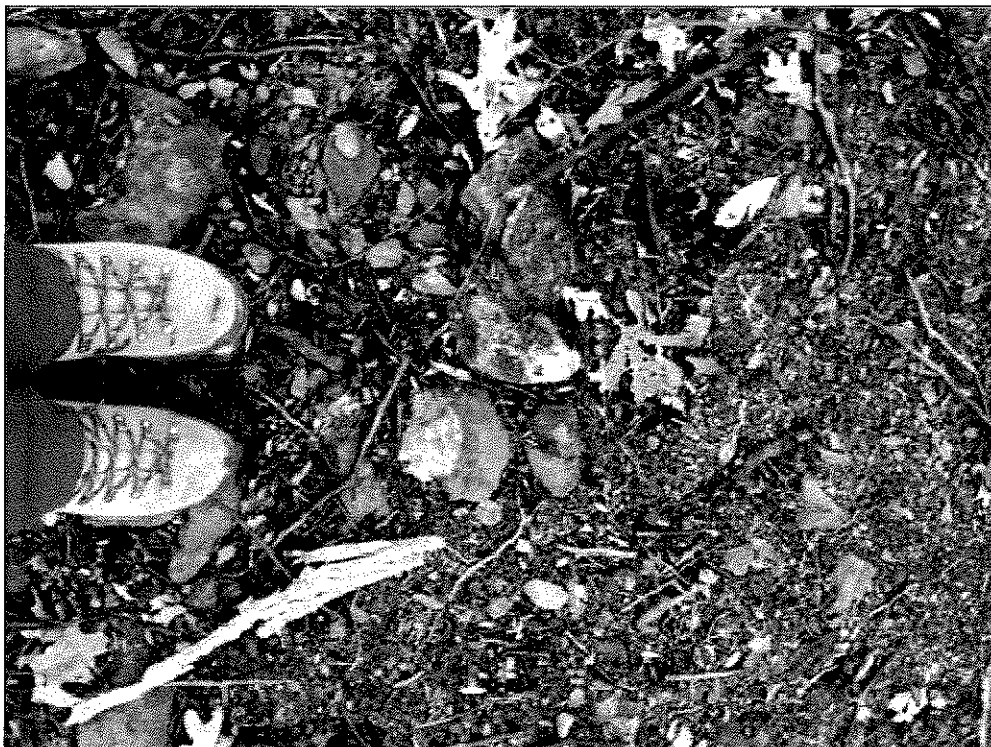
The following photograph show charred but not consumed ground cover. Dry litter and leaves were consumed by a backing fire. Forest duff and fine roots were minimally impacted by fire. The soil burn severity is low and the risk for damaging post fire erosion is also low in these areas

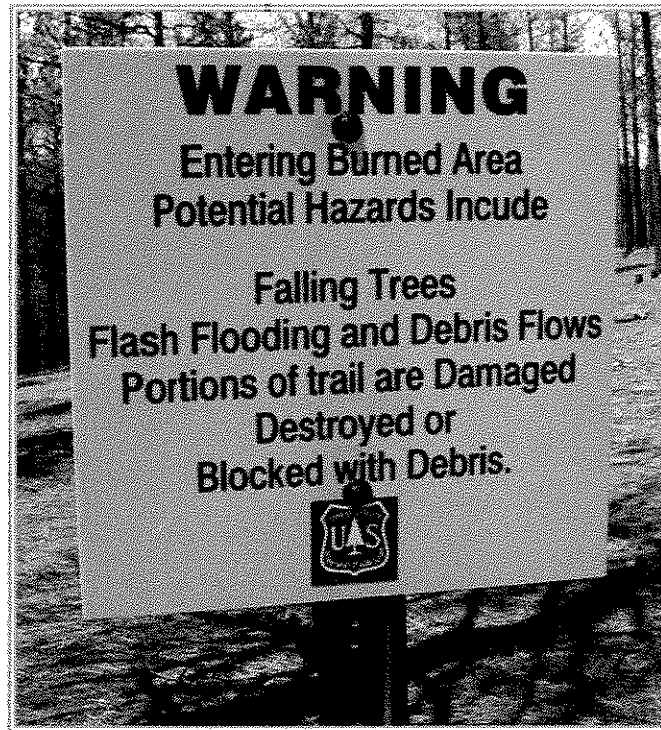
Place appropriate hazard signage at the 9 trailheads that lead to the Wilderness in the spring when trailheads open. Costs include sign replacement due to weather and/or vandalism. Insert information on trail hazards on the Forest Public facing website. Sign language could include:

WARNING

Entering Burned Area
Potential Hazards Include:

Flash flooding

Portions of trail are damaged or destroyed or blocked with debris
