Date of Report: 11/13/2012**BURNED-AREA REPORT**  
(Reference FSH 2509.13)**PART I - TYPE OF REQUEST****A. Type of Report**

**PART II - BURNED-AREA DESCRIPTION****A. Fire Name:** Isabella Complex  
(Wash, Jug, Crimper Fires)**B. Fire Number:** ID-CWF-000625**C. State:** Idaho**D. County:** Clearwater**E. Region:** R1**F. Forest:** Clearwater**G. District:** North Fork**H. Fire Incident Job Code:** P1G8E1**I. Date Fire Started:** 09/09/12**J. Date Fire Contained:** 10/15/2012**K. Suppression Cost:** \$26,000**L. Fire Suppression Damages Repaired with Suppression Funds**

## Appendix A. Cost Details and Photos

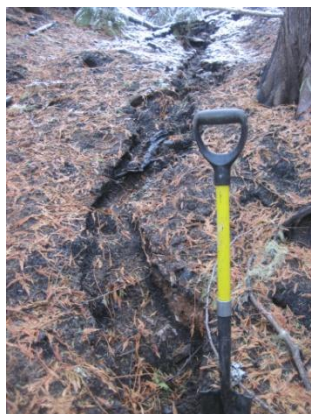
### Road 705 stream crossing, MP 3.3, unnamed trib.

Runoff from moderate burn high in watershed

30 in. culvert on Rd 705 draining 43% burned basin. Approximately 1/3 of this burned at a mod-high severity (yellow-red).

- 20 cfs post-burn 10-yr flow sizes to minimum 36" culvert; modeled Q100 = 33 cfs (from StreamStats), sizes to minimum of 42" diameter
- Replace with 48" CMP

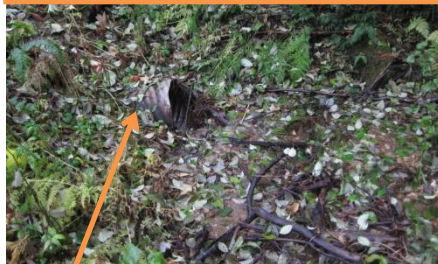
Existing 30" culvert

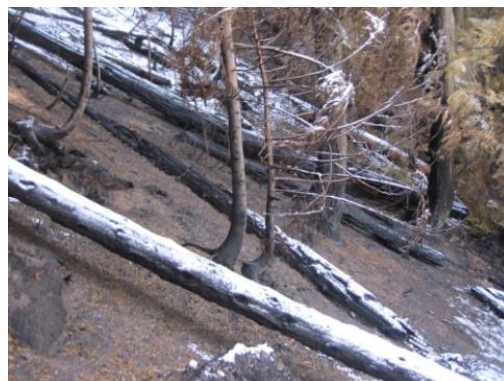
Typical moderate to high burn within watershed above MP3.3
