USDA-FOREST SERVICE

**FORK COMPLEX FIRE BURNED-AREA REPORT**  
(Reference FSH 2509.13)

**PART II - BURNED-AREA DESCRIPTION**A. Fire Name: Fork Complex FireB. Fire Number: CA-SHF-002067C. State: CAD. County: TrinityE. Region: 5F. Forest: Shasta-TrinityG. Districts: South Fork Management UnitH. Fire Incident Job Code: P5J0HSI. Date Fire Started: July 31, 2015J. Date Fire Contained: September ??, 2015K. Suppression Cost: \$20?? million

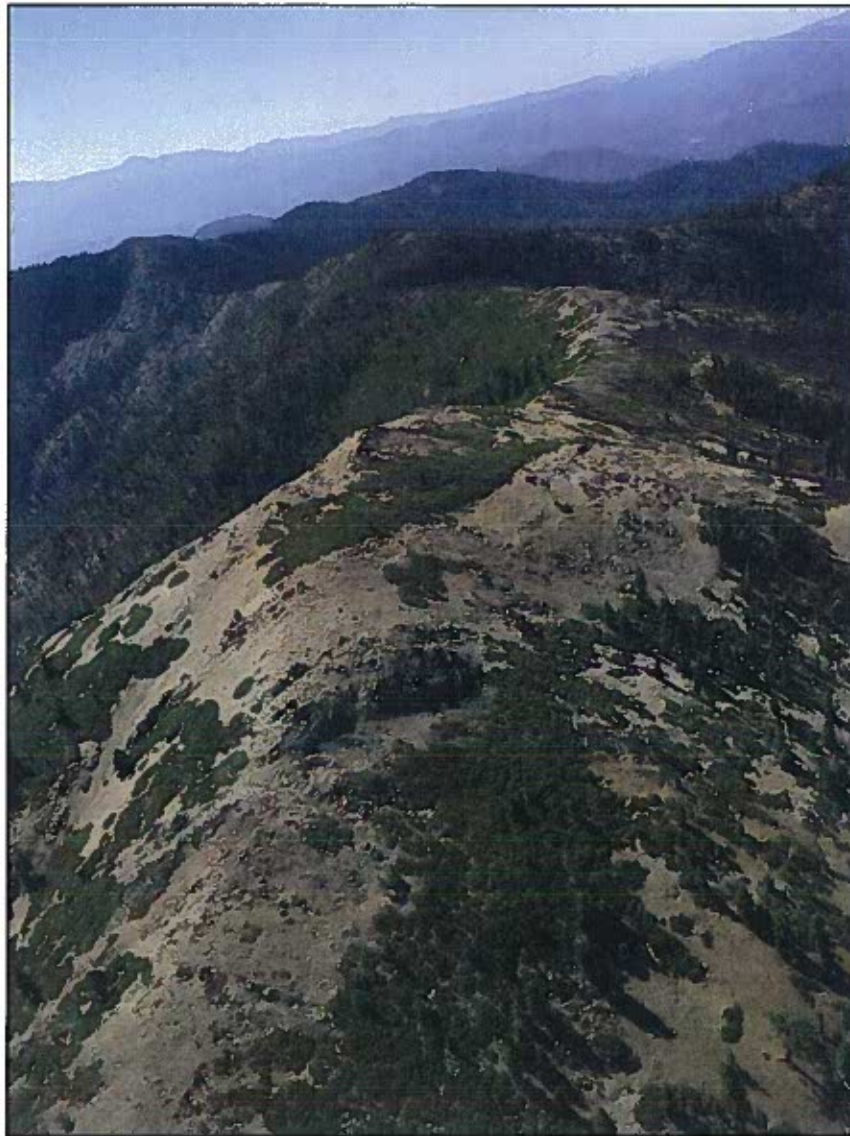
The Fork Complex Fire of 2015 looking at Chancelulla Peak within the Shiel Fire.

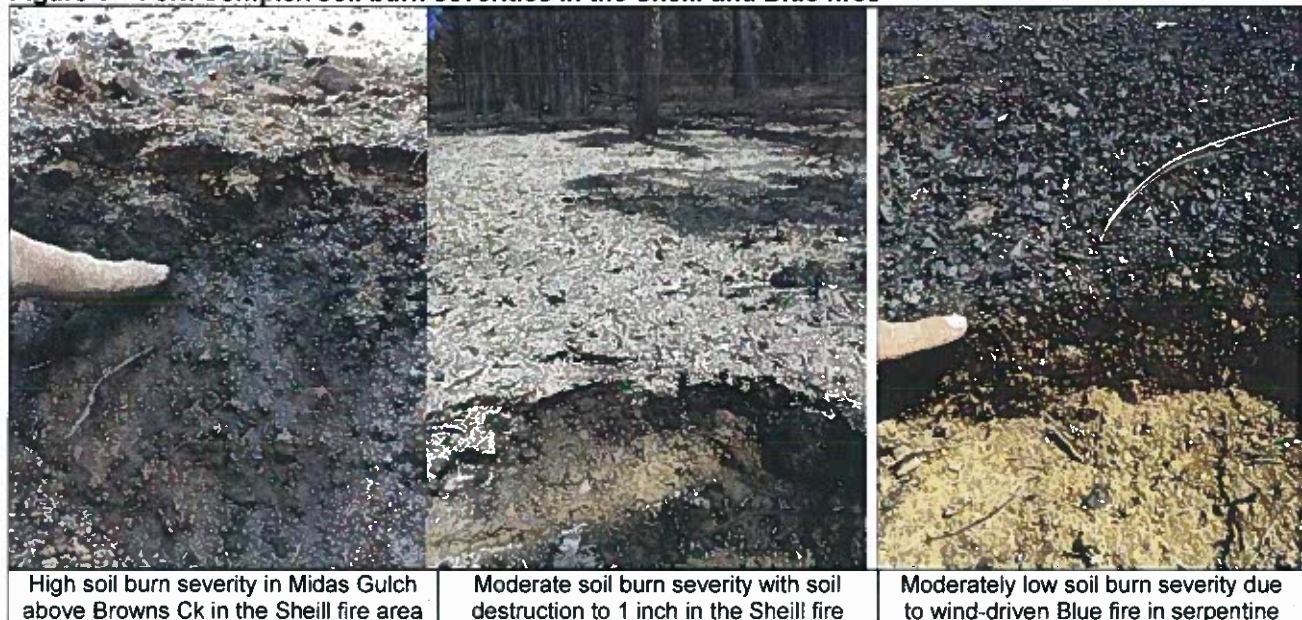
**Figure 1 – Fork Complex soil burn severities in the Sheill and Blue fires**

The Fork Complex Fires consist of 5 large fires ranging from about 4,000 to 15,000 acres on steep terrains surrounding Hayfork with large dead snags in thick brush left over from several past fires or unthinned conifer plantations. As a result the fire was driven by heavy fuel loads along with initial windy conditions. BAER specialists concluded that the amount of high soil severity burn was low given time of year in comparison to other fires due heavy smoke inversion that set in and the lack of wind driven events. This cooled the fire and moderated fire behavior to create slow ground fires with occasional torching and crown fires only in the afternoon when the inversion would lift at higher elevations. The exception to this was the first two days when the fires grew rapidly due to winds, crowning, and lack of inversion. These conditions caused the moderate and low soil burn severity observed in the following maps and pictures (Figures 1 and 2).

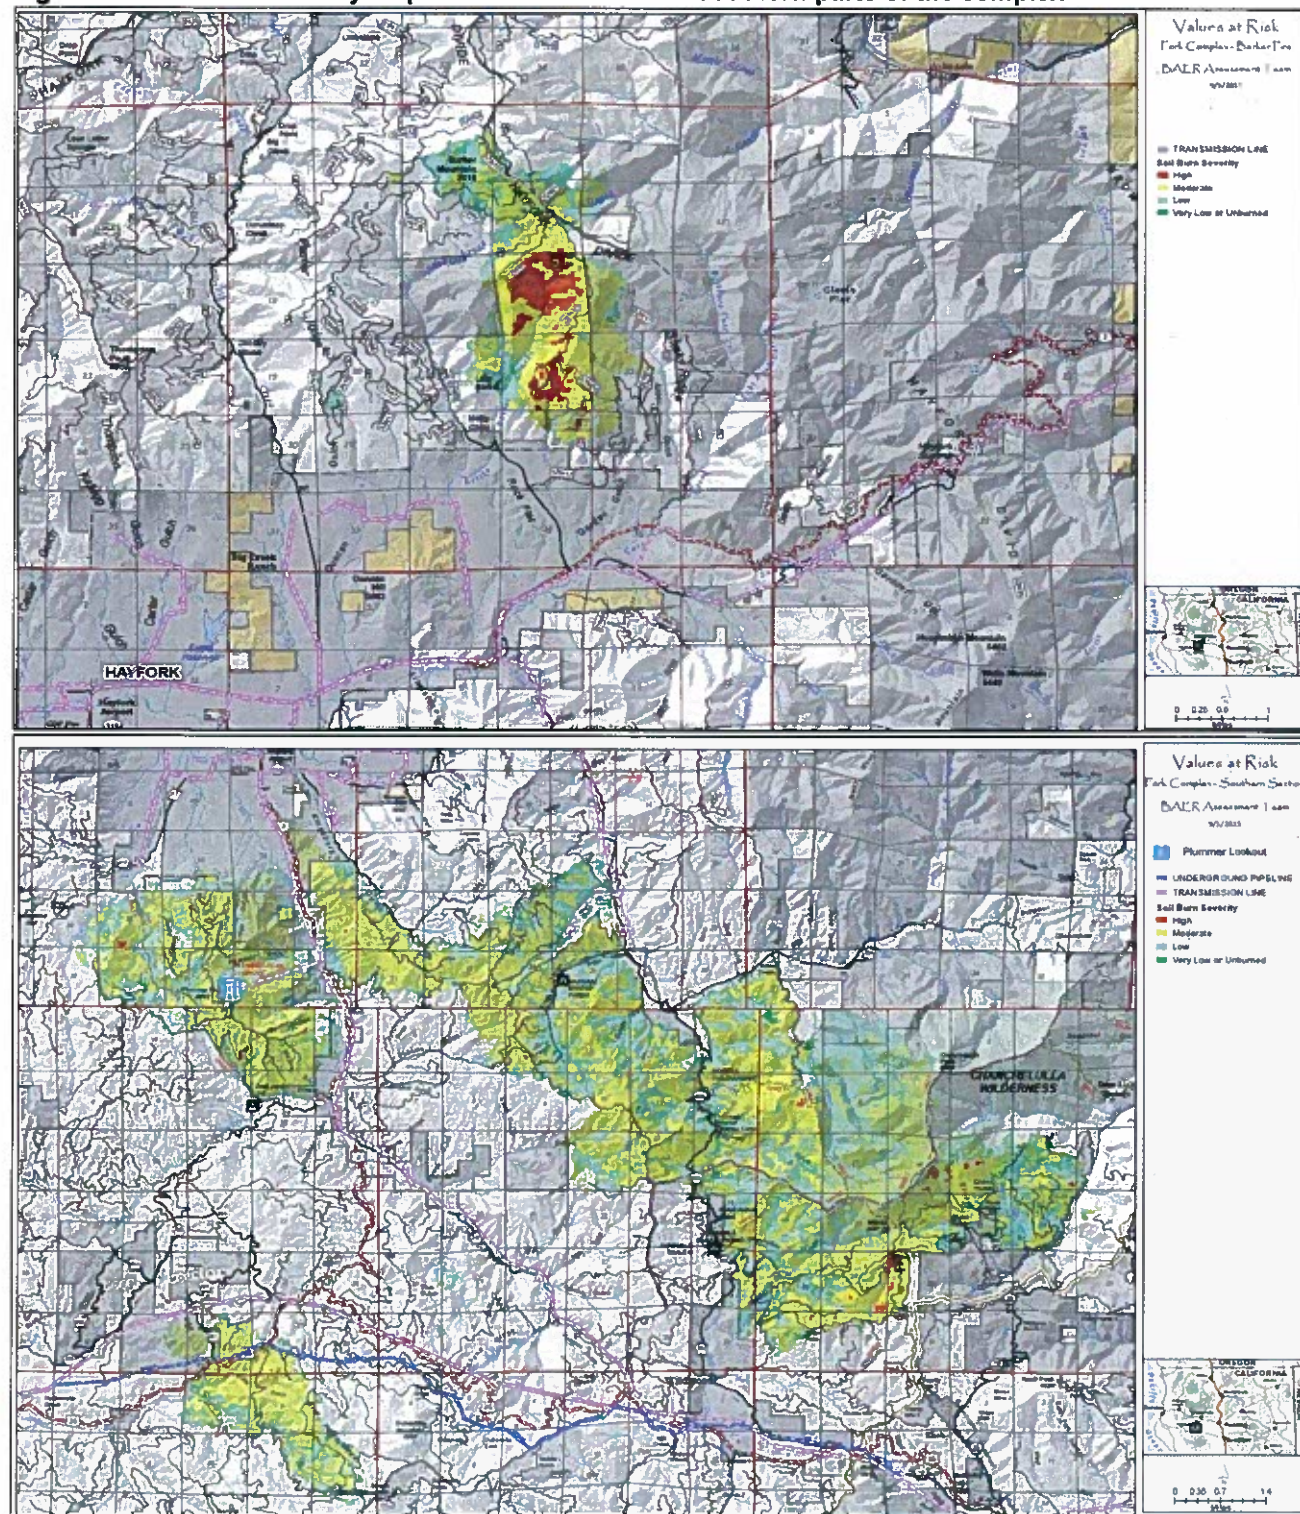
**Figure 2 – Soil Burn Severity Maps for the northern and southern parts of the complex**

Approximately 63% burned at high and moderate soil burn severity. The rest of the fire was either low or very low soil burn severity (see Figure 2 soil burn severity maps). Looking at the maps below shows little Barker creek, Wilson, and Stone creek headwaters burned hot. These areas in particular had large old growth timber stands with heavy accumulation of down woody material thus producing hot fires with long residence time.

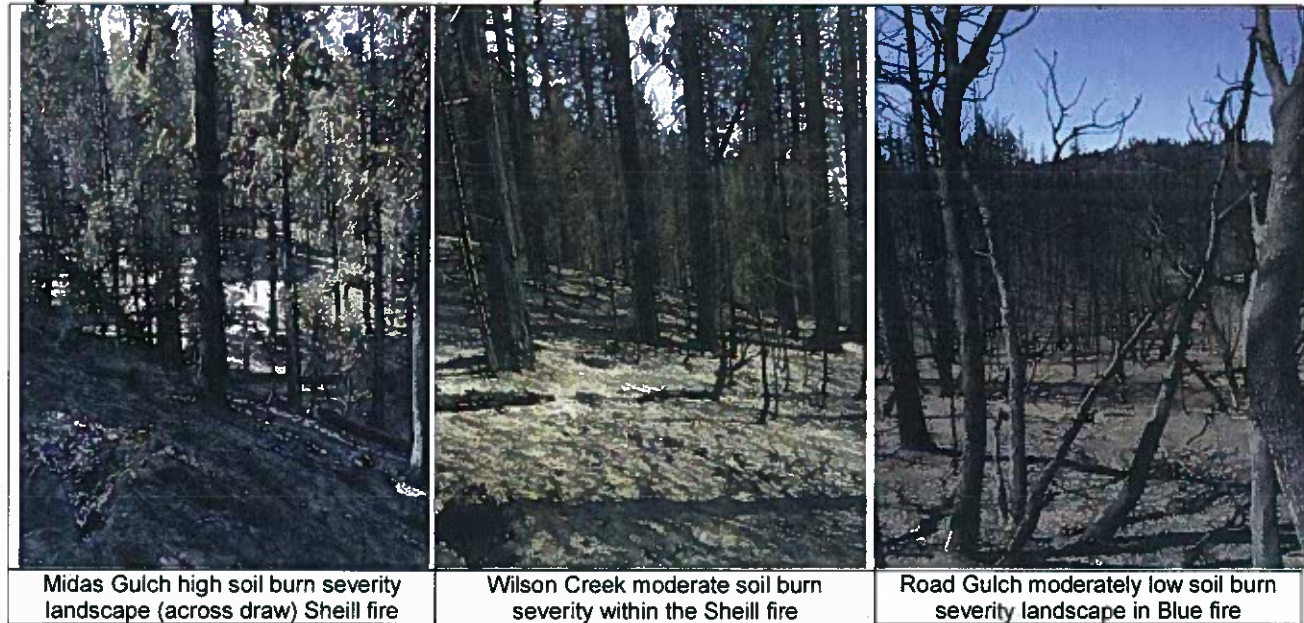
**Figure 3 – Landscapes for soil burn severity in Sheill and Blue fires**

condition evaluation in BAER analyses. Fire intensity or burn severity as defined by fire, fuels, or vegetation specialists may consider such parameters as flame height, rate of spread, fuel loading, thermal potential, canopy consumption, tree mortality, etc. For BAER analysis, we are not mapping simply vegetation mortality or above-ground effects of the fire. Soil burn severity considers additional surface and below-ground factors that relate to soil hydrologic function, runoff and erosion potential, and vegetative recovery. Companion pictures to figure 1 pictures are shown below (Figure 3) showing the landscape with mixed mortality due to differing vegetation types, slopes, aspect, and location.

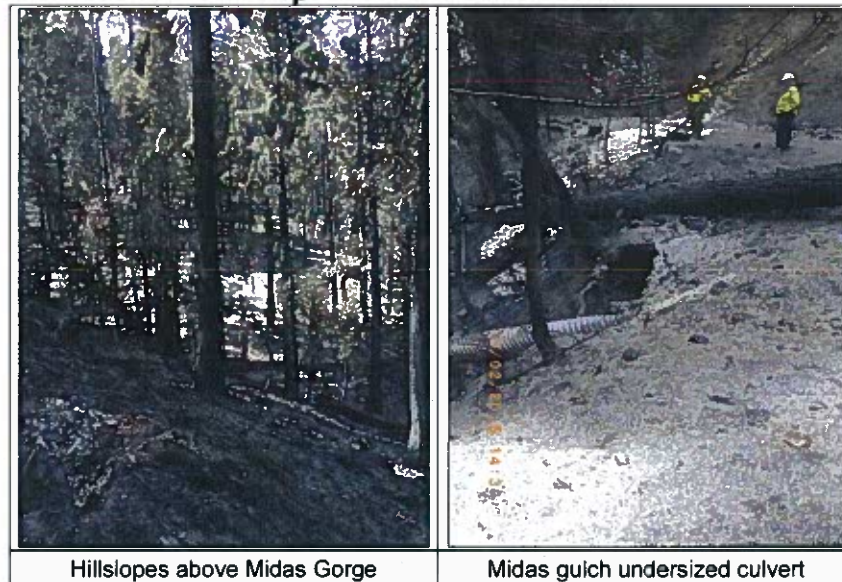
**Figure 4 – Midas Gulch road 30N16 hillslope above and culvert below**

Particular area of concern is Little Barker Creek, Upper Wilson Creek, Upper Rattlesnake Creek, and Midas Gulch which were entirely burned at moderate to high soil burn severities. These areas have Neuns or Dubakella soils (moderately deep gravelly loams) that have strong water repellency due their porous fine gravel nature. All vegetation including an existing conifer stand was 100 percent killed along with in-channel vegetation with undersized culverts that could plug and cause these roads to fail (Figure 4 below).

Hillslopes above Midas Gorge

Midas gulch undersized culvert
