USDA-FOREST SERVICE

DRAFT THOMAS BURNED AREA REPORT
(Reference FSH 2509.13)

A. Fire Name: Thomas Fire

B. Fire Number: CA-VNC-103156

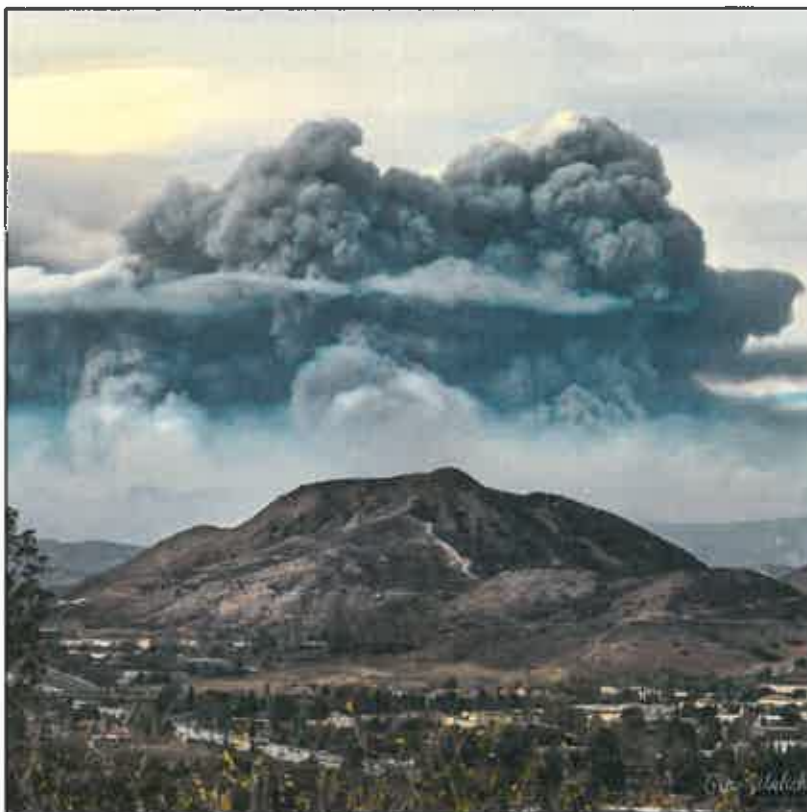
The Thomas Fire of 2017 looking at Santa Paula River drainage.
