## BURNED-AREA REPORT

- A. **Fire Name:** Big Red
- B. **Fire Number:** CO-RTF-402
- C. **State:** CO
- D. **County:** Routt
- E. **Region:** 02
- F. **Forest:** Medicine Bow-Routt NF

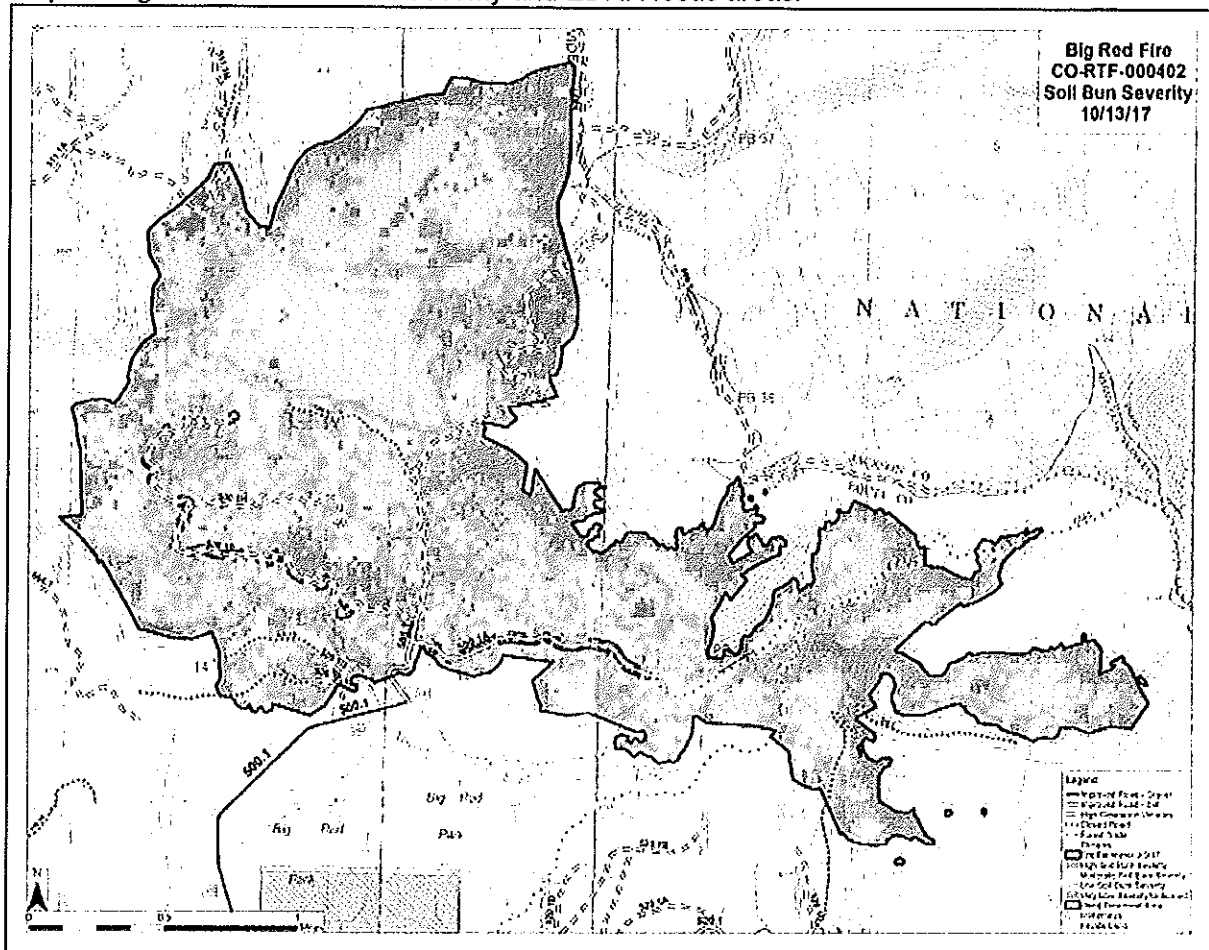
Map 1: Big Red Final Soil Burn Severity and EDRR focus areas.

The BAER team utilized a Burn Area Reflectance Classification (BARC) map to produce an accurate soil burn severity map in a short timeframe (see Map 1). The Burned Area Emergency Response (BAER) team acquired BARC images which covered most of the burned area. Following field review, minor systematic adjustments to the classification were made and the BARC map was adjusted to reflect field observations in the burn area.

Invasive Weeds: Early Detection Rapid Response surveys: This treatment is to reduce the potential for impaired vegetative recovery and loss of native plant communities due to the spread of invasive weeds by conducting detection surveys and rapid response eradication efforts in the areas identified as being at the highest risk. High risk areas are those burn areas that contain known weed populations, or suppression disturbances (ie hand line etc) adjacent to known weed population, and where vectors exist such as roads and trails.
