# **Black Fire BAER 2500-8**

## **Initial Request**

**Gila National Forest: Wilderness, Black  
Range, Silver City Ranger Districts**

June 27, 2022

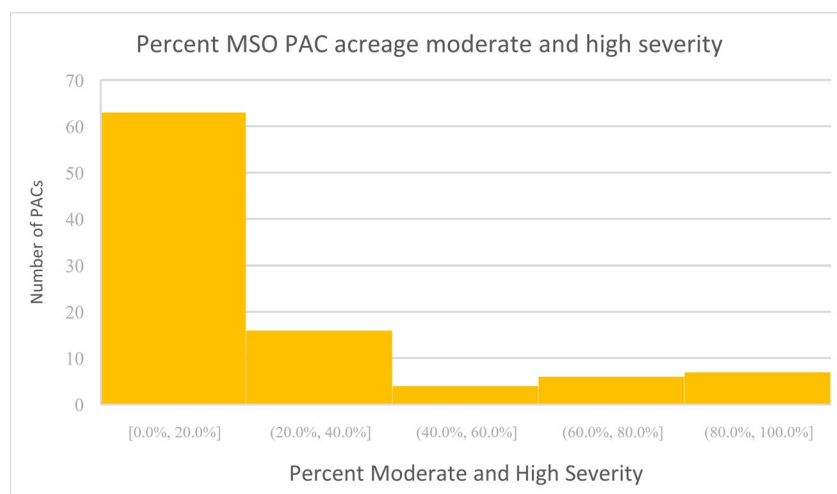
Figure 1. MSO PACs Burn Severity

High and moderate soil burn severity (SBS) are likely to have altered MSO habitat to an extent that would result in those areas being no longer suitable habitat, with the majority of the large overstory conifers killed and most pre-fire snags and downed logs largely consumed. High and moderate soil severity burn patches may have short term benefits by increase foraging habitat for MSO, however for MSO to persist long term they

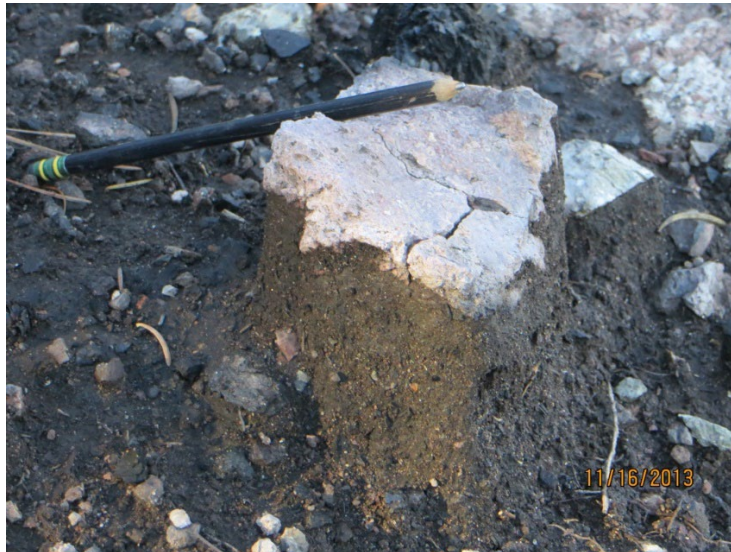
The probability of damage or loss to soil productivity is **Very Likely**. This is attributed to two types of storms that occur annually in the Southwest. One is the monsoon season which typically occurs in early July in the southwest and is characterized by recurring, localized, intense showers, and thunderstorms within a 2–3-week period. This is followed later in the year (September – October) by frontal cyclonic storms that are more widespread/damaging and often accompanied by multiple days of steady rains. Further, 56% of the fire area has a severe erosion hazard rating and fire occurrence is outside of ecological context with much of the Black Fire footprint having experienced stand replacing fire within the last 70 years. Most recently, the 2013 Silver Fire that burned 72,200 acres within the Black perimeter. Also, a majority of the high and moderate SBS occurred on steep slopes that have lost 90-100% of ground cover. The magnitude of the consequence in these areas is **Major** due to the potential loss of the entire A horizon, high levels of erosion and the inability of the vegetation to recover naturally. The Black Fire burned in the same soils, climate and vegetation as the Silver Fire which has documented 3-4 inches of soil loss (a total loss of A horizon) on untreated areas (Figures 4 & 5).

Figure 3. Approximately 3" Soil loss. Silver Fire 2013 Level II Monitoring (untreated plot)

- Seed approximately 6,694 acres of large contiguous areas of high soil burn severity to provide for relatively quick establishment of vegetative ground cover to assist the burned area in maintaining soil productivity. This will be done with a quick-germinating annual barley that results in ground cover within three weeks. The treatment will assist in greatly reducing the amount of erosion and loss of hydrologic function that the burned area will experience. This quickly assists in stabilizing slopes and reducing negative effects to water quality that will devastate T&E aquatic habitats.

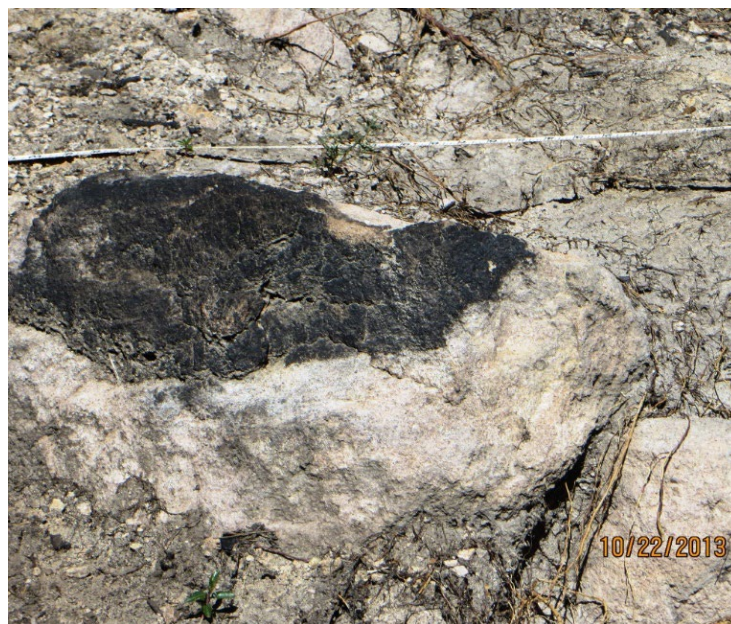
Figure 4. Appx 4" soil loss - Silver Fire 2013 Level II Monitoring (untreated plot)

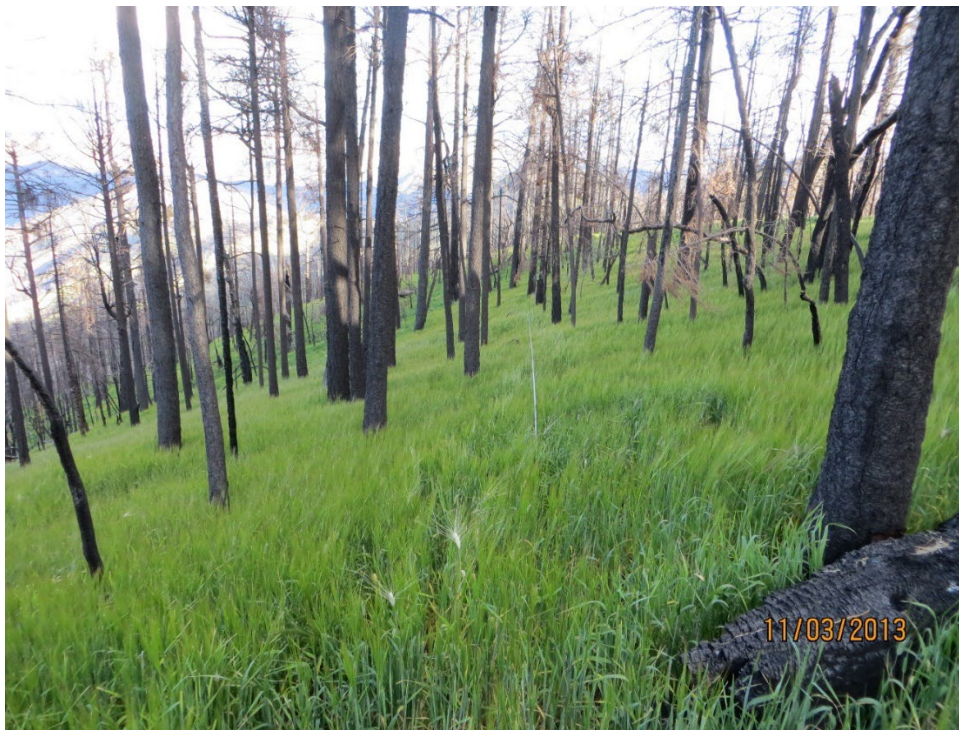
The 2013 Silver Fire monitoring report confirms that seeding with annual barley provides for adequate ground cover and its associated benefits at reducing erosion, verses no treatment. Monitoring was conducted annually for three years, with five weeks of data collected on ground cover. These two monitoring reports have been included with dated photographs as confirmation of the succes of these studies. They provide detailed information as to the success of seeding as a land treatment on the Gila NF and in the Southwest (see attachements)

*Figure 5. Barley Growth 4 months post 2013 Silver Fire seeding*

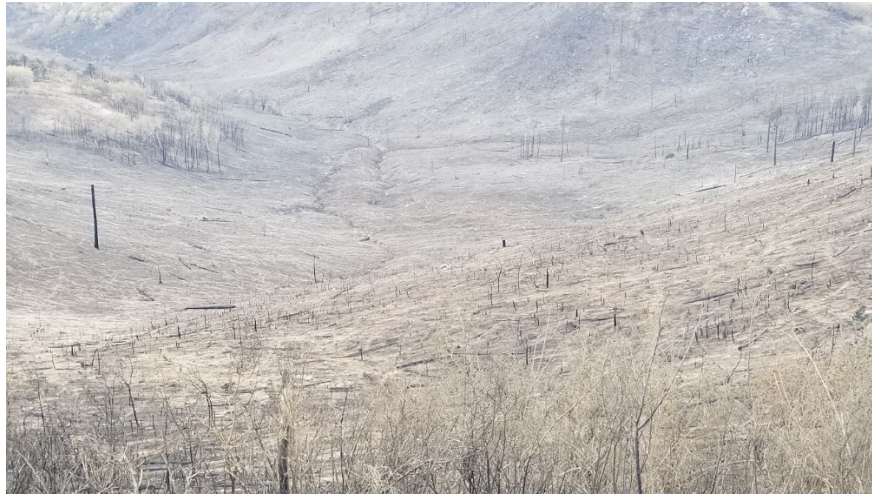
Figure 6. Pretty Canyon – high soil burn severity; at risk of severe soil loss in 1<sup>st</sup> year
