Date of Report: Sept. 11, 2006

BURNED-AREA REPORT
(Reference FSH 2509.13)**PART I - TYPE OF REQUEST**

- A. Fire Name: Sand B. Fire Number: AZ-ASF-060100 (P3CH9C)
C. State: AZ D. County: Coconino
E. Region: 03 F. Forest: Apache-Sitgreaves
G. District: Black Mesa
H. Date Fire Started: April 22, 2006 I. Date Fire Contained: April 27, 2006
J. Suppression Cost: \$847,000 (as of 5/4/06)
K. Fire Suppression Damages Repaired with Suppression Funds
1. Fireline waterbarred (miles): 6.6
2. Fireline seeded (miles): 0 (seeding will be accomplished in conjunction with BAER rehab if feasible)
3. Other (identify): 0.5 miles of fence repair
L. Watershed Number: 1502001001
M. Total Acres Burned: 1280
NFS Acres(1280) Other Federal () State () Private ()
N. Vegetation Types: Ponderosa pine, pinyon-juniper
O. Dominant Soils: 051,186, 189, 061, 052, 182, 187
P. Geologic Types: Limestone and sandstone

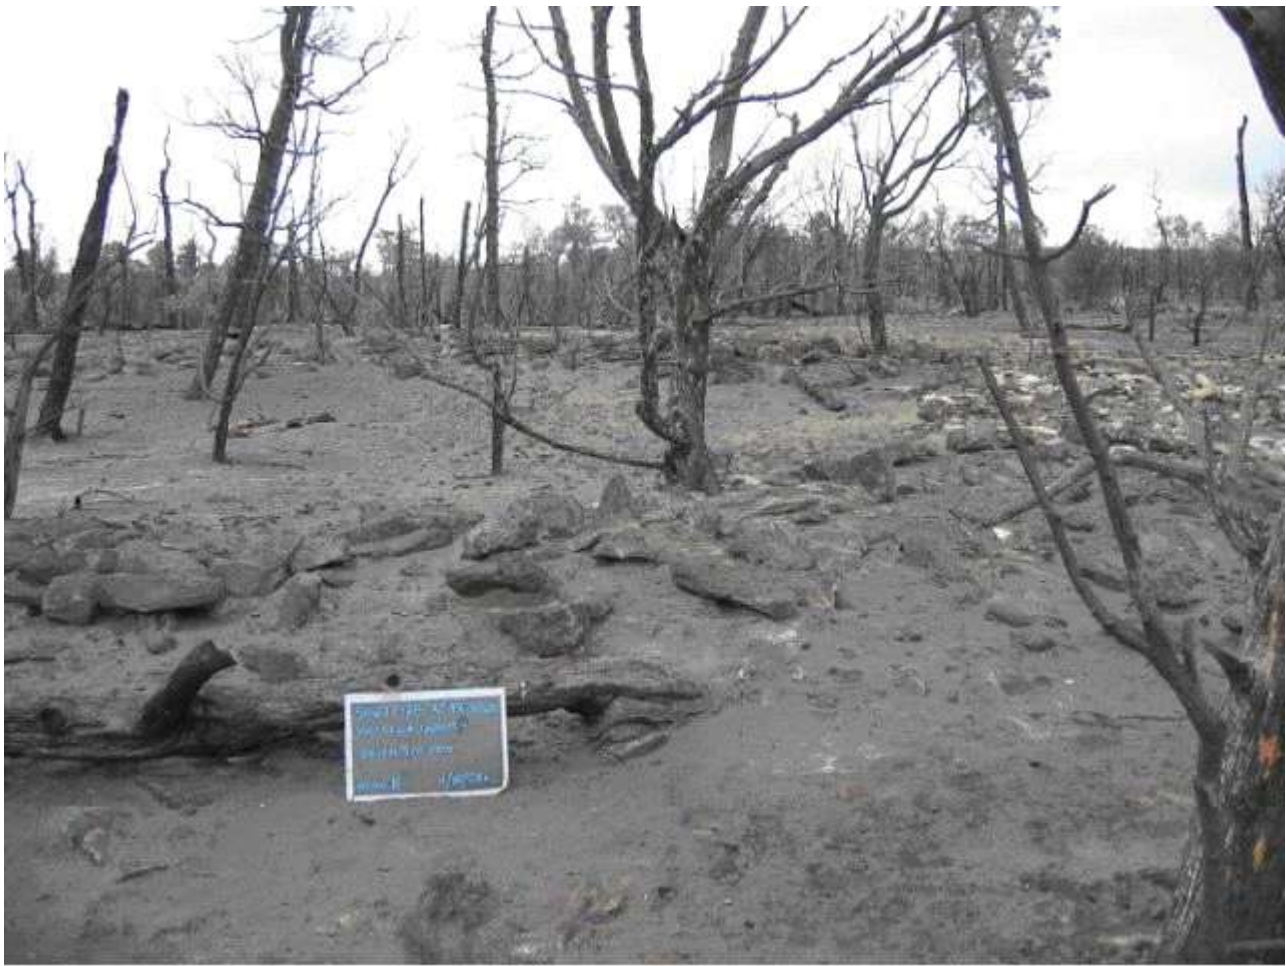
During fire suppression five new archaeological resources were identified and recorded. One of these sites, 03-01-02-03593 (Prison Point Kiva), is one of the largest and most intact NRHP eligible cultural resources identified on the forest. This site is at risk of damage from burned area conditions.

Sites 03-01-02-03593 (Prison Point Kiva), 03-01-02-03602, and 03-01-02-03607 are all NRHP eligible sites located in moderate to severe burn areas in which the duff, ladder fuels, and crowns have been completely consumed. Soils within and immediately upslope of these resources show observable levels of hydrophobicity. Resource threats include: 1. rilling through these sites which may expose buried cultural resources or human remains; 2. an increased level of sheet wash that may transport artifacts off site and/or expose buried cultural deposits. 3. fire killed trees within these sites falling due to unstable soils and pulling their roots systems (as well as cultural deposits) with them. Since looting and vandalism was absent at all sites encountered, it is assumed that these sites had received protection from previous episodes of looting and vandalism due to their obscurity caused by limited, pre-fire visibility. As exposed in the post-fire environment, these sites are clearly visible from a distance.

Figure 1. Overview of Great Kiva feature at Prison Point site.

Method: Approximately 4 acres of site stabilization is required within the site boundaries and immediately upslope of the 3 above mentioned archaeological sites. Previous stabilization treatment and studies have found that the most cost-effective and successful treatments include heavy seeding, straw mulching, felling of fire killed trees within architectural features, and contour felling within and upslope of site boundaries. (Haines et.al. 2005; Robichaud et.al. 2000). These four stabilization measures will be performed by NFS field crews supervised by the Black Mesa District Archaeology staff. In the event that aerial mulching is funded for other stabilization needs, hand mulching will not be employed at the sites. However, it may be necessary to redistribute mulch by hand to assure optimum site stabilization.

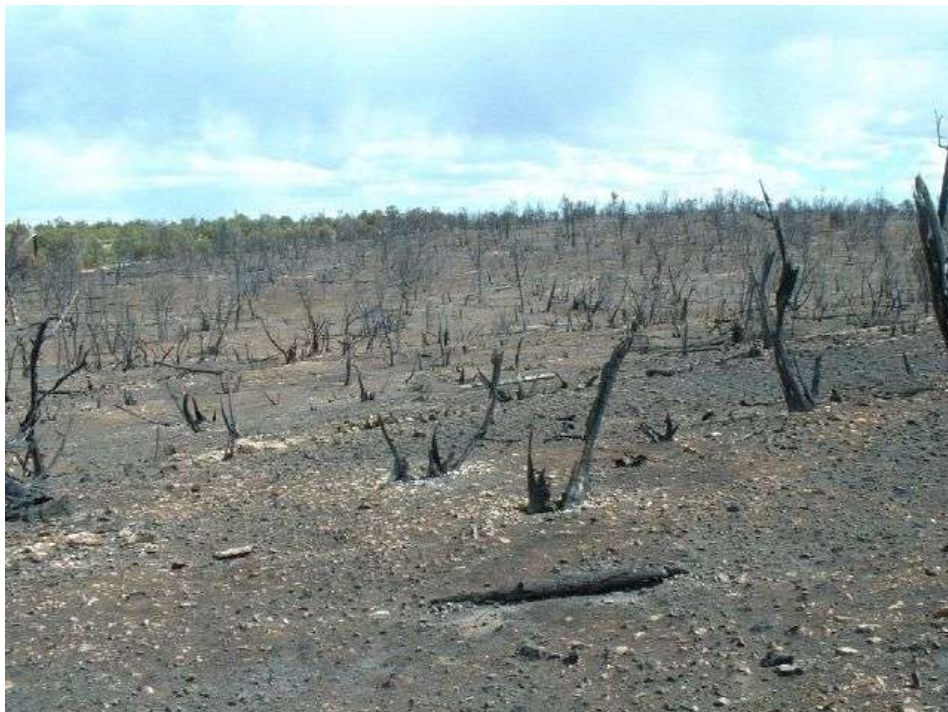
Hydrophobic conditions were encountered in moderate to high severity burned areas surveyed on the central and northern portions of the Sand fire. This portion of the fire was dominated by pinyon-juniper forests with pre-existing high mortality of pinyon due to bark beetle infestation. The survey team noted a spatial pattern, typical of severe burns in this vegetation type, of highly variable levels of hydrophobicity with moderate to severe hydrophobicity in areas of higher pre-fire organic matter accumulation beneath trees and no to light hydrophobicity in grass dominated openings in the pre-fire tree canopy. Some degree of recovery of grasses (primarily blue grama) is expected in these former openings. However, nearly 100% of pre-fire vegetative ground cover in the moderate to severely burned areas has been lost as well as nearly 100% the tree and shrub canopy. The removal of the canopy and ground cover combined with the hydrophobicity has decreased the infiltration rate of these areas and will lead to highly elevated levels of runoff and consequent highly elevated soil erosion from them.

Figure 2: Typical severe burn area
