Date of Report: August 28, 2020**BURNED-AREA REPORT****PART I - TYPE OF REQUEST****A. Type of Report**

PART II - BURNED-AREA DESCRIPTION**A. Fire Name:** Beach**B. Fire Number:** CA-INF-002140**C. State:** CA**D. County:** Mono**E. Region:** Pacific Southwest**F. Forest:** Inyo**G. District:** Mono Lake**H. Fire Incident Job Code:** P5NFR120**I. Date Fire Started:** Aug. 16,2020**J. Date Fire Contained:** August 27,2020**K. Suppression Cost:** 3 million**L. Fire Suppression Damages Repaired with Suppression Funds (estimates):****1. Fireline repaired (miles):**

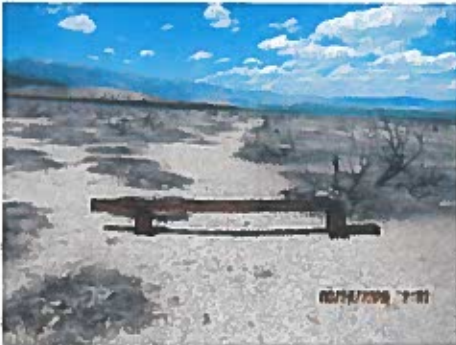
P1- OHV Barricade Installation: Install carsonite signs and physical barricades at entry points to unauthorized routes off Forest roads 0N152, 0N151, 0N160 where previous barricades were burned and trails are now exposed, and at entry points to fire on Forest system routes (9 points) that will be under a Forest Order for a one year closure. The Forest proposes placing 6x6 treated wood barricades built extra strong (braced framework) with carsonite closure signs at the entry points. Similar to the one in the picture below. The open areas within the fire are vulnerable to OHV trespass and soil disturbance. The BAER Team considers this treatment to be the minimum necessary to achieve a reduction in risk to critical values and is less expensive and intrusive than installing fencing. In addition to barricades and signs, one heavily used unauthorized route will require ½ mile of subsoiling work by backhoe to ensure effective closure and soil rehabilitation to expedite vegetative recovery.
