Date of Report:9/16/2021

GOOSE BURNED-AREA REPORT

PART II - BURNED-AREA DESCRIPTION**A. Fire Name: Goose Fire****B. Fire Number: MT-BDF-006227****C. State: Montana****D. County: Madison, Beaverhead****E. Region: R1****F. Forest: Beaverhead Deerlodge****G. District: Madison****H. Fire Incident Job Code: P1N4QH****I. Date Fire Started: July 1st, 2021****J. Date Fire Contained: October 31st, 2021
(estimated)****K. Suppression Cost: \$3.7 million****L. Fire Suppression Damages Repaired with Suppression Funds (estimates):**

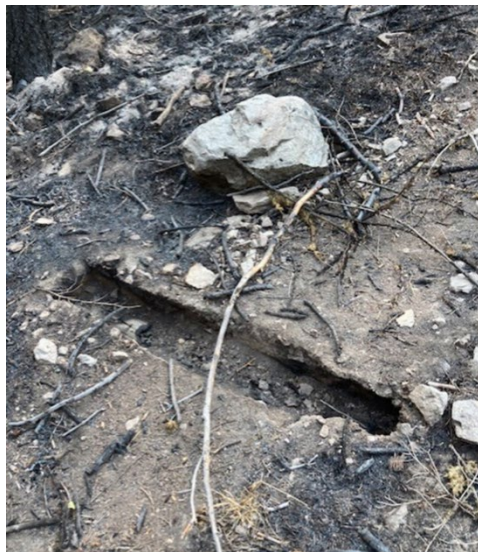
Figure 1. Burned wood water bar on 6019 trail.

The 6.2 miles of maintained trail in the fire perimeter downslope from high and moderate burn severity will need drainage ensured. Figure 1 shows an example of trail structures that need replacement or drainage dips and outsloping installed in lieu of structures. These pressure treated wood water bars were fully consumed in places on the 6019 trail and significant erosion is expected given the grade of the trails with limited erosion control in place. Due to the remote setting of these trails, trail work costs will be slightly higher due to the need to camp out and transportation costs.

RT13 Trail Drainage/Tread Stabilization:

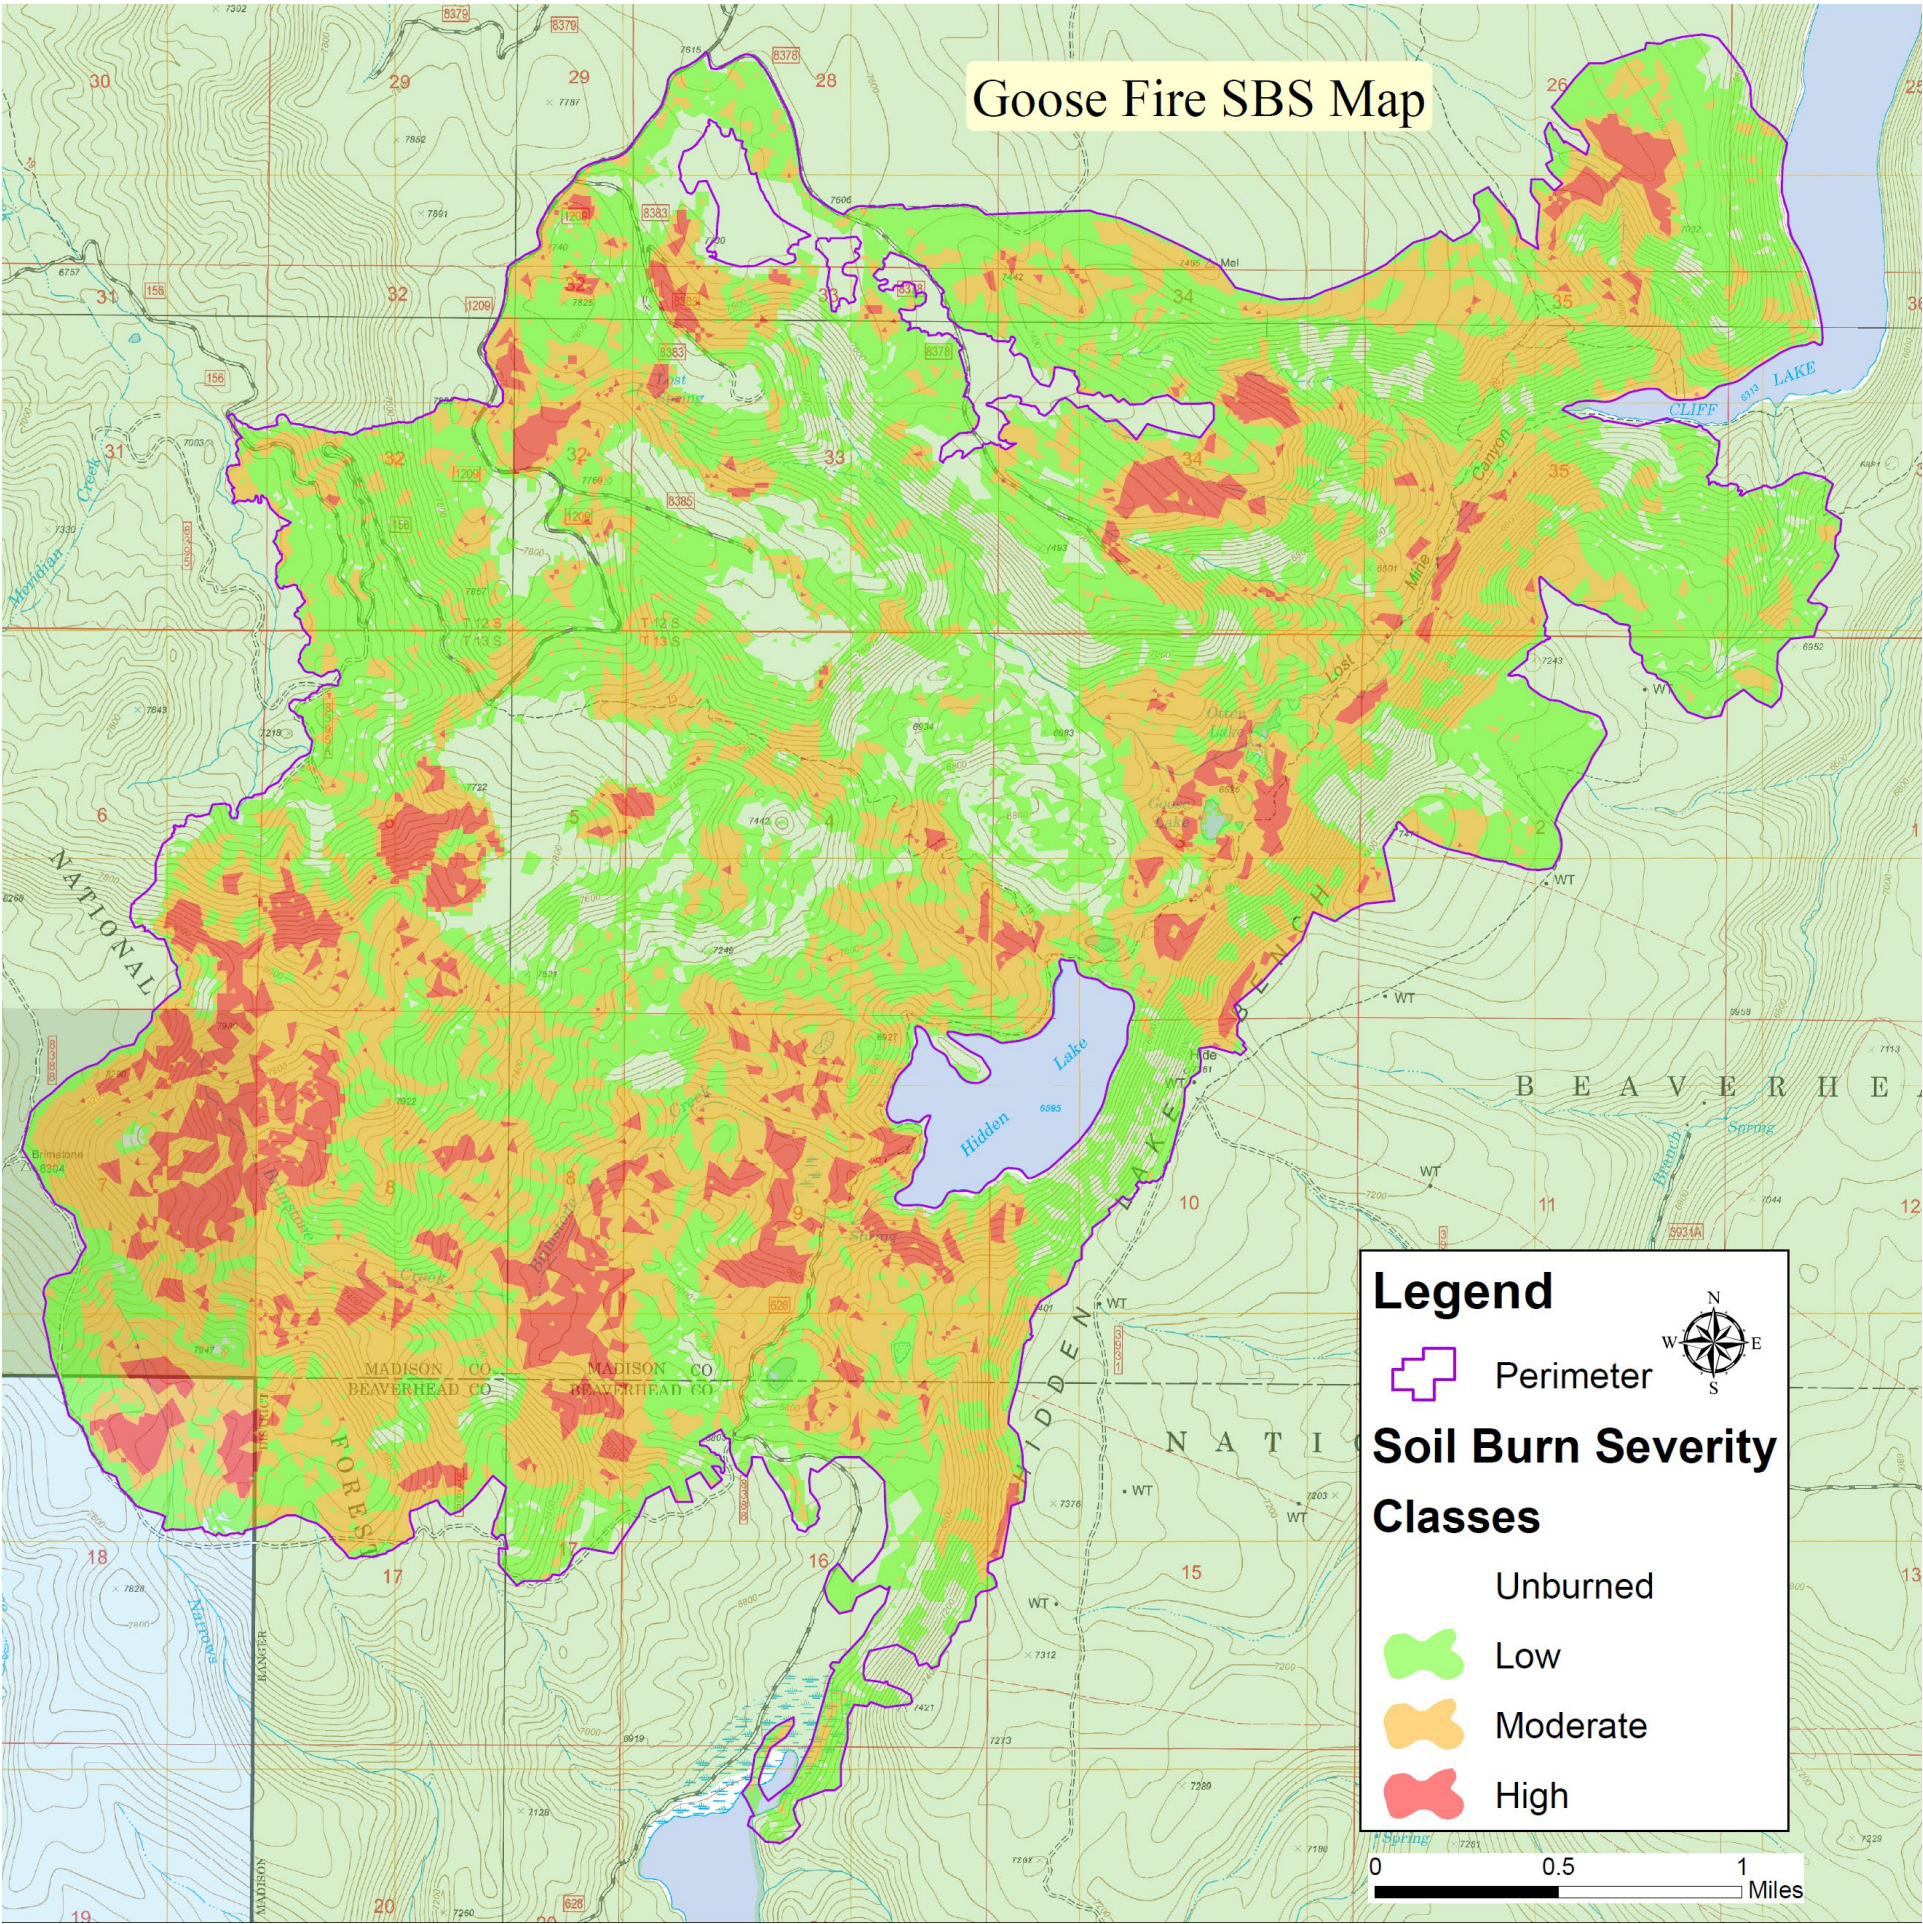
Figure 2. Goose fire Soil Burn Severity Map.

Soil Burn Severity	NFS	State	Private	Total	% within the Fire Perimeter
Unburned	1,019	1	6	1,026	14
Low	3,181	39	8	3,228	43
Moderate	2,649	44	4	2,697	36
High	600	30	0	630	8
Total	7,449	114	18	7,581
