BURNED-AREA REPORT

PART II - BURNED-AREA DESCRIPTIONA. Fire Name: Mt. Hood Fire ComplexB. Fire Number: OR-MHF-140C. State: OregonD. County: Hood River/WASCOE. Region: 06F. Forest: Mt. Hood National ForestG. District: Hood RiverH. Fire Incident Job Code: P6C22VI. Date Fire Started: August 7, 2006J. Date Fire Contained: 9-14-06K. Suppression Cost: \$ 10,000,000

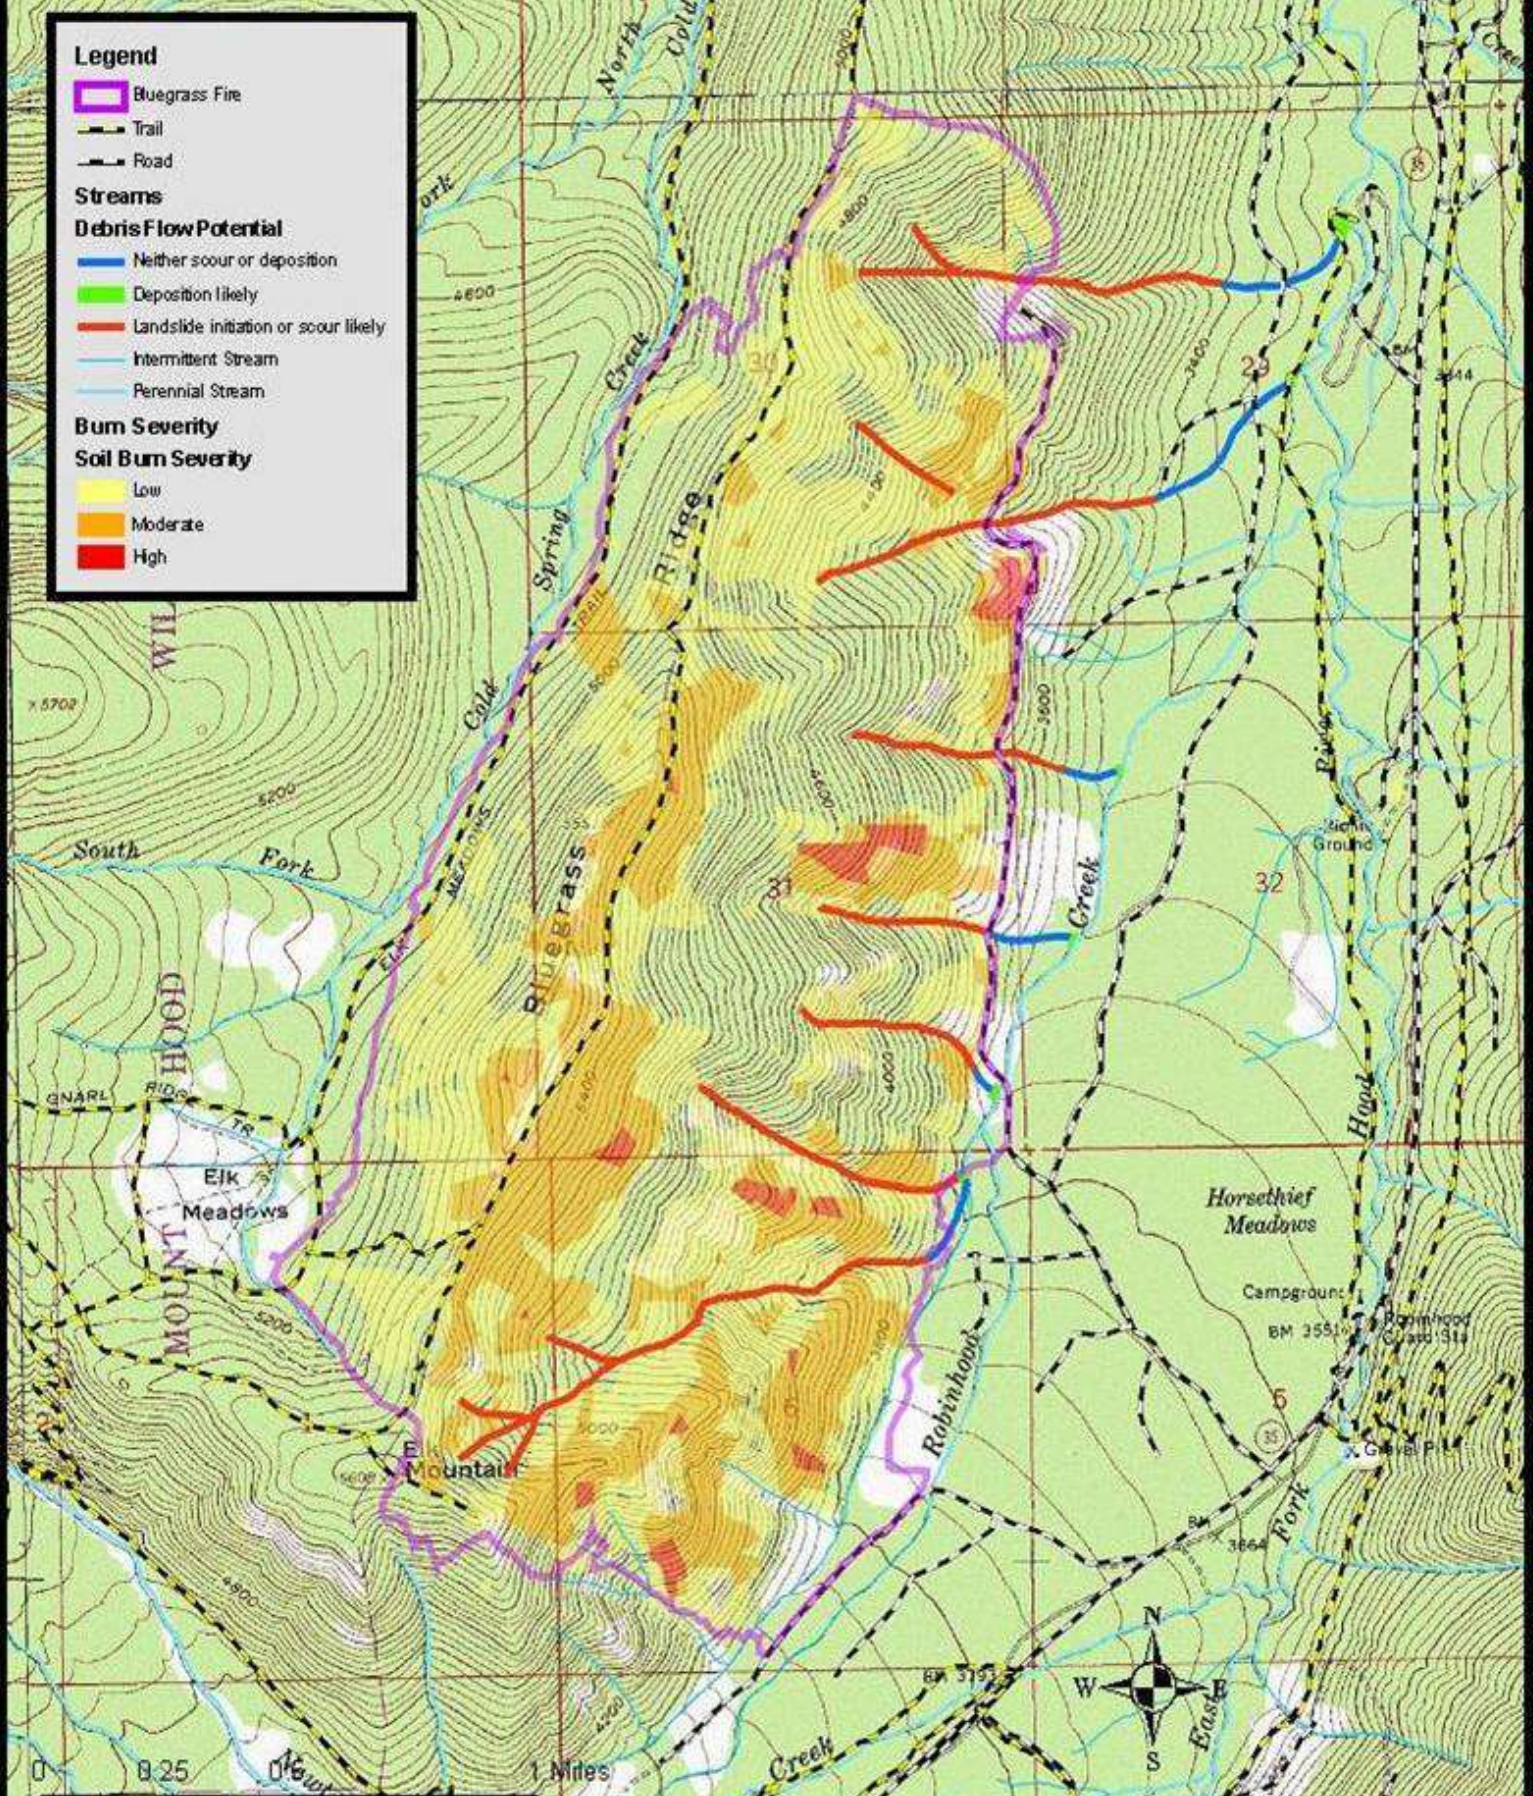
Bluegrass Fire - Soil Burn Severity and Debris Flow Potential

A. Burn Severity (acres): 818 (unburned) 610 (low) 377 (moderate) 28 (high)

An analysis of debris flow potential indicates several possible sources, all of which are steep gradient small intermittent or perennial tributaries to Robinhood Creek. All of the potential debris flows are expected to have run out zones that end at Robinhood Creek, which would contribute additional sediment to this system. This post-burn derived sediment and flooding pose a risk to the 3520620 and 3520650 Robinhood Creek crossings. These stream crossings are currently culverts that are a high risk to wash out when subjected to increased flood flows that are anticipated after the fire (12% to 133% increase over prefire flows for the 25 year event). Flood flow calculations indicate that the 3520620 crossing has a 35 to 45% chance of failure within the first year after the fire and a 65 to 75% chance of failure within the first 3 years. The 3520650 has an even greater chance due to the undersized culvert that is currently in place. In addition, one trail bridge is threatened due to the inability of the structure to pass anticipated post-burn flows.
