BURNED-AREA REPORT
(Reference FSH 2509.13)

A. Fire Name: McNally

B. Fire Number: 55764 (CA-SQF-1888)

F. Forest: Sequoia NF incl. Giant Sequoia Natl. Monument

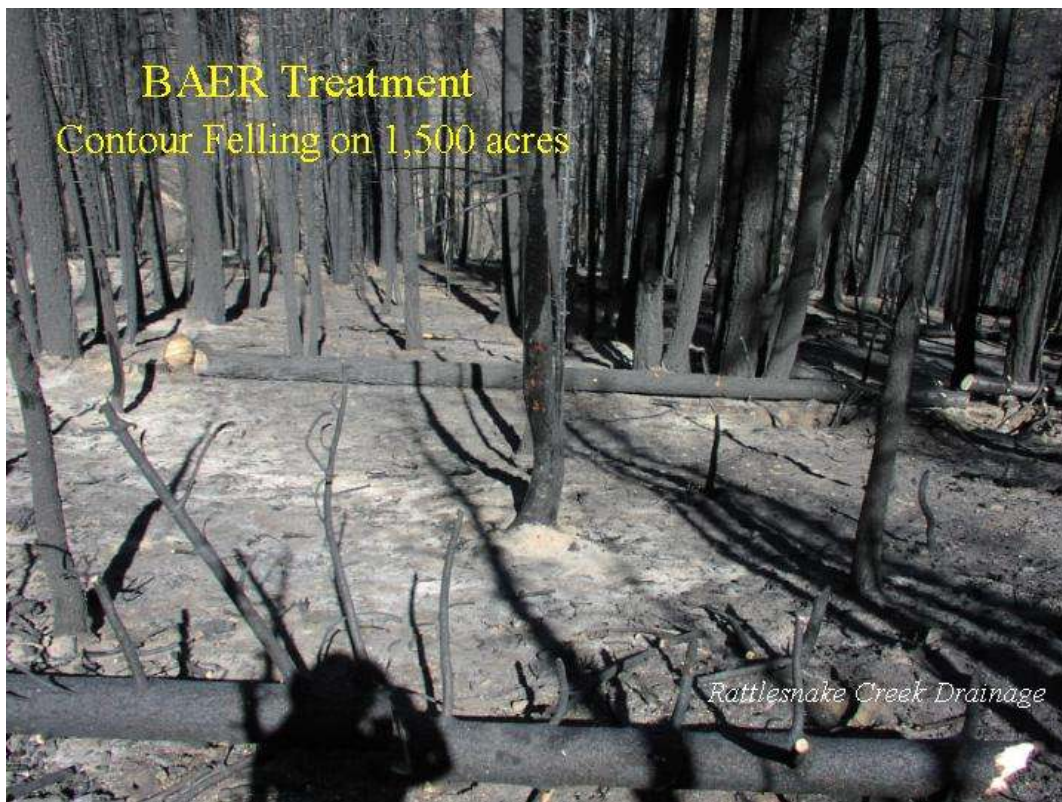
Contour felling of trees is prescribed for areas of high severity in formerly forested communities where sufficient stems per acre and/or the appropriate diameter class exist. All trees < 14" dbh will be felled on contour on slopes ranging between 15-40% followed by scattering of slash. Felling on the contour should occur where feasible. The main trunk of the tree should be limbed and bucked to provide effective contact with the soil surface. Trenching and staking is not required.

Contour felling is complete and occurred through force account and contract. Force Account costs were \$236,878.34 with treatment on 1,446 acres. Contract work occurred on 673 acres at a cost of \$148,062.00.

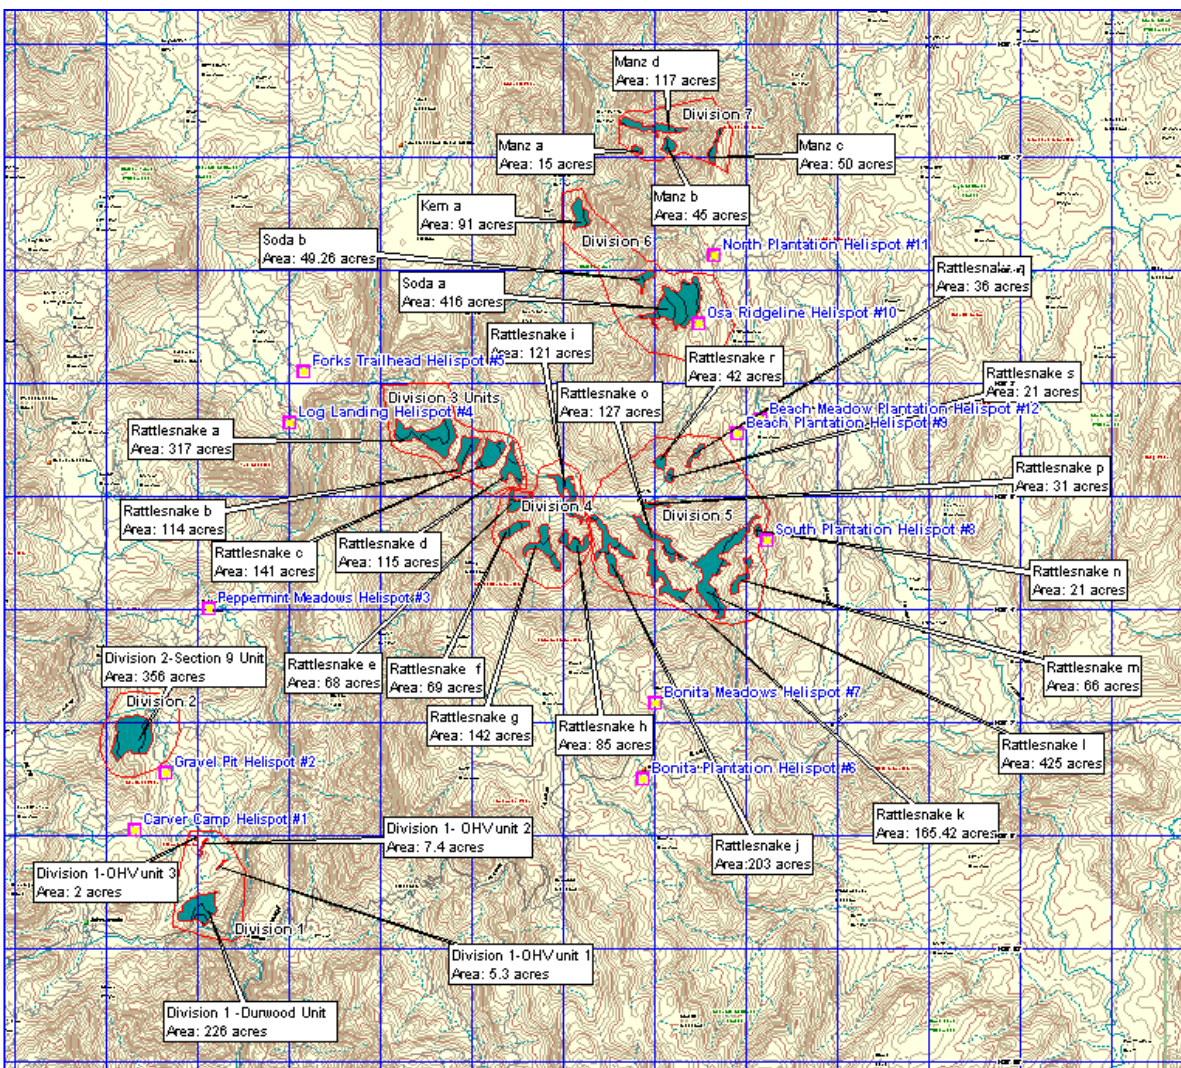
Helimulching Location Map

Heli-mulching was accomplished in the Rattlesnake Creek Drainage, Nobe Young Creek and South Creek on the areas of severe burn. The Durwood Creekside Resort is included in this area. This work was done through contract. Contract cost was \$1,700,013.18. Hay was purchased separately at a cost of \$416,764.17. A total of 2993.5 acres were treated, of these 87.5 acres were archeological areas of concern. The above map shows helimulching locations. These locations were

flown using GPS coordinates. Ninemile, Osa, Soda, Grouse, and Manzanita areas were not treated after further field evaluation and need to transfer dollars to areas with higher treats to life property and resources.

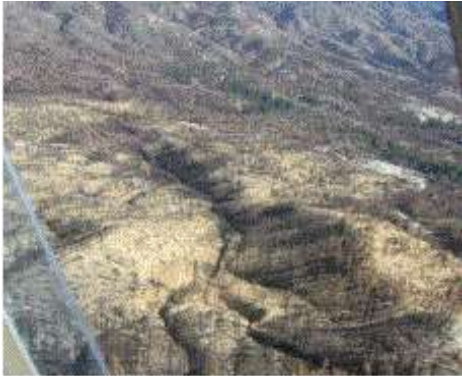
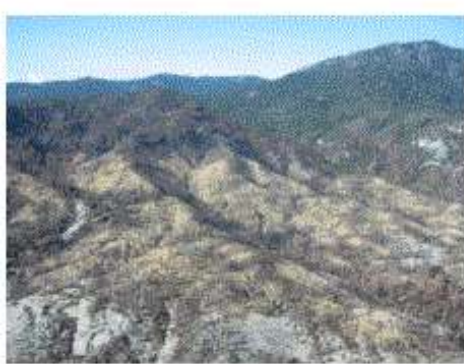
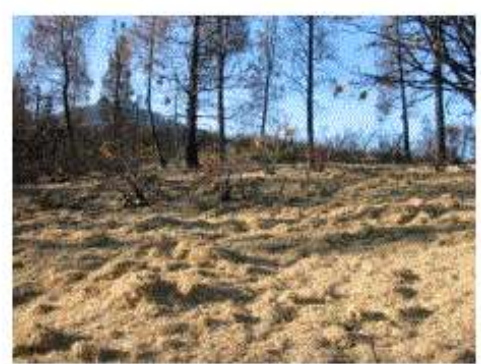
Helimulching in Rattlesnake Creek Basin in photos 1 and 2, photo shows on the ground investigation of treatment in Section 9.

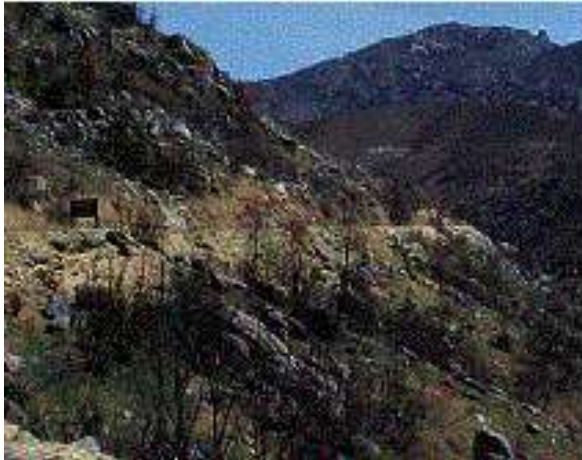
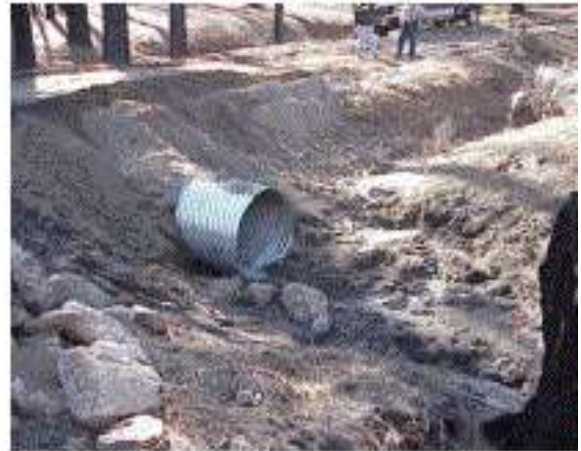
Contracts for all roadwork have now been awarded. The McNally 1 contract (Sherman Pass and Cherry Hill Roads) is 90% complete: erosion control work consisting of construction/reconstruction of 2,150 feet of roadway ditch and installation of 307 cubic yards of riprap; drainage improvement work consisting of removing 24 undersized culverts and replacing with larger sized culverts, installation of 40 metal end sections, installation of 5 new spillway inlet assemblies, and cleaning of 76 culverts and spillway inlet assemblies. Thirty-five tons of mulch was applied to fill slopes to prevent erosion. This contract is currently at \$397,735.56.

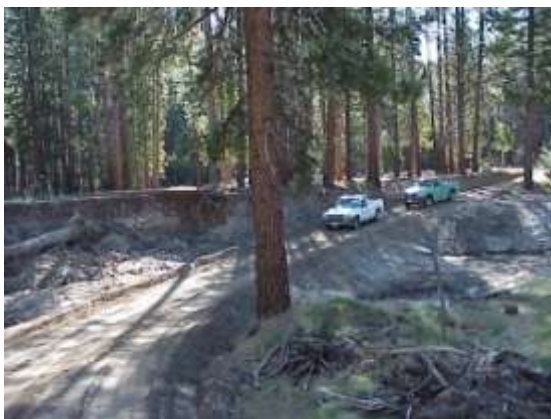
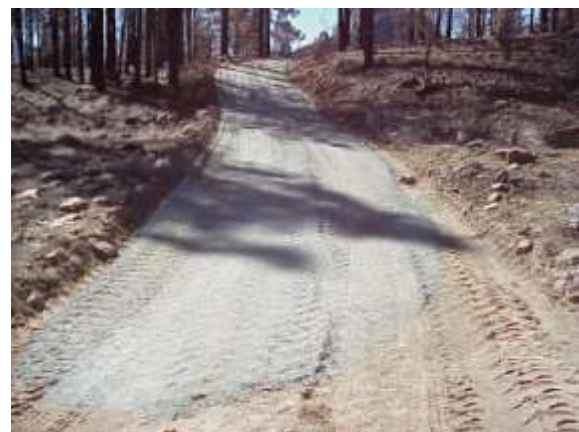
The McNally 2 contract (Lloyd Meadow Area Roads) is 90% complete: erosion control work consisting of construction/reconstruction of 150 feet of roadway ditch, 15 feet of runoff ditch, 60 feet of drainage channel, installation of 138 cubic yards of riprap and placement of 125 tons aggregate surface course; drainage improvement work consisting of removing undersized culverts and replacing with larger sized culverts, installation of 12 metal end sections, installation of 10 new spillway inlet assemblies, and cleaning of 22 culverts and spillway inlet assemblies. The cost of this contract is currently at \$222,057.50.
