BURNED-AREA REPORT
(Reference FSH 2509.13)

PART I - TYPE OF REQUEST

- A. Fire Name: Rush Ridge - Fish Fire Complex B. Fire Number: KY-DBF-100062
- C. State: Kentucky D. County: Powell
- E. Region: 08 F. Forest: Daniel Boone National Forest
- G. District: Cumberland H. Fire Incident Job Code: P8EK2U
- I. Date Fire Started: 10/7/2010 J. Date Fire Contained: 11/5/2010
- K. Suppression Cost: \$50,000
- L. Fire Suppression Damages Repaired with Suppression Funds
 - 1. Fireline waterbarred (miles): 0.25
 - 2. Fireline seeded (miles): none
 - 3. Other (identify): none
- M. Watershed Number: HUC 6: 051002040209 (Indian Creek - Red River)
- N. Total Acres Burned: _____
NFS Acres(60) Other Federal (0) State (0) Private (0)
- O. Vegetation Types: yellow poplar, white oak, northern red oak, chesnut oak, white oak, northern red oak, hickory, and scarlet oak
- P. Dominant Soils: Alticrest-Ramsey(ArF) on the ridges and Helechawa (HeF) midslope

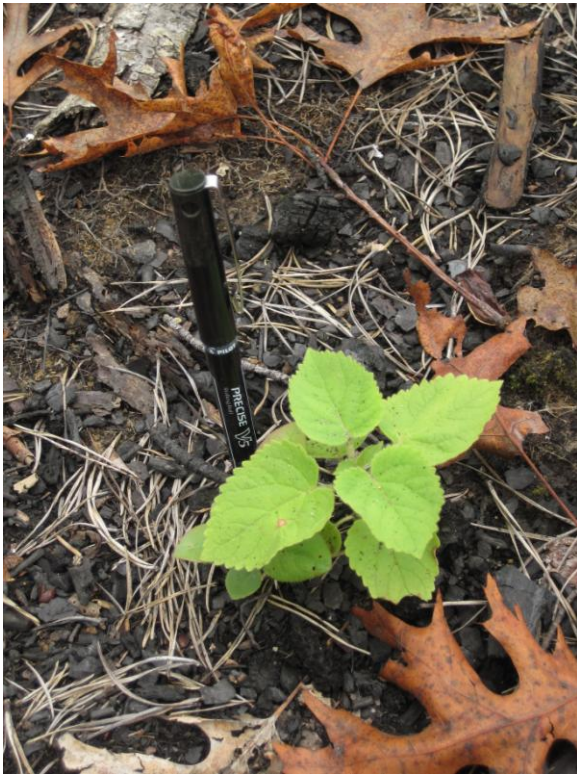
Fig. 1. Princess tree ca. 3 in tall (September 2011).

Of particular concern are princess tree and coltsfoot both from the standpoint of sheer numbers of plants and their reproductive potential. These two species are also expected to persist as the forest begins to recover. Princess tree grows quickly (some individuals encountered reached 6ft in less than one full growing season- see Fig. 2 below) and will maintain itself in the canopy for 20-30 years before it is overtopped. A single tree at 6" inches dbh (about 3-4 years growth) is capable of producing 1/4 million seeds. Individual plants pulled indicate a wide variation in growth strategies. Many plants put down large carrot-like taproots and produced small stems (Fig. 4). These plants will grow rapidly in the next few years and will persist even in drought. Others produced more fibrous roots and grew to 6ft tall (Fig. 3). These also will grow rapidly, but may be more susceptible to drought conditions. Some produced a combination of both types of roots. Based on treatment through November, the chances of removing individuals of this species by hand after mid-summer 2012 are slim. At that point targeted treatment with chemical will be required over a large area for multiple years to control the species. Eradication may not be possible for years if at all.

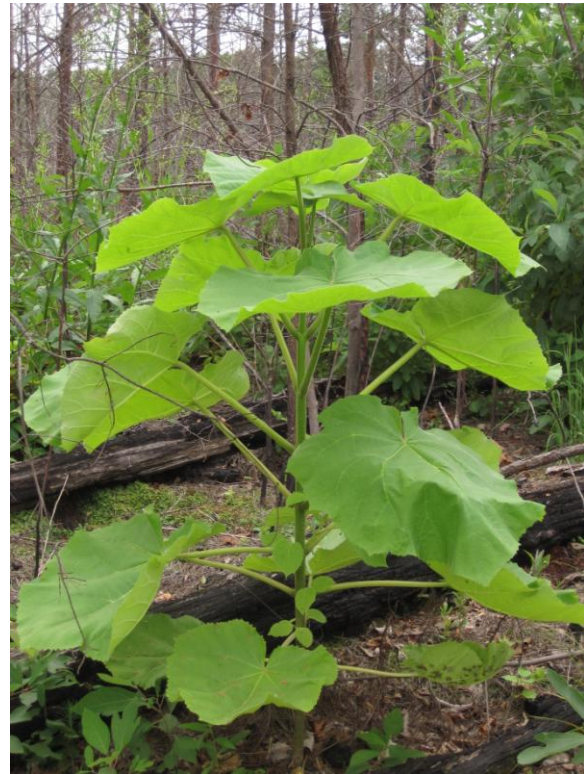
Fig. 2. Princess tree ca. 6 ft tall (September 2011).

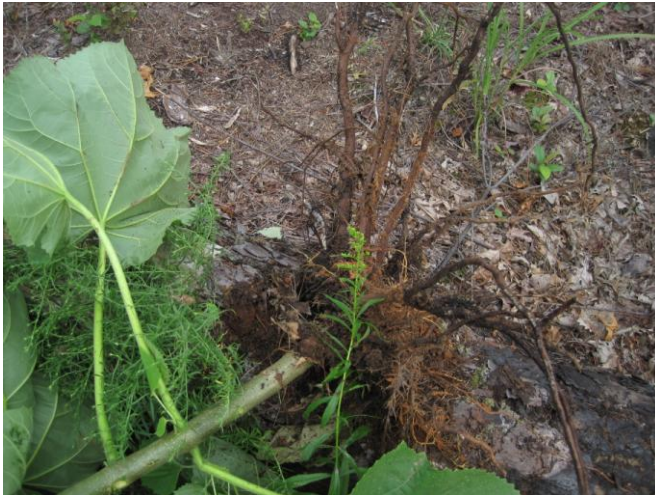
Fig. 3. Princess tree with fibrous root system (September 2011).

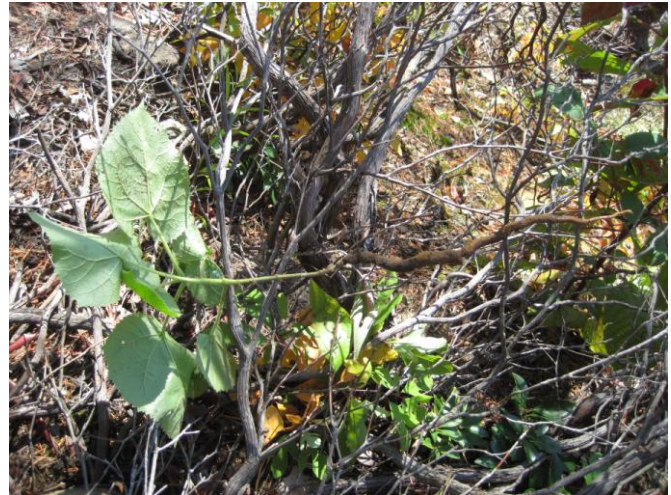
Fig. 4. Princess tree with taproot system (November 2011).

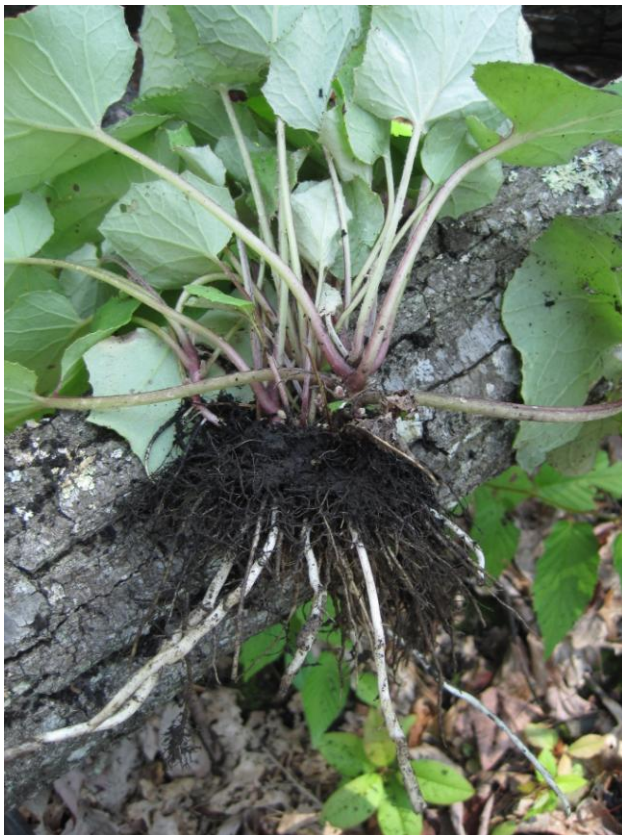
Fig. 5. Coltsfoot with rhizomes (September 2011).

Coltsfoot will maintain itself in moderate shade for years, but with reduced flowering. Buds are already set and may actually open anytime between December and March (Fig. 6). The plants observed were averaging 25 buds per plant (after one growing season). Each bud produces 100-200 seeds for 2500-5000 seeds per plant. The plants once established form large rosettes that smother vegetation. The plant produces an extensive rhizome system that grows downward and then laterally at multiple levels (Fig. 5). Treatment (hand pulling) accomplished so far indicates that complete removal of plants will become difficult at best. Many have already begun to grow vertical rhizomes. It is not known how much of these rhizomes need to be removed to ensure death. Even small plants with 2-3 leaves were producing lateral rhizomes to 12 inches long. At best one more growing season of hand pulling is available to treat plants established in 2011. After that, it will require the use of targeted chemical over a large area for multiple years to control the species. Eradication may not be possible.

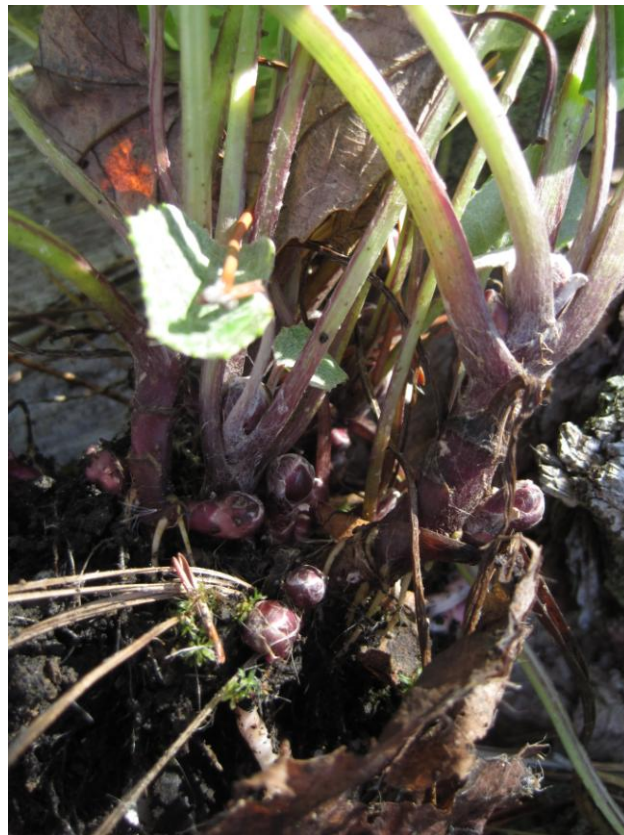
Fig. 6. Coltsfoot with flower buds (November 2011).

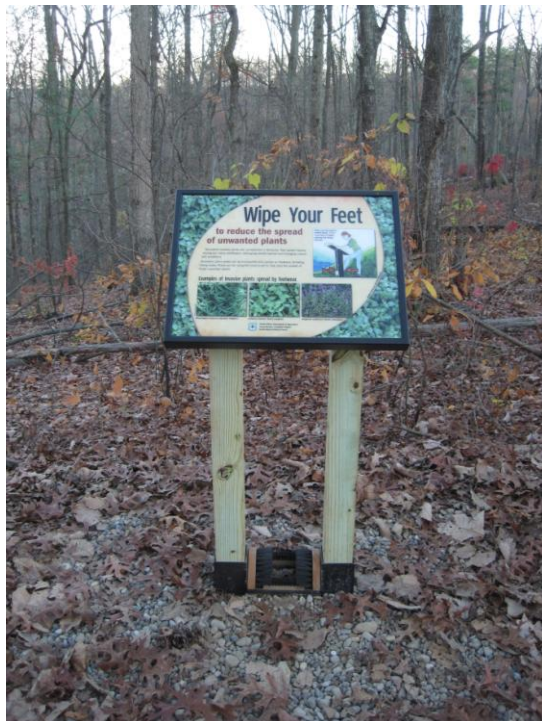
Fig. 7. Completed Boot Brush Station.

maintained product. The final design chosen consisted of a small plaque (18" x 24") mounted on two 4" x 4" posts. Near ground level, a boot brush was attached to the posts. Surrounding the posts is a 48" x 48" wooden frame filled with gravel (see photo below). As soil and seeds are wiped off boots and shoes, it falls into the gravel and is captured. Once seed sprouts, plants can be pulled and identified to know what was kept off of the trail system.

Only the trail head station was installed on the Rush Ridge BAER area. A survey of connecting trails indicated that the second station was probably not required. Only one soil carried nonnative invasive species was found at the northern end of the Rush Ridge trail, and that at a small campsite. The connecting Rough trail was without nonnative invasive species for ½ mile either way. The connection with the Pinch-em Tight trail was likewise without a soil carried nonnative invasive species concern. The area will be monitored and a station installed if soil carried nonnative invasive species are detected in the area.

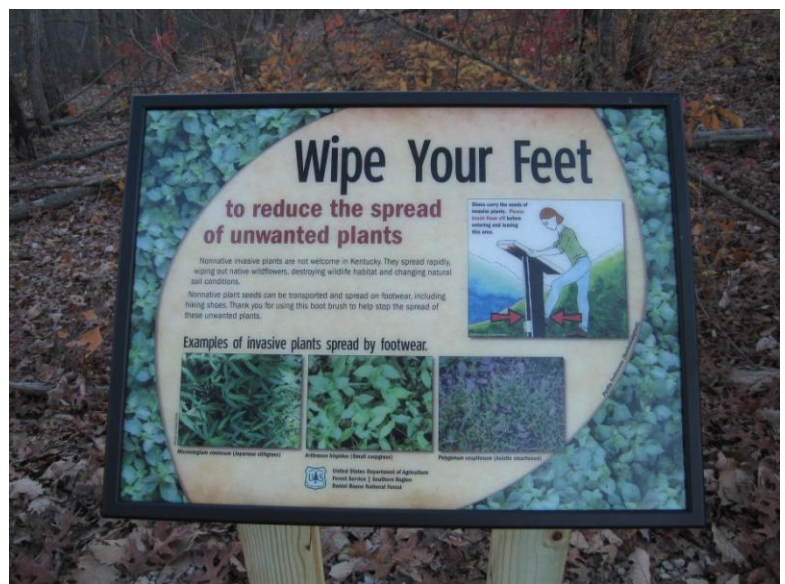
Fig. 8. Plaque on boot brush station.

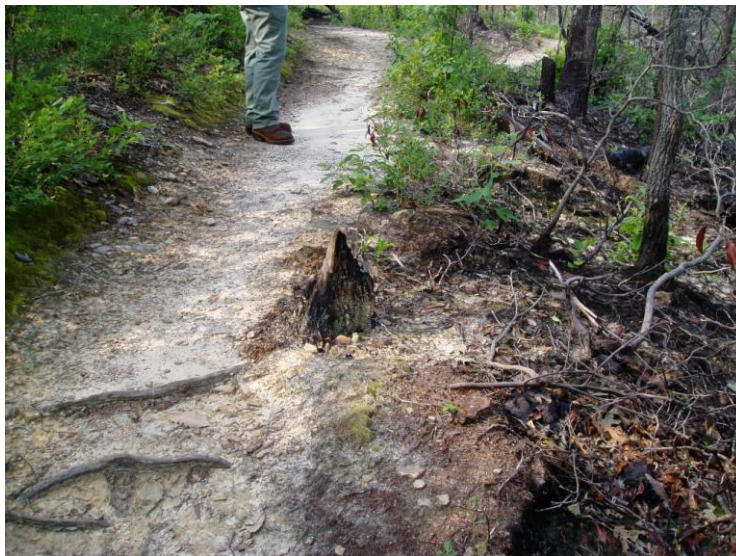
Fig. 9. Berm removal from trail to allow better drainage.

Work on the trails commenced the week of February 14, 2011. Installed treatments included surveying and marking the trail for exact locations of damage, filling of stump holes within 6 feet of the trail, correcting “slumped” trail tread that resulted from tree roots burning out beneath the trail, installing/shoring up water bars, removing trail berms for water dispersal off the trail, and trail outsloping. A total of 0.5 miles of the Rush Ridge Trail were improved using the BAER funds.

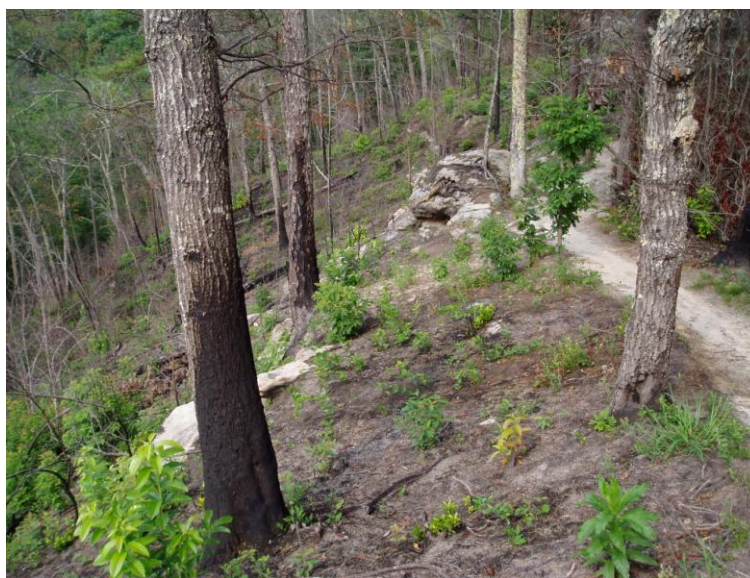
Fig. 10. Berm removal from trail to allow better drainage.
