**Rabbit Foot Fire
2018
Salmon-Challis National Forest**

**FS-2500-8
Burned Area Report**

October 29, 2018

Date of Report: October 29, 2018**BURNED-AREA REPORT**

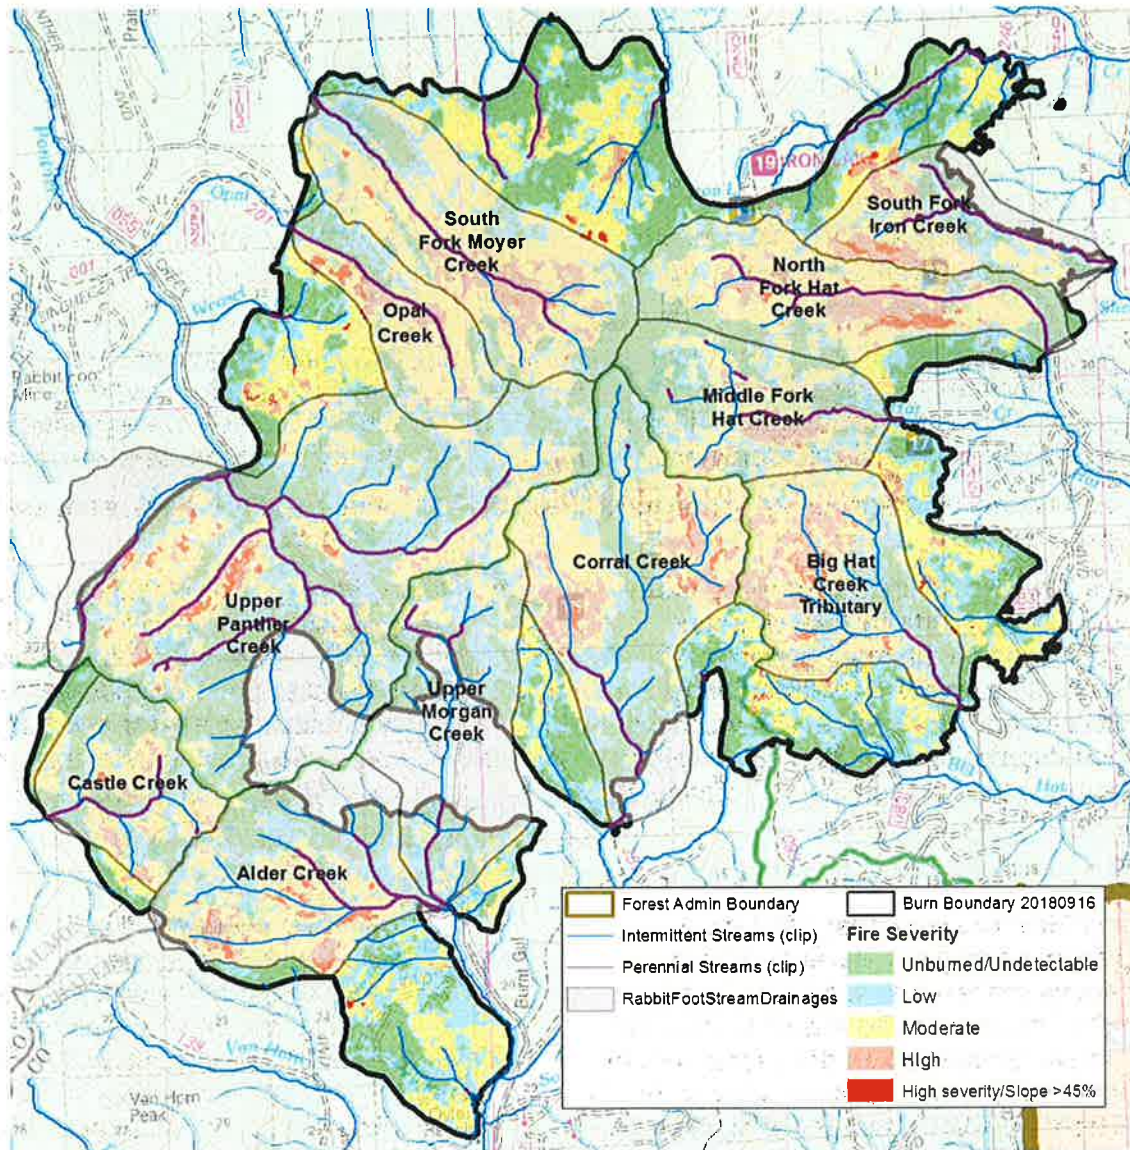
Individual drainages most affected by the Rabbit Foot Fire

Individual drainages most affected by the fire	Acres burned by burn severity				Total Acres burned	Percent of drainage burned
	Unburned	Low	Moderate	High		
Alder Creek at confluence with Morgan Creek	34%	21%	37%	9%	1608	66%
Big Hat Creek Tributary at fire perimeter	15%	22%	45%	18%	1814	85%
Castle Creek at fire perimeter	35%	23%	37%	5%	939	65%
Corral Creek at fire perimeter	35%	18%	35%	12%	2257	65%
Middle Fork Hat Creek at fire perimeter	32%	21%	38%	9%	1283	68%
North Fork Hat Creek at fire perimeter	24%	12%	47%	18%	1728	76%
Opal Creek at fire perimeter (Opal Lake)	19%	18%	49%	15%	1020	81%
South Fork Iron Creek at fire perimeter	30%	20%	37%	13%	989	70%
South Fork Moyer Creek at fire perimeter	18%	18%	49%	15%	2316	82%
Upper Morgan Creek upstream of Alder Creek	68%	21%	10%	0.2%	764	32%
Upper Panther Creek at fire perimeter (includes Mink and Otter Creeks)	49%	24%	24%	3%	3926	51%

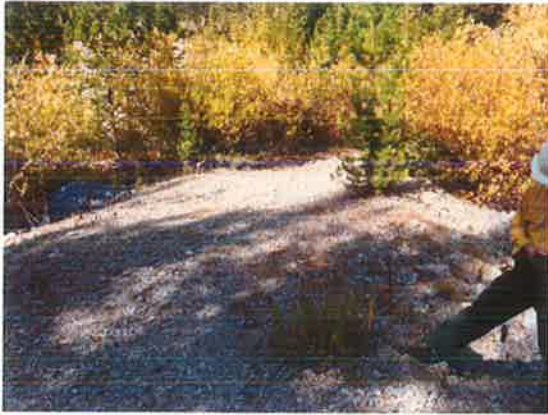
Middle Fork Hat Creek Culvert

FR#60049: Culverts are present at the crossings of North Fork Hat Creek and Middle Fork Hat Creek. These are both 6-foot culverts with downhill approaches on both sides. They are both fairly large culverts for the stream size and will handle high flows. There is some concern that with the potential for bulking and additional wood material, these culverts could plug and maybe be overtopped. If overtopped, bedding material would be lost and the culvert would need to be re-set. Because this road receives very little use and access is relatively difficult, the BAER Team is not proposing any action at this time for either culvert.

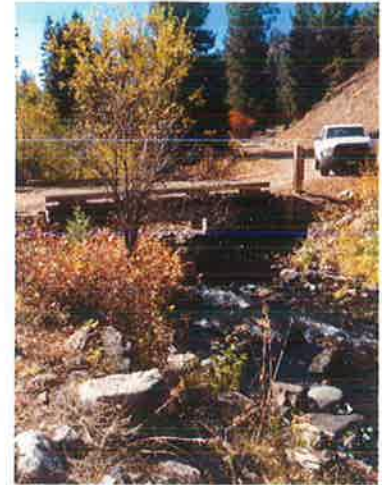
Hat Creek Bridge

FR#60083: The bridge over Hat Creek has 6 feet of freeboard and is located over a mile downstream of any burned area. The BAER Team determined that this bridge does not require any emergency treatments at this time.

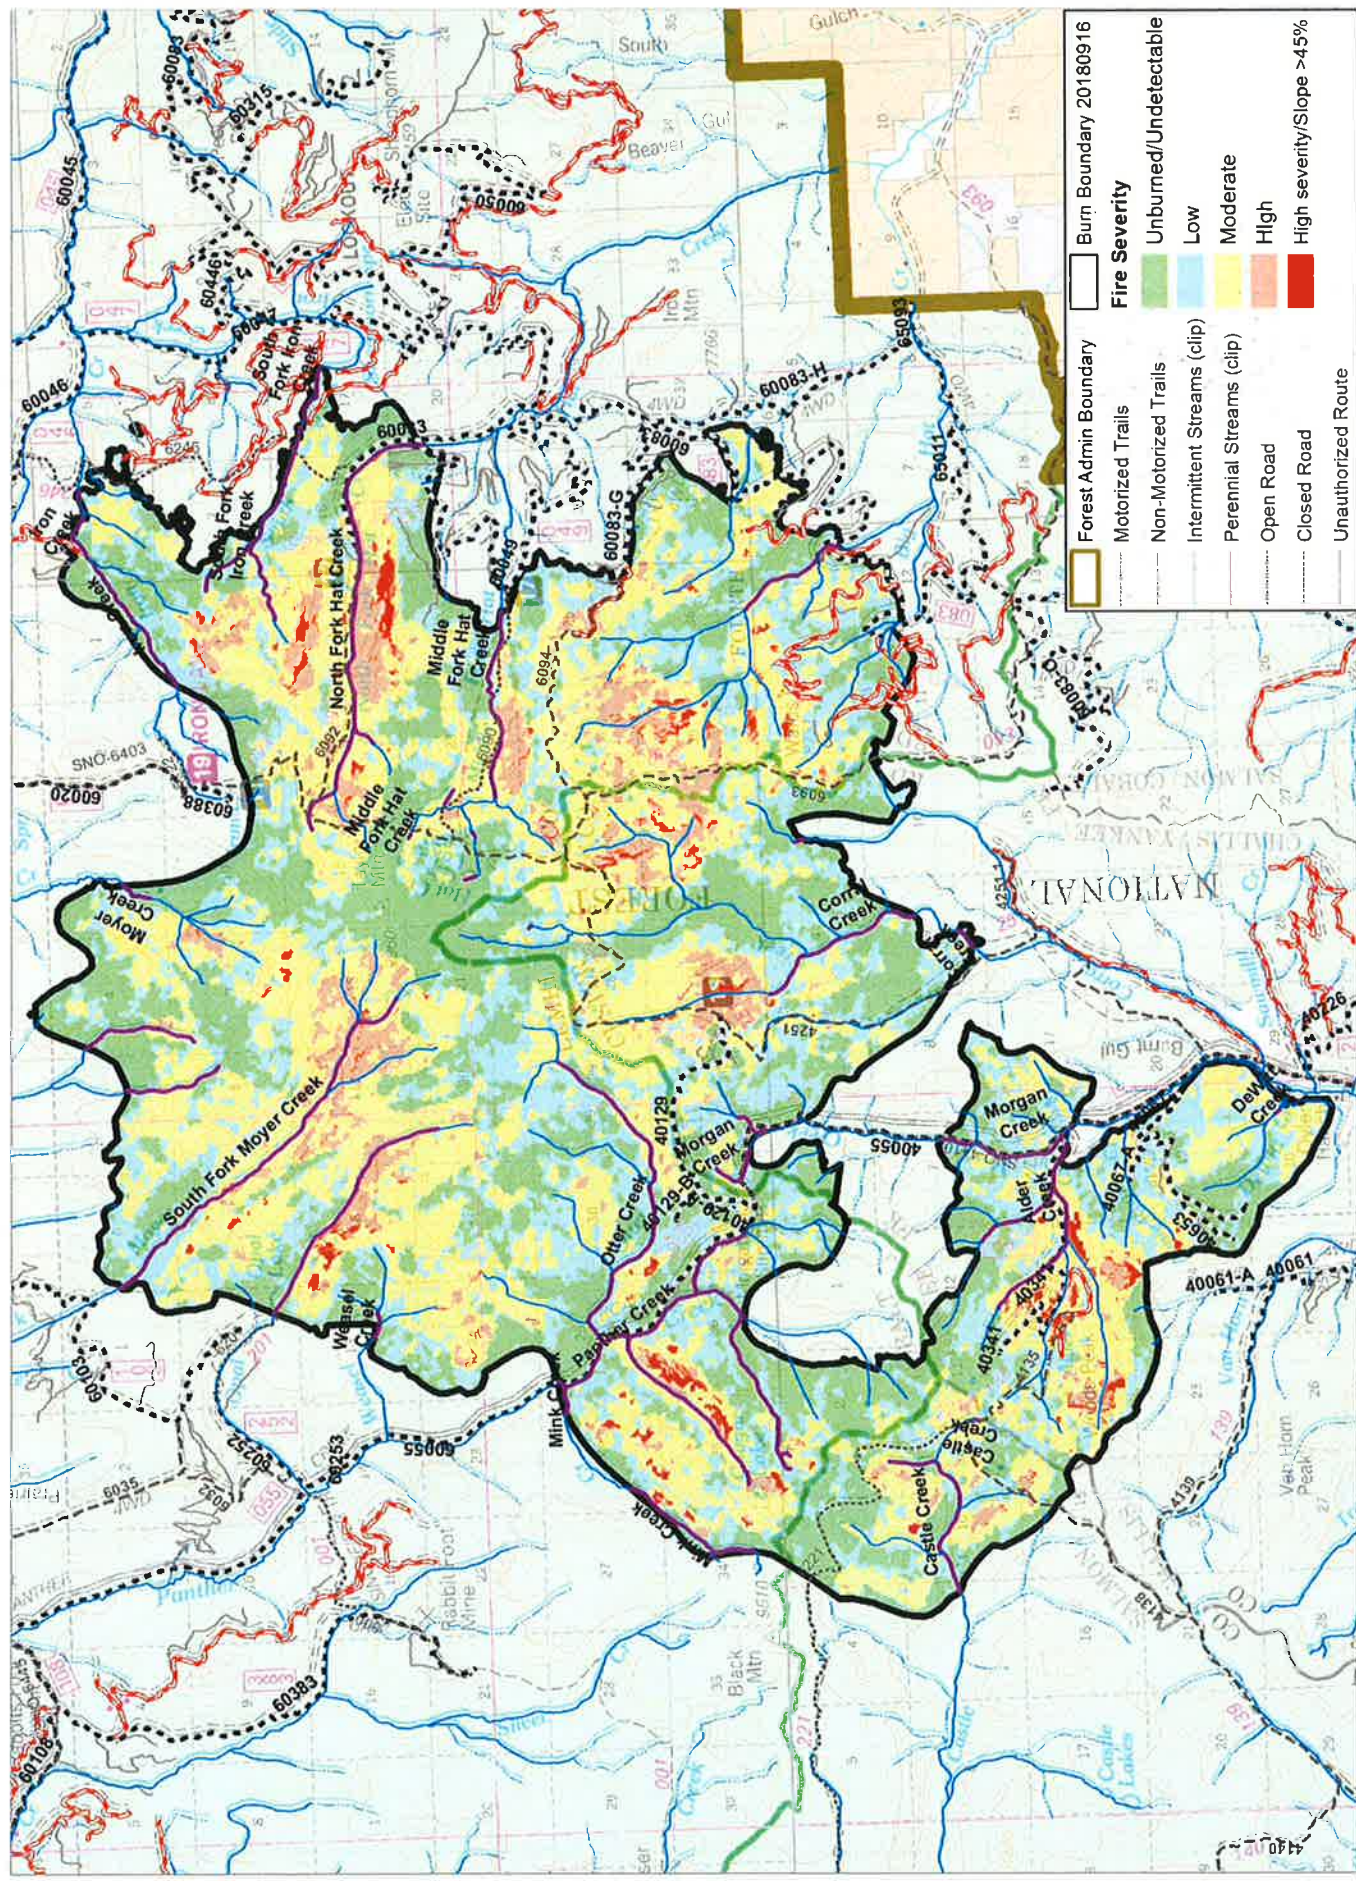
Burn Severity Map for the 2018 Rabbit Foot Fire, Salmon-Challis National Forest

Map created 10/4/2018 by the Salmon-Challis National Forest Rabbit Foot Fire BAER Team.
Burn severity data from 9/16/2018 Landsat 8 satellite imagery. Burn severity data has been field verified.
