Date of Report: 08/26/2021**BURNED-AREA REPORT****PART I - TYPE OF REQUEST****A. Type of Report**

PART II - BURNED-AREA DESCRIPTION**A. Fire Name:** Parleys Canyon**B. Fire Number:** UT-NWS-000763**C. State:** Utah**D. County:** Salt Lake County**E. Region:** R4 – Intermountain Region**F. Forest:** Uinta Wasatch Cache NF**G. District:** Salt Lake RD**H. Fire Incident Job Code:** PNN8FS (1522)**I. Date Fire Started:** 8/14/2021**J. Date Fire Contained:** 8/21/2021**K. Suppression Cost:** \$2,600,000**L. Fire Suppression Damages Repaired with Suppression Funds (estimates):**

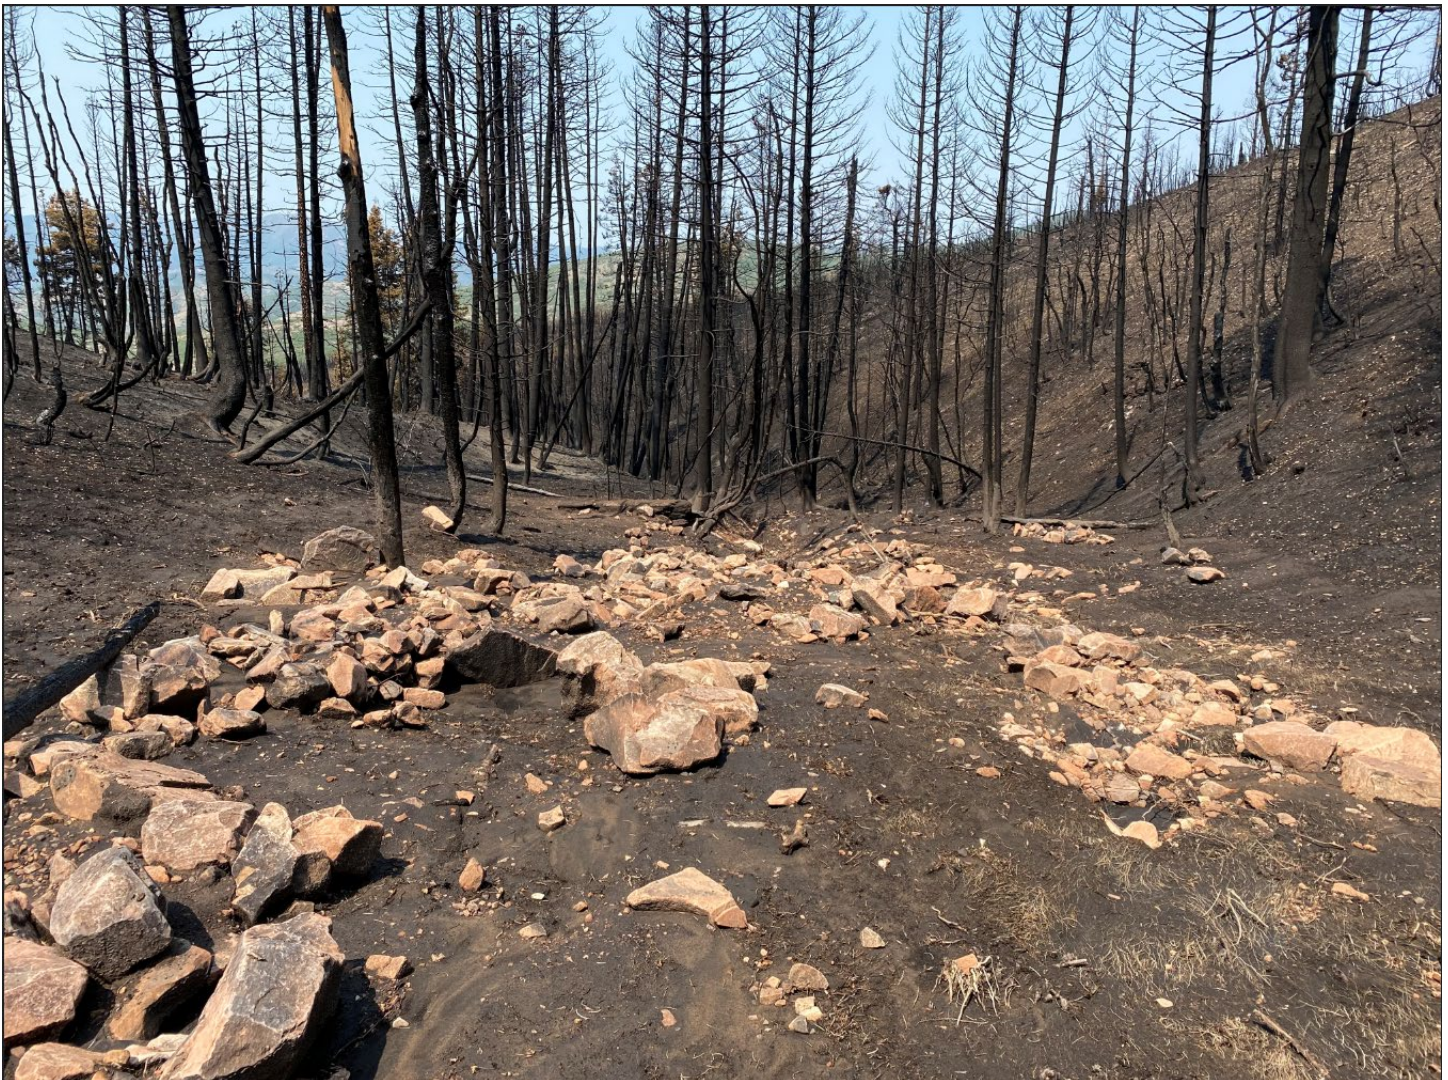
Figure 1. Minor debris flow deposits in the burn scar located at 40° 44.183', -111° 38.610'.

An initial BARC map image was acquired by the Forest Service Geospatial Technology and Applications Center following a Sentinel 2 satellite pass over the burned area on August 20th. BAER specialists returned to the burnscar to validate the BARC map and further review flood and debris flow threats. Heavy rainfall had occurred in between the two site visits and evidence minor debris flow activity (Figure 1) and moderate flash flooding (Figure 2) were observed.

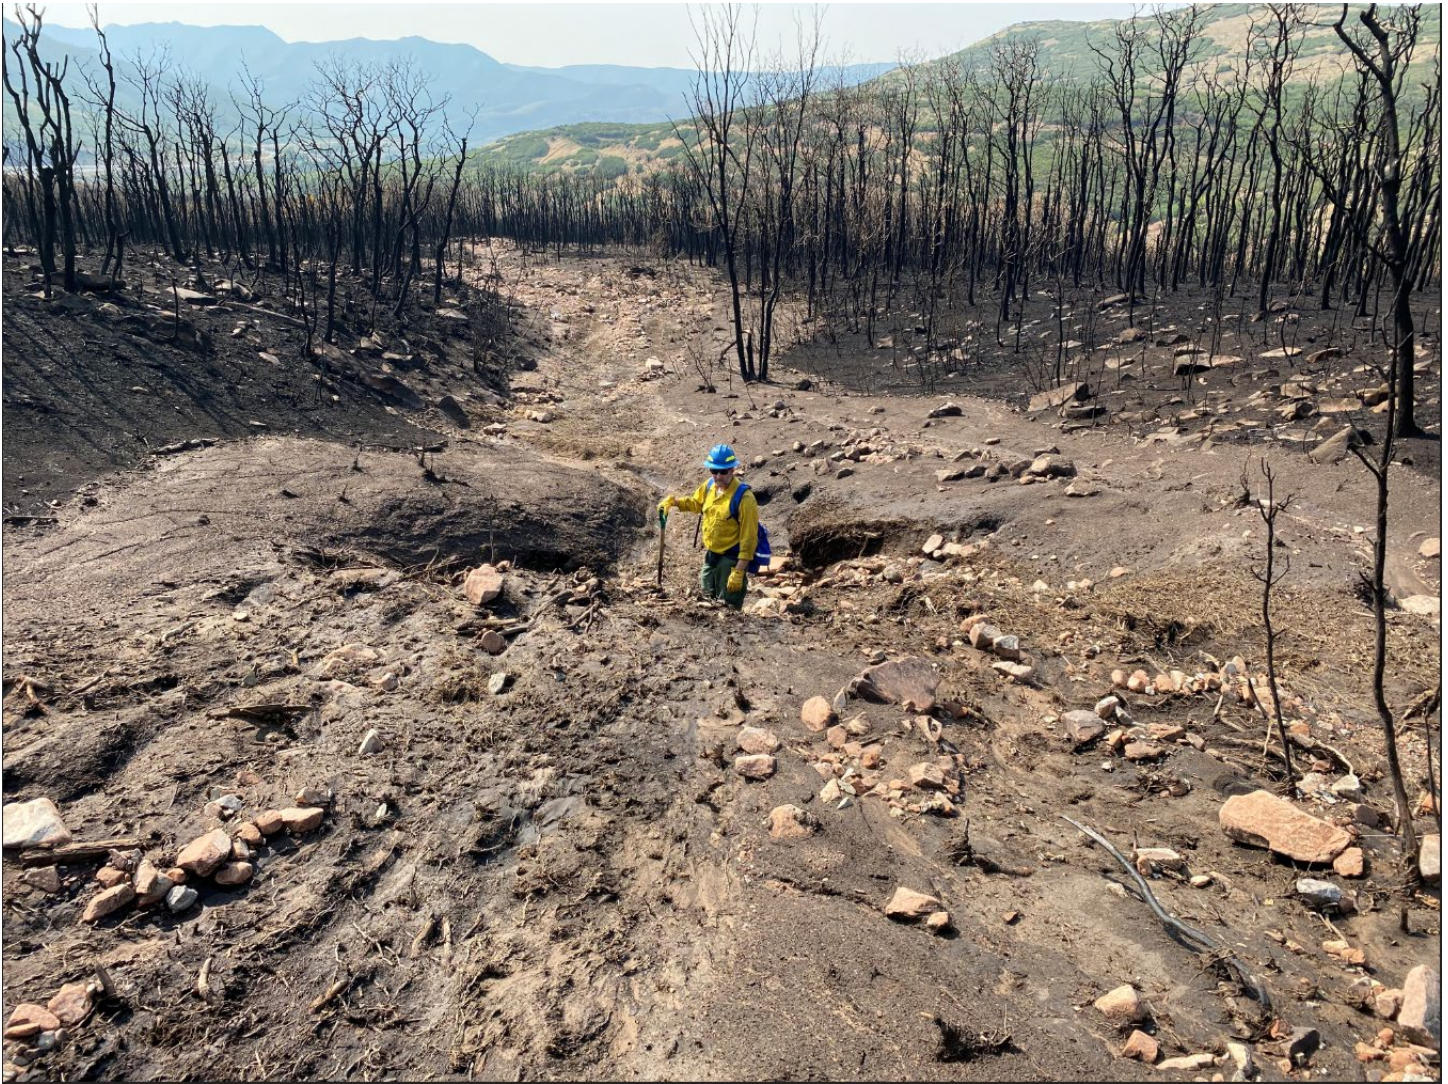
Figure 2. Flash flood deposits in the burn scar located at 40° 44.475', -111° 39.290.
