BURNED-AREA REPORT

PART II - BURNED-AREA DESCRIPTION**A. Fire Name:** West Riverside**B. Fire Number:** MT-SWS-000056**C. State:** Montana**D. County:** Missoula**E. Region:** Northern (1)**F. Forest:** Lolo**G. District:** Missoula**H. Fire Incident Job Code:** PMGB1A(1502)**I. Date Fire Started:** 08/22/2011**J. Date Fire Contained:** 09/15/2011**K. Suppression Cost:** \$5,500,000**L. Fire Suppression Damages Repaired with Suppression Funds**

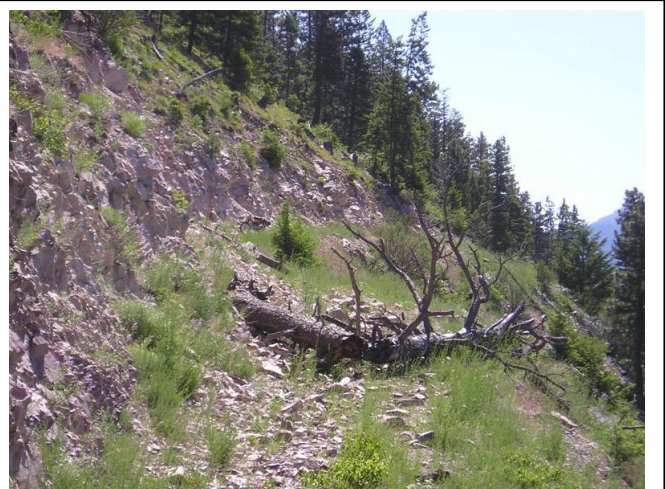
Photo 2. Prefire conditions of roads in Section 3.

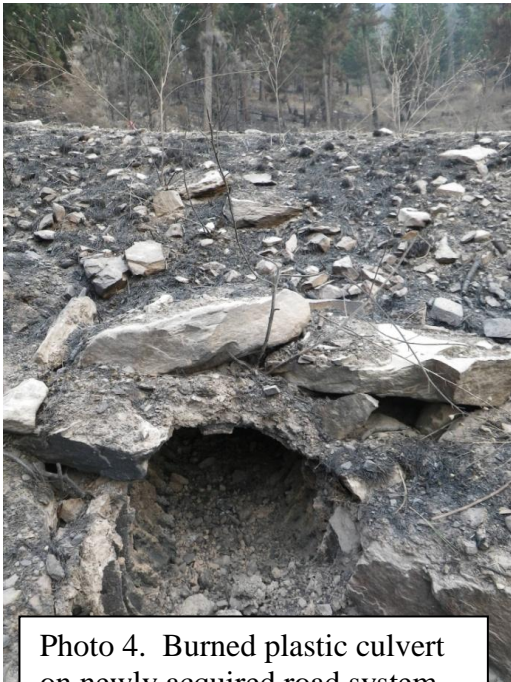
Photo 4. Burned plastic culvert on newly acquired road system

Plum Creek Timber Company used plastic culverts in some areas. Two burned completely through the road fill. Photo 3 shows the remains of a plastic culvert which was burned in the fire on Road #53039. A similar culvert was burned on Road #53040. The burned structures pose a safety risk due to the potential for sudden road fill collapse, and should be replaced with 18" Corrugated Metal Pipe culverts.

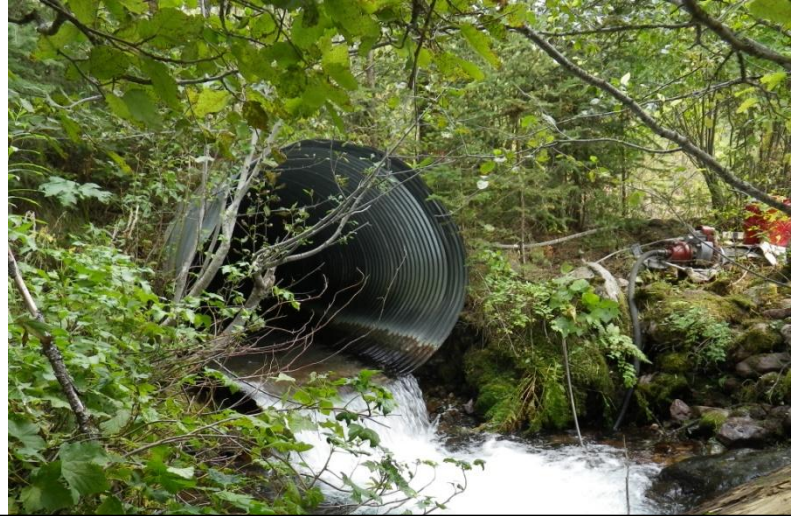
The four arch pipes on Roads 53037, 53041, and 53050 have constriction ratios of approximately 0.5-0.7 (the culverts constrict half to seventy five percent of the active channel). Pre-fire, these culverts did not meet USFS stream simulation criteria for accommodating bankfull channel widths. Post-fire, under storm precipitation scenarios and modeled flow values, they are at a moderate to high risk of failure.

Photo 5. Example of outlet scour and 'hourglass effect' from substantively undersized culvert crossings in Johnson Creek. This culvert is 7 feet wide; the bankfull stream width is 14 feet; the culvert width is half the active channel width.

From a fisheries perspective, two options are recommended: 1) Remove culverts, restore stream channels, and re-contour the road network; or 2) install BMPs and upgrade the crossing structures to meet Q100 standards. The implementation of the treatments described above will have a high degree of success in mitigating the effects of the hydrologic changed condition related to the West Riverside fire.

Culvert replacement would require fish passage design and culvert upsizing to meet current engineering design standards. Storm proofing the road system in Section 3 would require considerable reconstruction. The culvert replacement option would cost approximately \$68,000 for the three culverts on the main stem of Johnson Creek and about \$32,000 for the western tributary, totaling approximately \$236,000. Storm-proofing by adding additional drainage, buttressing, and road reshaping would cost an estimated \$10,000 per mile or about \$80,000 (as portions of the roadway that are slumped closed and not affecting drainage would not be treated. Total cost to address the road system would be at least \$348,000, not including engineering and contracting efforts. For comparison, the cost to recontour and/or storm proof roads placed in storage, including contract support, is estimated at \$96,000.

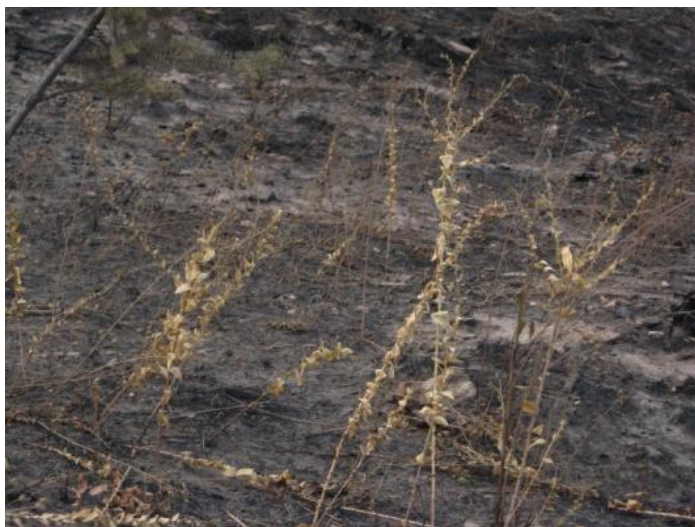
Photo 6. Dalmatian toadflax stems in high severity burn area

were infested with spotted knapweed. Dalmatian toadflax infestations were underestimated because it is difficult to see when not in flower. Roads were treated in the fall of 2011 with Picloram (Tordon) to prevent the growth of spotted knapweed, Dalmatian toadflax and other broadleaf weeds along the roads. The prescription to use Tordon was designed to have residual effect for the spring to target weeds. In the spring of 2012, the roads were inspected and the prescription was determined to be successful in preventing weed growth along the roads. This also decreased spotted knapweed spread into the interior of the burned area as well. A reduction in spotted knapweed was observed in spring inventories; however, Dalmatian toadflax spread remains an issue.

It is recommended to immediately target Dalmatian toadflax plants strategically as individuals in order to preserve the new growth of native plants and other preferred vegetation. This would require having a team of backpack sprayers canvassing the burned area and spraying the herbicide directly on individual plants. In order to accomplish this effectively, it is estimated a team of 5 employees

would be needed to hike through the burn, identify Dalmatian toadflax, take a GPS reading, and treat the plant for 30 days. The GPS location would be used for future monitoring. The treatment would consist of an application of Tordon at 1.5 quarts per acre. The use of Tordon would provide a residual effect to prevent any new seedlings of Dalmatian toadflax to establish. The team would also survey the area for other weed species and spot treat these weed infestations with the same precision approach as the Dalmatian toadflax to ensure further protection to native and preferred vegetation communities. It would be expected the crew could treat up to 0.5 acres per day per person which would ultimately equate to 75 acres wetted; however, considering only individual plants are being treated (1 ft²) this would cover most of the burned area (3,703 acres). This treatment would cost \$31,150 and would be accomplished with through a partnership agreement (already in place). **It is recognized that treatment must be completed within the next several weeks (within one year of fire containment).**

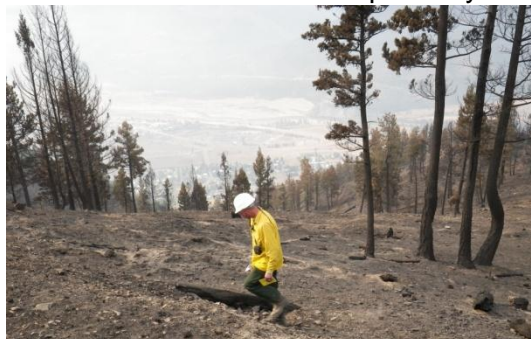
Photo 7. High severity burn area, showing steepness of the terrain below.
