**BURNED-AREA REPORT**  
(Reference FSH 2509.13)**PART I - TYPE OF REQUEST**

- ☐ 1. Initial Request (Best estimate of funds needed to complete eligible rehabilitation measures)  
☒ 2. Interim Report #1  
☐ Updating the initial funding request based on more accurate site data or design analysis  
☐ Status of accomplishments to date  
☐ 3. Final Report (Following completion of work)

- A. Fire Name: Runway Fire B. Fire Number: CA-BDF-9304  
C. State: CA D. County: San Bernardino  
E. Region: 05 F. Forest: San Bernardino  
G. District: Cajon/Front Country

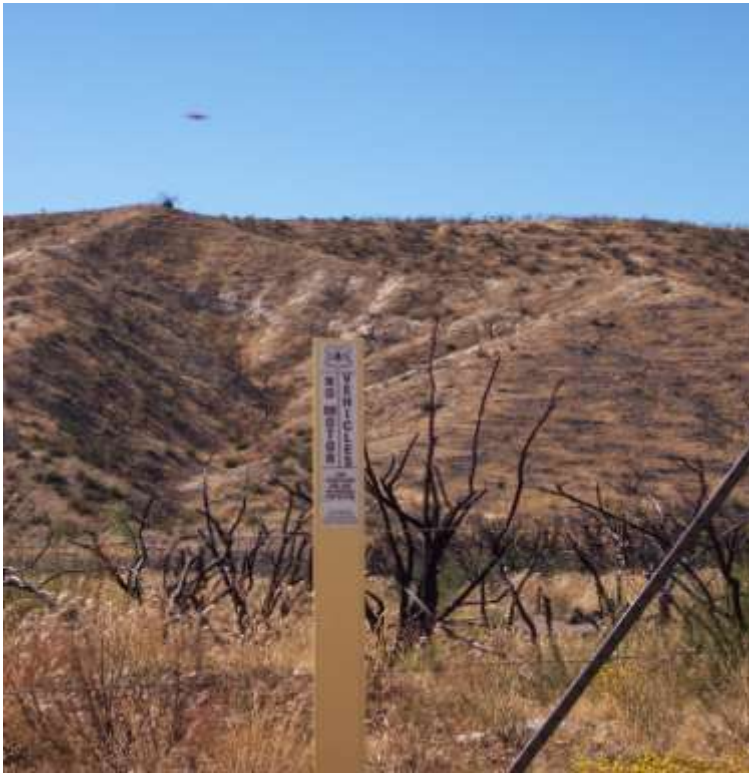
Continuing needs: Due to lack of vegetative recovery, access into the fire area by OHVs and potential for cross country travel will continue to persist. Therefore, materials and supplies for the repair and maintenance of damaged fenceline is needed to effectively reduce impacts to cultural, soil, botanical, and wildlife resources within and adjacent to the fire area.

Continuing needs: Due to lack of vegetative recovery and terrain that is easily accessible to OHVs there is still a need for continued monitoring, patrol, and repair of damage to treatment areas (see examples of damaged fencelines).

**Continuing Need:** There is a need to continue monitoring these sites once per month due to their locations in a highly used OHV area that remains open after the fire, where unauthorized OHV activity is still rampant. The remaining sites should continue to be monitored on a quarterly basis.
