**WEST FORK ROAD FIRE
BURNED-AREA REPORT**
(Reference FSH 2509.13)**PART I - TYPE OF REQUEST**

PART II - BURNED-AREA DESCRIPTIONA. Fire Name: West Fork RoadB. Fire Number: MT-GNF-010002C. State: MontanaD. County: CarbonE. Region: Northern (1)F. Forest: Custer GallatinG. District: BeartoothH. Fire Incident Job Code: P1JK2YI. Date Fire Started: 03/28/2015J. Date Fire Contained: 04/06/2015K. Suppression Cost: TOTAL: \$225,000**L. Fire Suppression Damages Repaired with Suppression Funds**

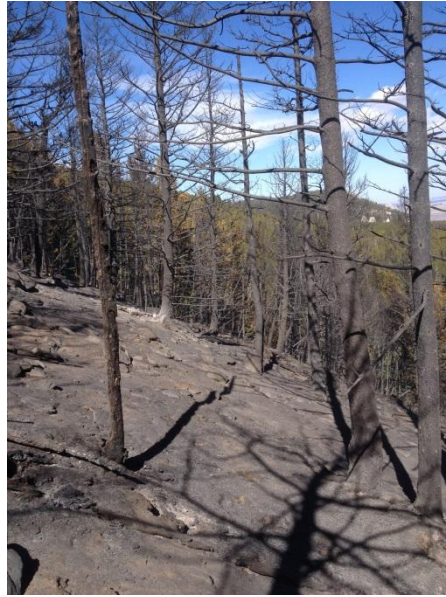
The fire's trajectory was generally upslope and down-canyon following ignition. As the fire moved upslope, the transition in fuel type from predominantly grass and sagebrush to forest resulted in an increase in burn intensity and severity (Photo 1). Pockets of high intensity burn were observed on steep slopes on both the west and east flanks of the fire perimeter. Prolific soil and litter moisture and minimal fire residence time were conducive to minimizing burn severity effects; while isolated pockets of high severity burn conditions were

Photo 1. Example of moderate tending high burn severity within the West Fork Fire perimeter. Photo was taken on the west end of the fire near its highest elevation extent.

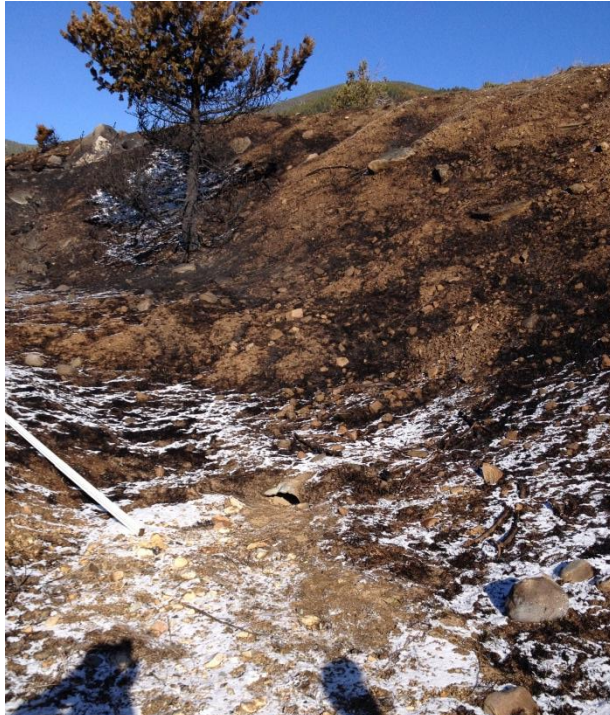
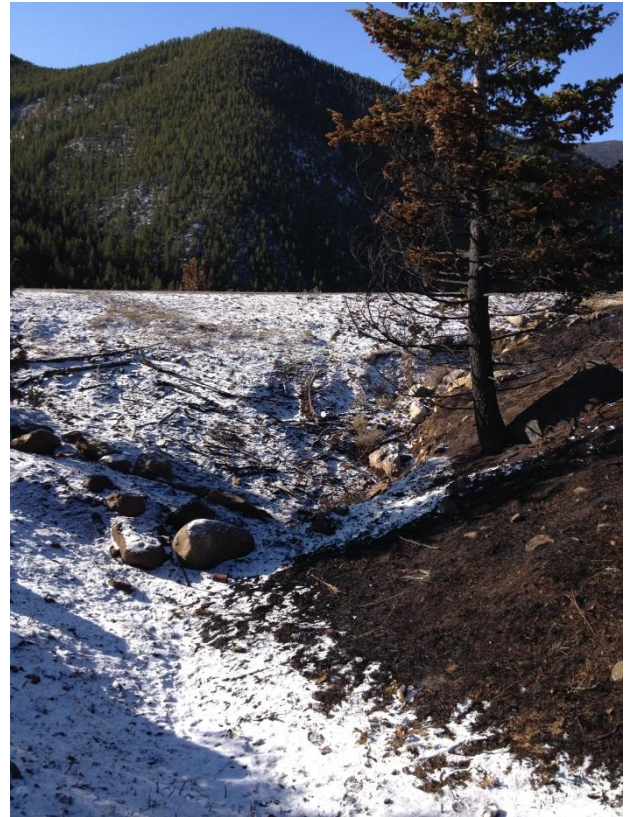
- **Water Quality:** An ephemeral/intermittent draw to the west of the Nichols Creek drainage is tributary to the main stem of Nichols Creek. Approximately 50% of the drainage burned. Of the drainage area that burned, approximately 18% of that burned under moderate to high severity. The existing conveyance structure is an 18" diameter culvert under approximately 15 feet of road fill. The culvert is almost completely plugged both upstream and downstream of the West Fork Road.

Road Treatments: As noted above, both the inlet and outlet of the Nichols Creek unnamed tributary crossing of concern are nearly 100% blocked (Photos 2 and 3), further exacerbating the potential for crossing failure in the event of a large post-fire runoff or debris flow event.

A modest increase in runoff response is projected as a result of the West Fork Fire (Table 1). The hydraulic capacity of an 18" diameter culvert is approximately 5 cfs. The 10 year post-fire discharge is projected to change by approximately the entire hydraulic capacity of the culvert.

HY-8 analysis suggests that the West Fork Rock Creek Road would overtop at approximately 23 cfs, well below that of the projected 10 year post-fire discharge event. Of note is that the roadside ditch to the east of the crossing would accommodate some storm flow and convey it to Nichols Creek.

Photos 2 and 3. Culvert outlet (left) and inlet (right, near rock at base of fill slope) where the West Fork Rock Creek Road crosses the unnamed tributary to Nichols Creek.

Acknowledging the inherent uncertainty in runoff modeling both pre- and post-fire, model estimates nonetheless suggest that there is an elevated risk of crossing overtopping and failure should a 10-25 year post-fire runoff event occur. To address this elevated risk, a combination of stormproofing and cleanout measures has been recommended. These measures would include armoring the upstream fill slope and hydraulic flushing of the culvert to remove sediment blockage. Storm inspection and response will also be done after annual higher flows and within one year to ensure this culvert remains clear and able to pass flows.

Runoff modeling suggests that the existing culvert is not adequately sized to accommodate anticipated post-fire runoff. While crossing replacement would be ideal, this would require tunnel boring under a paved road and would risk damaging the road surface through settling; implementation would be quite expensive and potentially incur peripheral damage to infrastructure during implementation. Given the modest projected increase in post-fire runoff, ponding capacity upstream of the culvert, and overflow capacity provided by the roadside ditch draining to the main Nichols Creek drainage, the more cost effective approach for addressing the elevated risk of crossing failure was chosen as the most viable treatment alternative.
