Date of Report: 07/25/2021**BURNED-AREA REPORT****PART I - TYPE OF REQUEST****A. Type of Report**

PART II - BURNED-AREA DESCRIPTION**A. Fire Name:** Dexter Fire**B. Fire Number:** CA-INF-001695**C. State:** California**D. County:** Mono**E. Region:** 05**F. Forest:** Inyo**G. District:** Mono Lake Ranger District**H. Fire Incident Job Code:** P5N5PV-0504**I. Date Fire Started:** July 16, 2021**J. Date Fire Contained:** July 27, 2021**K. Suppression Cost:** \$6,000,000**L. Fire Suppression Damages Repaired with Suppression Funds (estimates):**

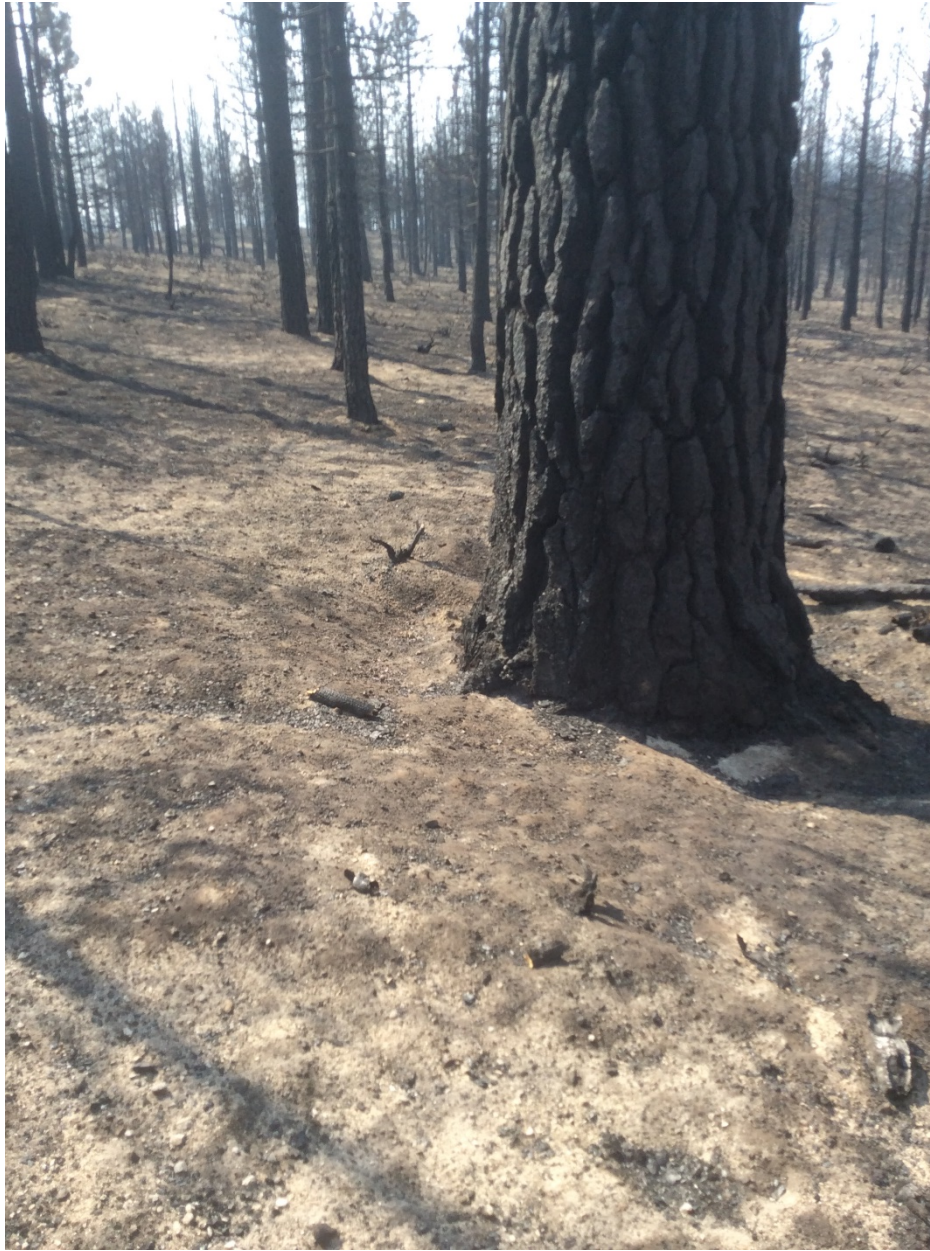
4. **Cultural and Heritage Resources:** Piagi trenches: Piagi rings used traditionally used to collect Piagi (Pandora Moth Larvae) are around many old growth Jeffrey Pine Trees. The Mono Lake Kutzadika's (Northern Paiute) collected Piagi beginning in late June to early July. Each family would dig and clean pre-existing trenches around the base of numerous large Jeffrey Pine trees in family gather areas. The trenches had vertical or back-cut walls to prevent the caterpillars from getting out. The trenches would be checked several times a day with trapped caterpillars collected.

These are culturally important features that could be impacted by post-fire runoff. Approximately 10 trees are in and below High and moderate severity areas adjacent to steep slopes. Post-fire runoff and erosion can negatively impact these features. Other Cultural Resources are not expected to be impacted by post-fire processes.

Photo 1: Piagi Trench around old growth Jeffrey Pine.

L2:Piagi trench protection: Place fiber rolls (straw wattles) upslope of 8-10 Jeffrey Pine with Piagi Trenches to protect them from post-fire rilling. Approximately 2 fiber rolls are needed per tree.

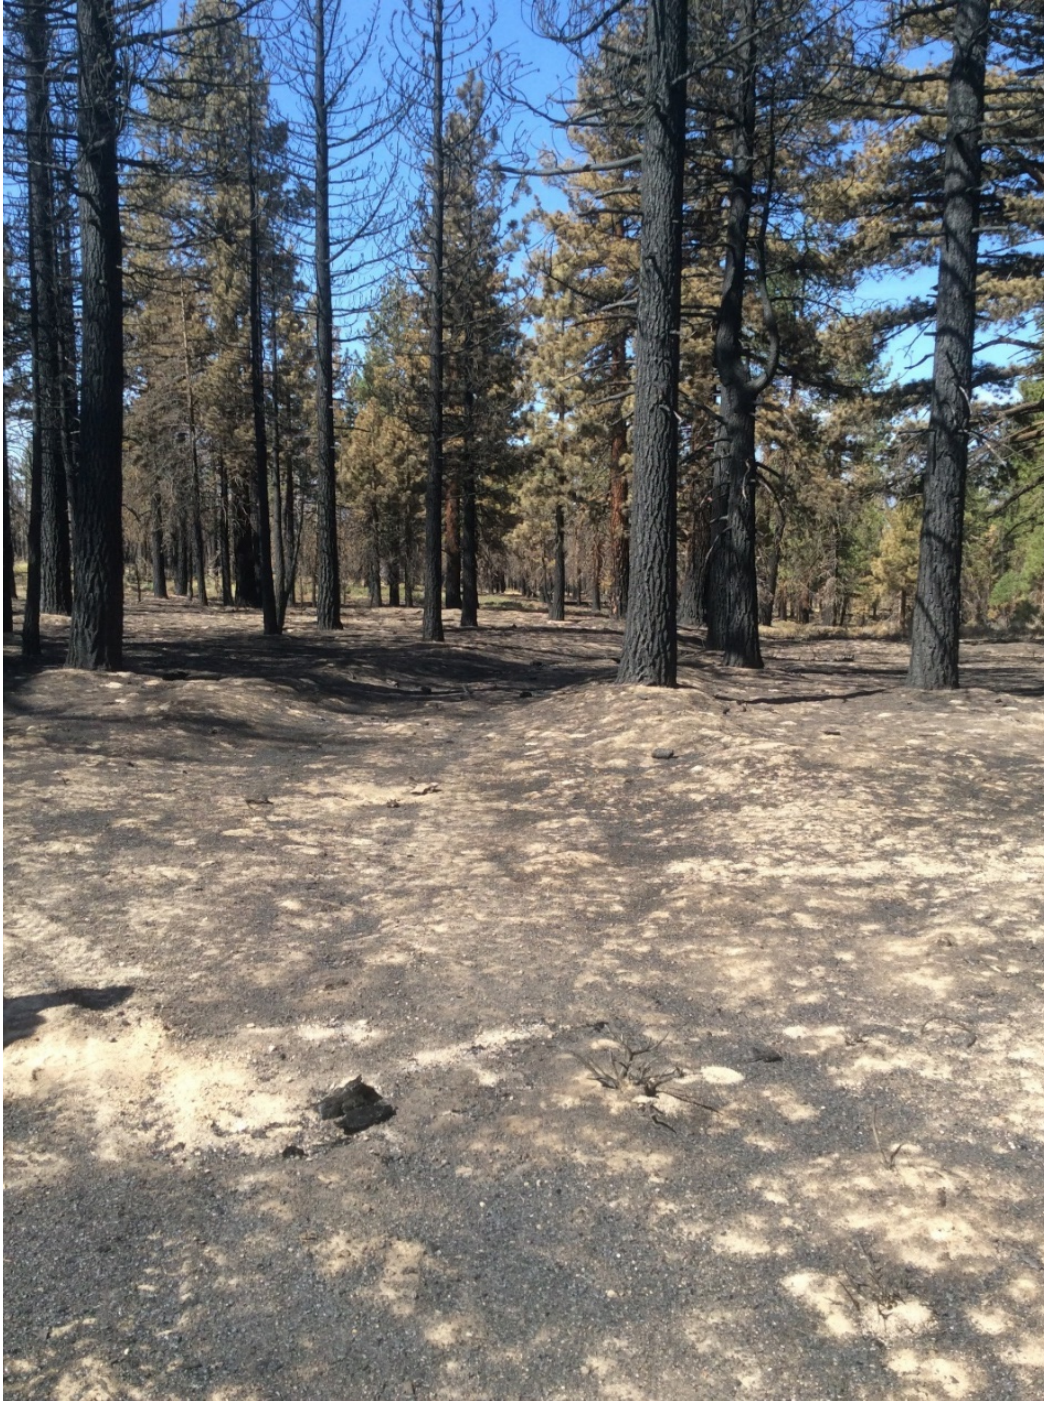
Five (5) previously blocked and disguised unauthorized routes were impacted by the fire. The Fire burned the blocks and vegetation used to disguise the route. These areas are most susceptible to OHV use after the fire. The natural vegetative recovery and barriers on these roads burned. Currently, there are no closure signs or physical barricades in place to advise the public from using these trails.

The area of greatest incursion risk burned at high and moderate soil burn severity, with all the vegetation consumed. The majority of the area is at low gradient, with few large rocks, making it easily traversed by an OHV.

Photo 2: Unauthorized Route that burned and is susceptible to traffic.

P1. Unauthorized Road disguising and block replacement: Replace block (1) and reapply mulch to disguise approximately eight (5) unauthorized roads. Strategic placement of carsonsite closed area signs will help keep motorized traffic on system routes.
