BURNED-AREA REPORT
(Reference FSH 2509.13)

- A. Fire Names: Myrtle Fire B. Fire Numbers: SD-BKF-120655
C. State: SD D. County: Custer (SD)
E. Region: R02 F. Forest: Black Hills
G. District: Hell Canyon
H. Fire Incident Job Codes: P2G2UD
I. Date Fire Started: July 19, 2012
J. Date Fire Contained: July 24, 2012 (approx. 1800)
K. Suppression Cost: Costs as of July 28th at 2100 hours: \$4,621,317

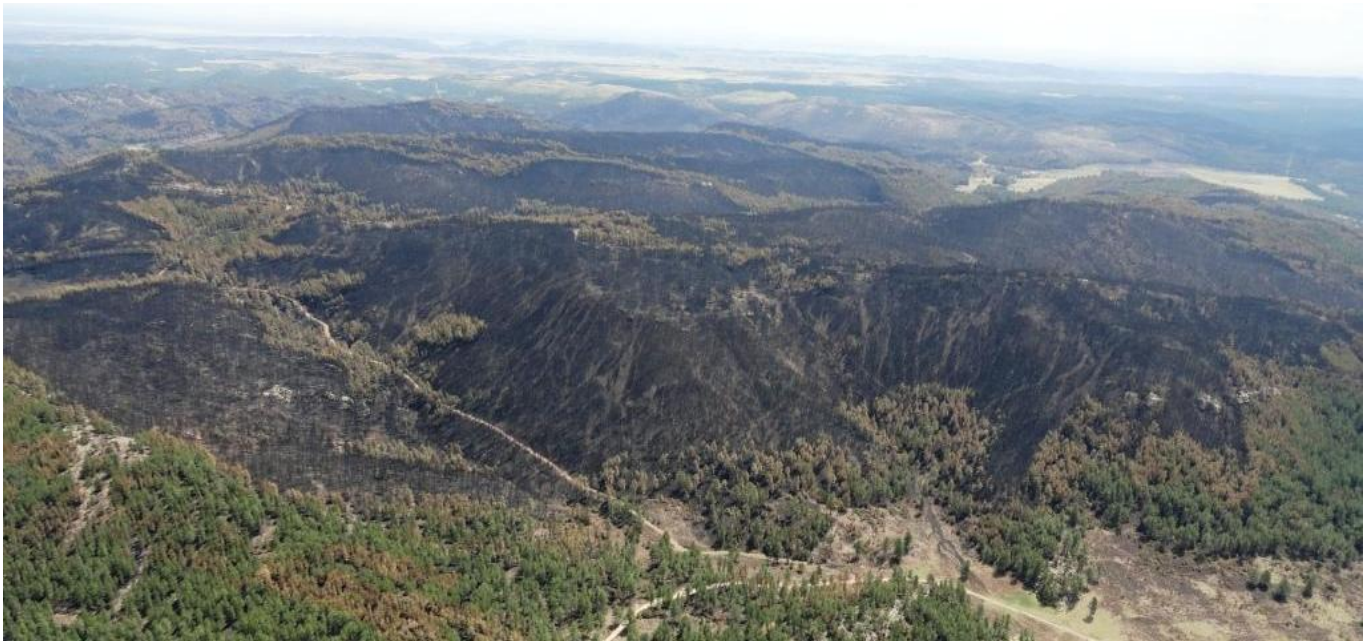
These areas have a **VERY HIGH RISK** of producing increased post-fire runoff, gully erosion, and localized slope failures. In fact increased runoff and gully erosion and flooding has already been observed in response to two thunderstorms occurring on successive days while fire suppression activities were on-going. The first storm event occurred on Tuesday evening, July 24, 2012 just prior to containment of the Myrtle Fire. The second storm occurred on Wednesday evening, July 25, 2012. Each storm varied in precipitation amount received over the fire area but ranged from approximately 0.25 to 0.5 inches according to nearby weather stations. Although the total storm depth was relatively low, the peak 10-minute rainfall intensities were extremely intense, forcing motorists on Highways 385 and 87 to pull over due to low visibility and unsafe driving conditions. These events have resulted in significant water runoff within the burned area as described previously. The amount of runoff and erosion will continue to increase with each successive storm event. Entire hill slope lengths are already contributing runoff as a result of the first storm event, indicated by the slope wash and rilling observed starting at ridge tops shown in Figure 1.

Figure 1. Typical hill slope runoff, rilling, and erosion starting at ridge tops observed throughout the fire area in moderate/high soil burn severity areas.
