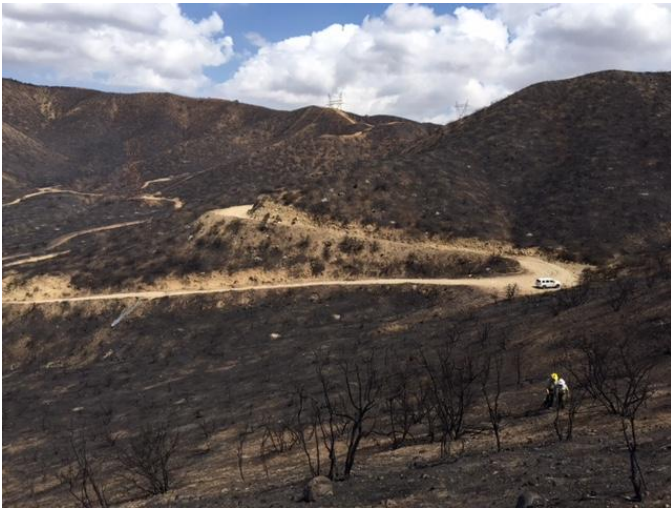
3N21 through moderate soil burn severity

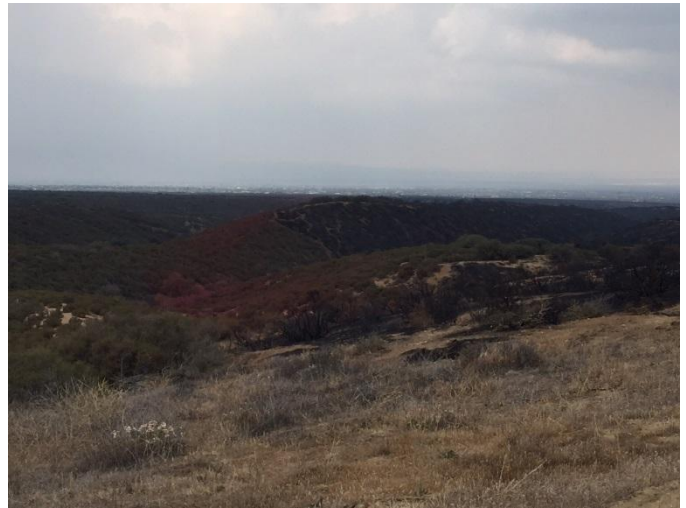
Retardant/fire line showing pre- and post-vegetation

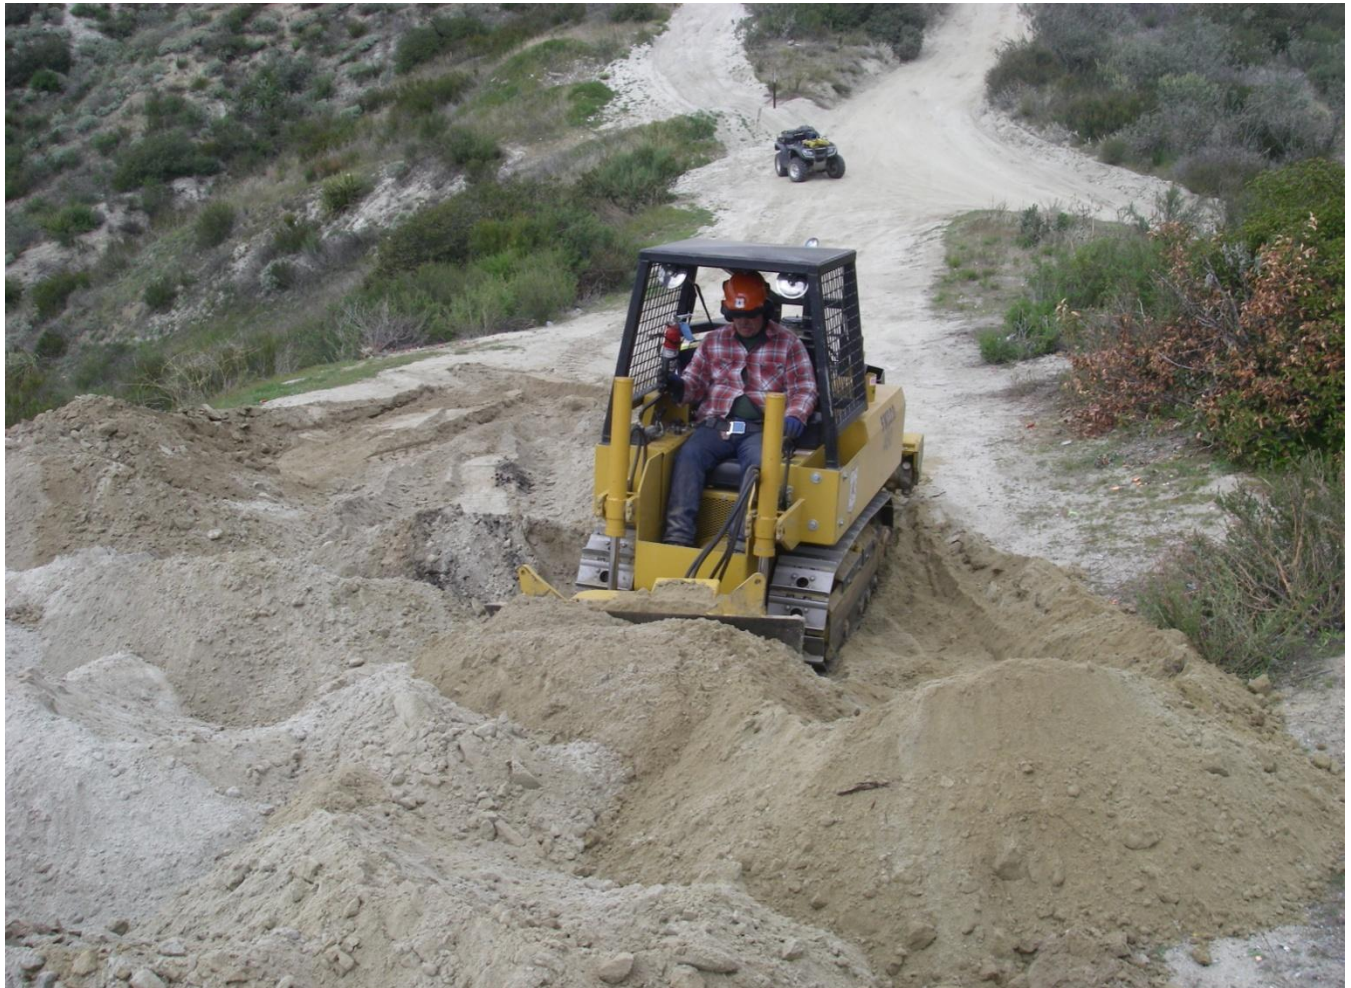
**Photo 1:** Chunking with a small trail dozer that has an articulating blade.

With the recreational use and vegetation types found in the Baldy Mesa area the Forest found the use of “chunking” with excavators an effective tool in protecting resources after a fire when combined with fencing, signs, and most importantly frequent patrols. Chunking is described as using the bucket of an excavator or articulating blade on small trail dozer to decompact roads/trails by digging into the compacted area and creating divets. These divets act as mini-catch basins (increasing infiltration), require minimal maintenance, and are found to collect seed and promote gemination (See photos below.)

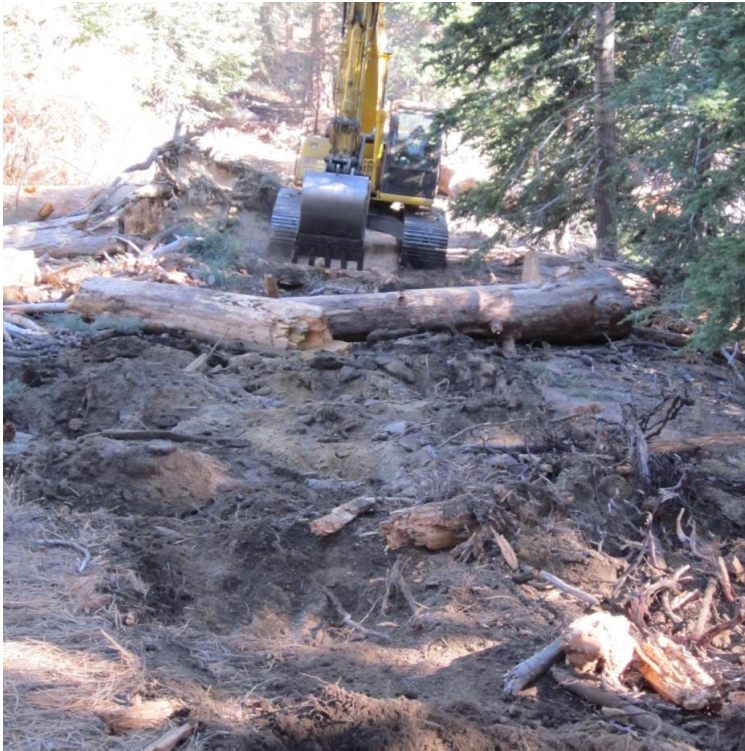
Photo 2: Chunking with an excavator along a dozer line. First chunking occurs, then the equipment spread topsoil and slash from the dozer piles over the treated area.

The North Fire burned a part of an OHV trail and also exposed some illegal trails from private onto forest lands. The recommended treatment is to use an excavator employing chunking and banked turns to help redirect the OHV trail and forest road recreation use away from cultural resources and out of the North burn area. The use of fence lines and fire recovery signage can help support the chunking along the impacted trail and road. With high levels of recreational use and the knowledge that we have gained from past fires in the Baldy Mesa area, using these multiple closure methods discussed will have the greatest success on the North Fire rehabilitation and resource protection.
