**BURNED-AREA REPORT**  
(Reference FSH 2509.13)**PART I - TYPE OF REQUEST**

**PART II - BURNED-AREA DESCRIPTION**A. Fire Name: **Carpenter 1**B. Fire Number: **NV-HTF-500068**C. State: **Nevada**D. County: **Clark & Nye**E. Region: **04 - Intermountain**F. Forest: **17 – Humboldt-Toiyabe**G. District: **Spring Mountains NRA**H. Fire Incident Job Code: **P4HM7D**I. Date Fire Started: **July 1, 2013**J. Date Fire Contained: **August 18, 2013**K. Suppression Cost: **\$19,861,000** (estimated from ICS209, July 26, 2013)

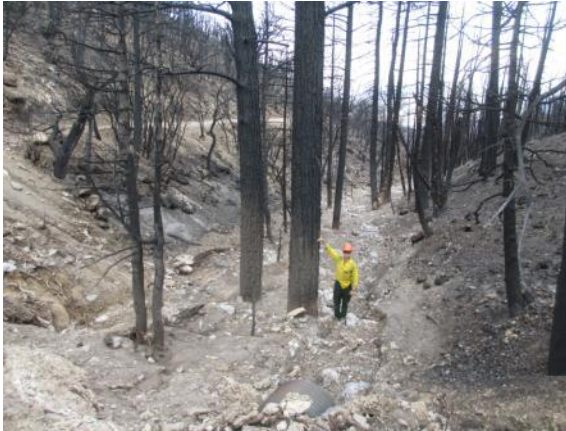
Figure 3. High flow mark from storm event that will be administratively closed.

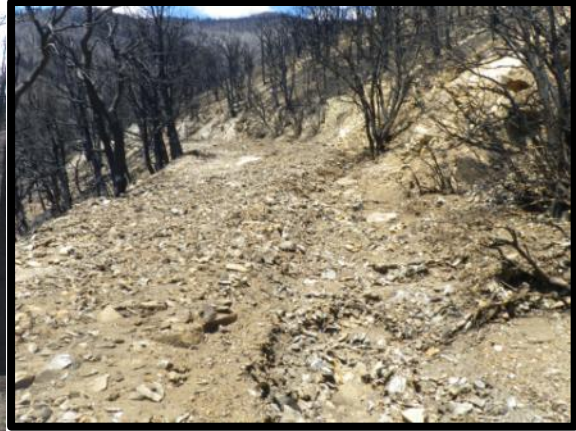
- b. **Very High** risk to road and bridge infrastructure with substantial damage expected because flooding, debris flows, and erosion is imminent. The highest risk is associated with 16 miles of roads and 2 stream crossings. Travel routes having the greatest concern are: FR094 (Cathedral Rock); FR066 (Rainbow Canyon; FR331 Wash Road; FR532 Harris Springs; FR104 Harris Mountain; FR535 Prospect Springs; FR537 Lovell Canyon, and FR550 Trout Canyon. (Treatments: T01, T03, T04, T08, T09) Figures 3 and 4 show runoff from rain event during the BAER assessment that had mostly moderate burn severity.

Figure 4. Section of Harris Mtn Road after storm

**Purpose of Treatment:** Minimize risks to human life and safety from post-fire hazards by restricting access to area. Treatment will prevent unauthorized travel on the damaged Harris Mountain Road, provide protection to vulnerable cultural and heritage resources, and minimize further impacts to soil productivity from illegal motorized vehicle travel off of designated routes.

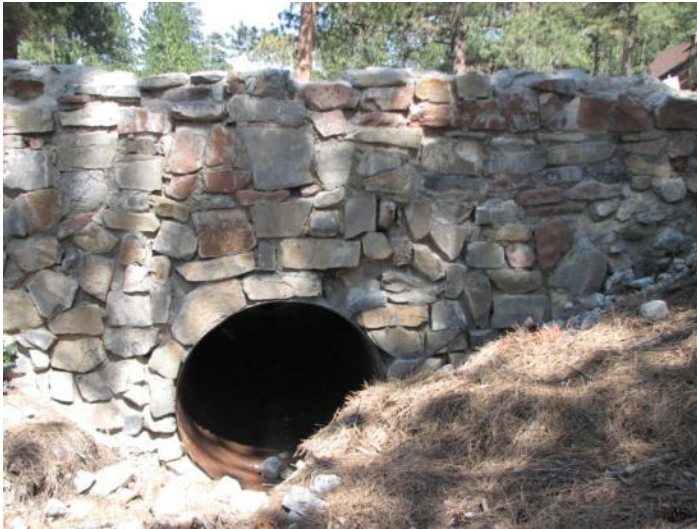
Figure 5.

- c. **Very High** risk to the Kyle Canyon Ranger Station due to increased threat from flooding and erosion associated with potential debris flows in Kyle Canyon. The threat is exacerbated by the presence of a CC-era culvert in the Kyle drainage at the entrance to this administrative site. Removal of the historic culvert would mitigate the threat. Figure 5 is a picture of an undersized historic culvert that is recommended for removal.

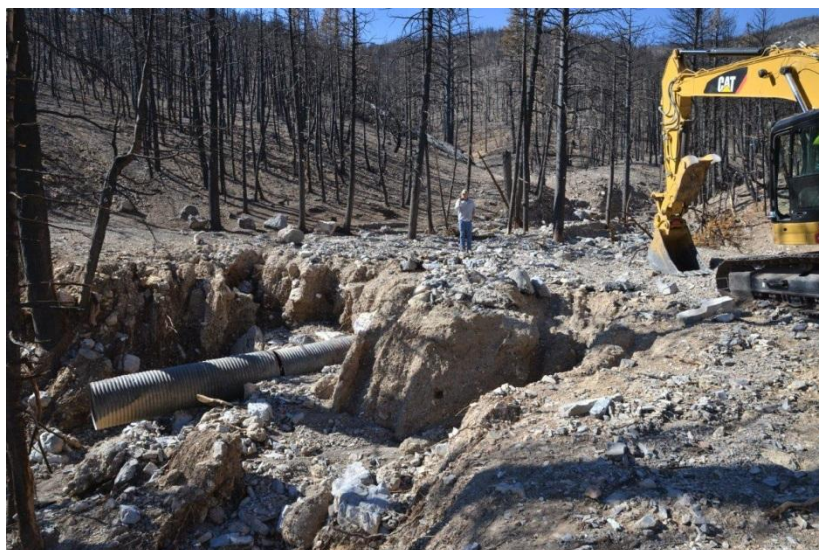
Following the Carpenter 1 Fire, the magnitude of runoff events increased dramatically due to runoff from burned slopes above the road. The resulting flows significantly damaged the road and severely gullied several crossings. (See picture below) The expected post-fire runoff events for the next 5 years are a significant threat to the historic road and the target crossings.

Because of the amount of debris expected during future runoff events, replacing old culverts at major crossings is not feasible since any subsurface water conveyance device there will not survive flash-flood events. Doing nothing will place the road itself at significant risk of loss since flood events can easily divert and channel down the bench-cut road template for long distances. Preservation of the road infrastructure itself is best served by constructing armored crossings at each of 5 major drainages.

A crew of four force-account equipment operators will deploy an excavator, dozer, and loader to the project site. Drilling and blasting will occur to create the necessary riprap for stabilization of the road at each stream crossing. Blasting sites are located at existing rock exposures created by construction of the original road alignment. Ford construction will involve use of heavy equipment to excavate excess sediment from each crossing site that was recently deposited from post-fire runoff-events. Riprap will be placed in the excavation, founded on bedrock where possible, to form a stable structure upon which the road template can be reconstructed. Construction techniques will create road profiles and flow-line conditions at each ford that will prevent diversion of runoff flows to the adjacent road alignments as well as protect road base material placed on top of the riprap structure from loss due to erosion. Future work on the road could involve maintenance after runoff events. Additionally, installation of culverts at each site once the slopes above the road naturally stabilize in 5-10 years may be the final best-practice disposition for management of the road at each crossing.
