BURNED-AREA REPORT
(Reference FSH 2509.13)**PART I - TYPE OF REQUEST**

- A. Fire Name: Cub Fire B. Fire Number: CA-LNF-002713
C. State: CA D. County: Tehama
E. Region: 5 F. Forest: Lassen NF
G. District: Almanor Ranger District H. Fire Incident Job Code: P5D8M9

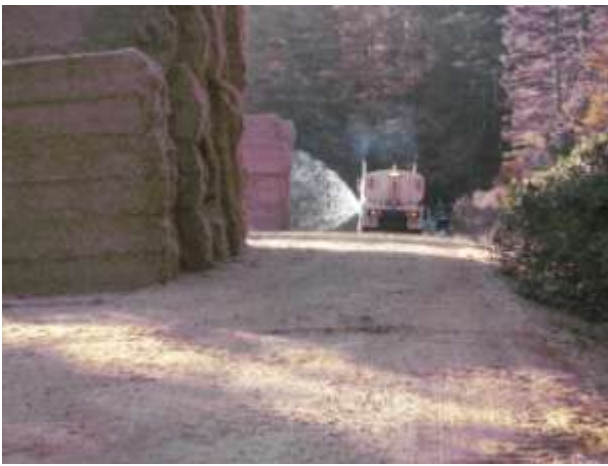
Rice straw staged on NFSR 27N12.

MWH began staging operations on Friday October 11 and commenced aerial application on Monday October 13. Two helicopters were used for aerial operations. Two hours into operations, one of MWHs' sub-contractors caused an accidental fire at the staging area and 500 tons of rice straw mulch was consumed (nearly 48% of its supply). The staging area was located within a rock pit, within the Cub Fire. There was no risk of a new wildfire. MWH spent all of Monday and Tuesday suppressing the fire with bucket drops from its two helicopters, while Forest Service personnel worked on the ground to contain the blaze. After two days of fire suppression, MWH was able to restart operations in a nearby staging area. MWH replaced the burned rice straw and absorbed any losses from loss of the mulch and suppression costs. A new staging area was created 0.25 miles from the burned mulch and was created in an old timber sale landing adjacent to NFSR 27N12. Despite this delay in operations, MWH completed the treatment on Saturday October 16. Final inspections were conducted that same day.

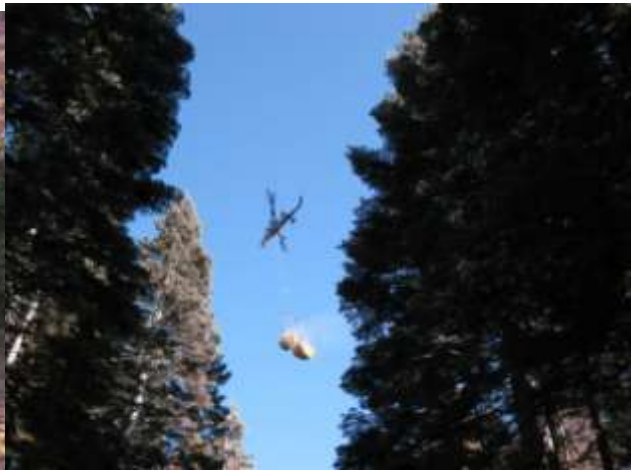
KMAX with one load.

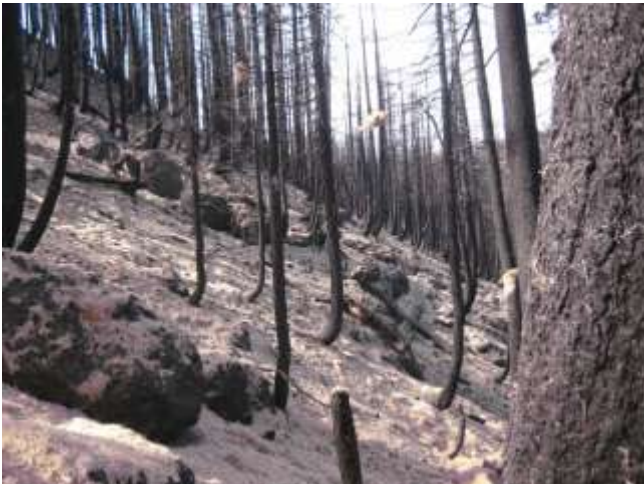
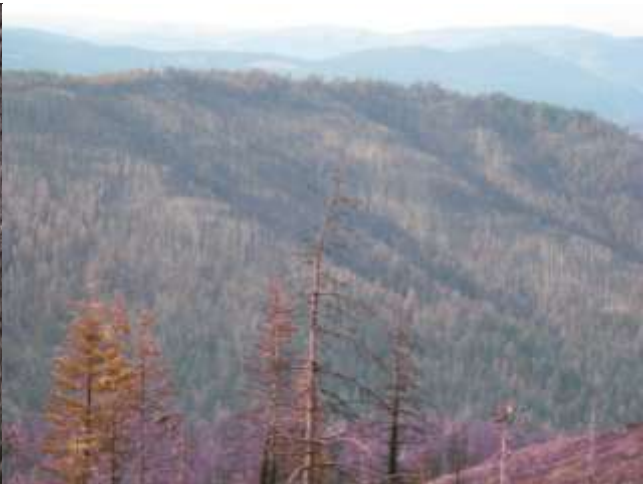
Both photographs show unit 2, which is comprised of conifers and slopes between

The BAER Team Implementation Leader reduced treatment acres from 1,061 acres to 1,042 acres due to concerns with safety and operability of helicopters. Mountain West Helicopters (MWH) completed the helimulch treatment of 1,042 acres at a cost of \$477/acre. Approximately \$9,800 was spent on Forest Service salaries for contract preparation (BAER Team Leader), GIS support, 4 inspectors, the COR, and per diem for the COR. Don Tinsley, Sierra Cascade Province Contracting Officer, served as the project CO. His salary is covered by the Province, so he didn't charge his time to the BAER code. Kirby Cook, Helitack Manager on the Bitterroot National Forest, was hired as the COR.

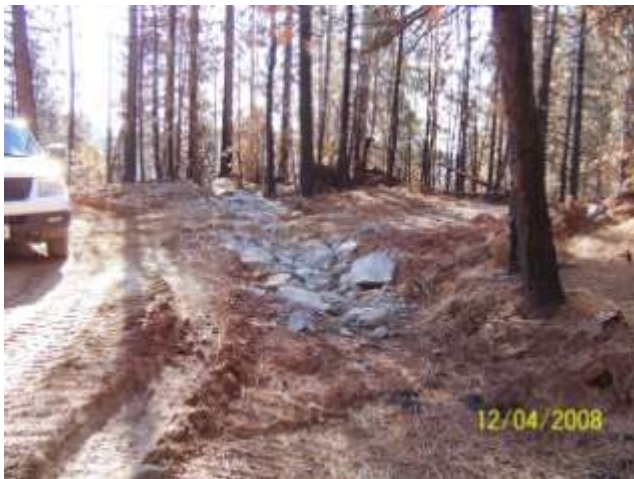
Rock-lined ditch on NFSR 27N12

- 5 new rolling dips were installed
- 12 rolling dips were reconstructed with 170 cubic yards of rip rap and 950 cubic yards of base material.
- 12 miles of road were bladed.
- 40 feet of a roadside ditch were lined with 30 cubic yards of rip rap.

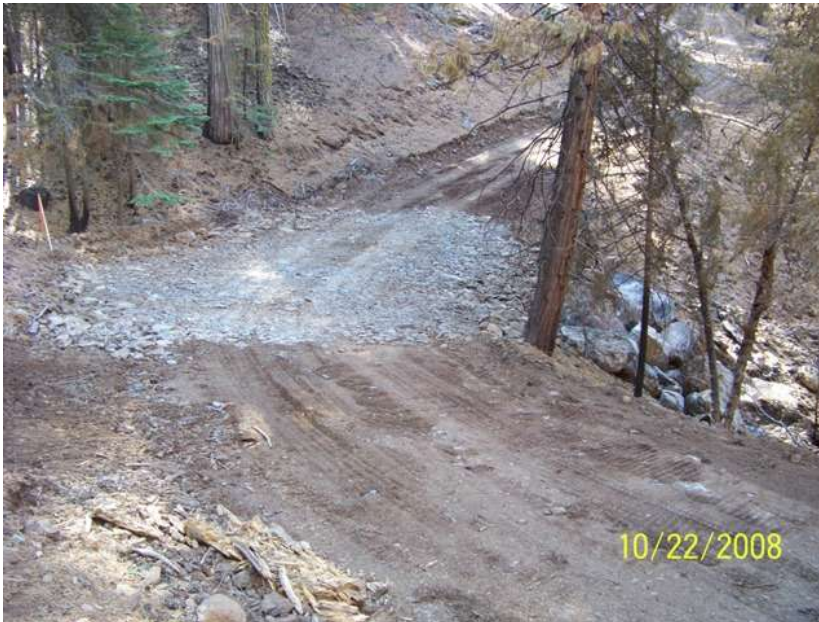
Low water crossing on 2*N12E on steep seasonal drainage with high soil burn severity upstream of crossing.

- Two low water crossings were constructed with 100 cubic yards of drain rock and 48 cubic yards of rip rap.
