Date of Report: May 14, 2014

BURNED-AREA REPORT

- A. Fire Name: Rock Creek B. Fire Number: MT-LCF00367
C. State: Montana D. County: Lewis and Clark
E. Region: Northern (1) F. Forest: Lewis and Clark
G. District: Rocky Mountain H. Fire Incident Job Code: P1HRP6
I. Date Fire Started: 7/17/2013 J. Date Fire Contained: 9/26/2013
K. Suppression Cost: TOTAL: \$0
L. Fire Suppression Damages Repaired with Suppression Funds
 1. Fireline waterbarred (miles): Handline 0; Dozerline - 0
 2. Fireline seeded (miles): 0
 3. Other (identify): 0

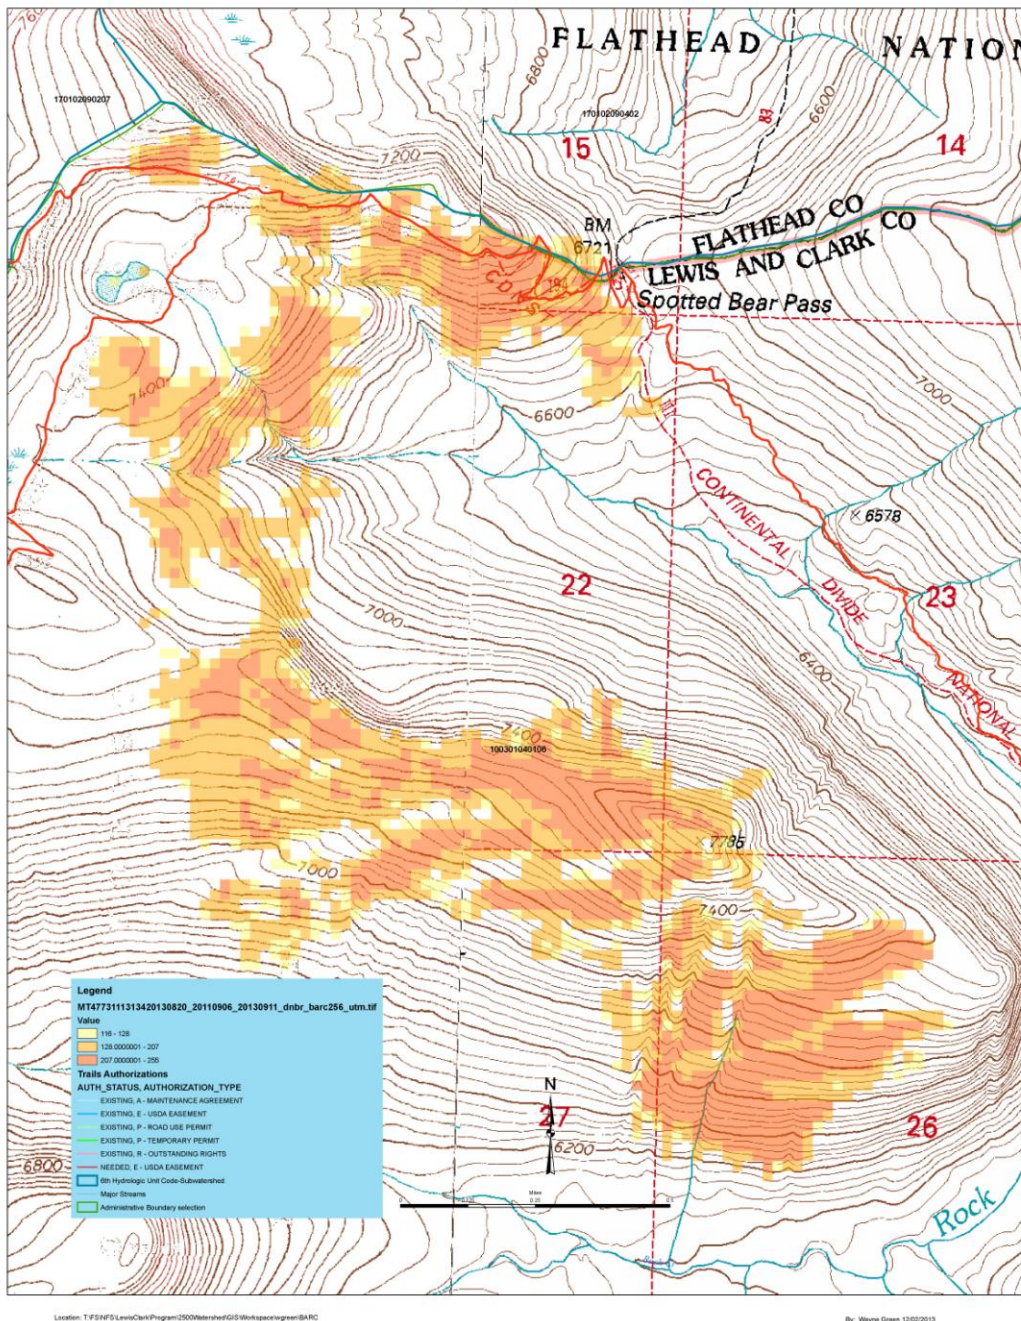
2013 Rock Creek Fire BAER
Burn Severity Map

The Rock Creek Fire burned exclusively with the Bob Marshall Wilderness area. Burn pattern was mosaic with large areas of moderate to low/non-burn throughout the interior of the fire. Low to moderate burns moist north facing slopes.

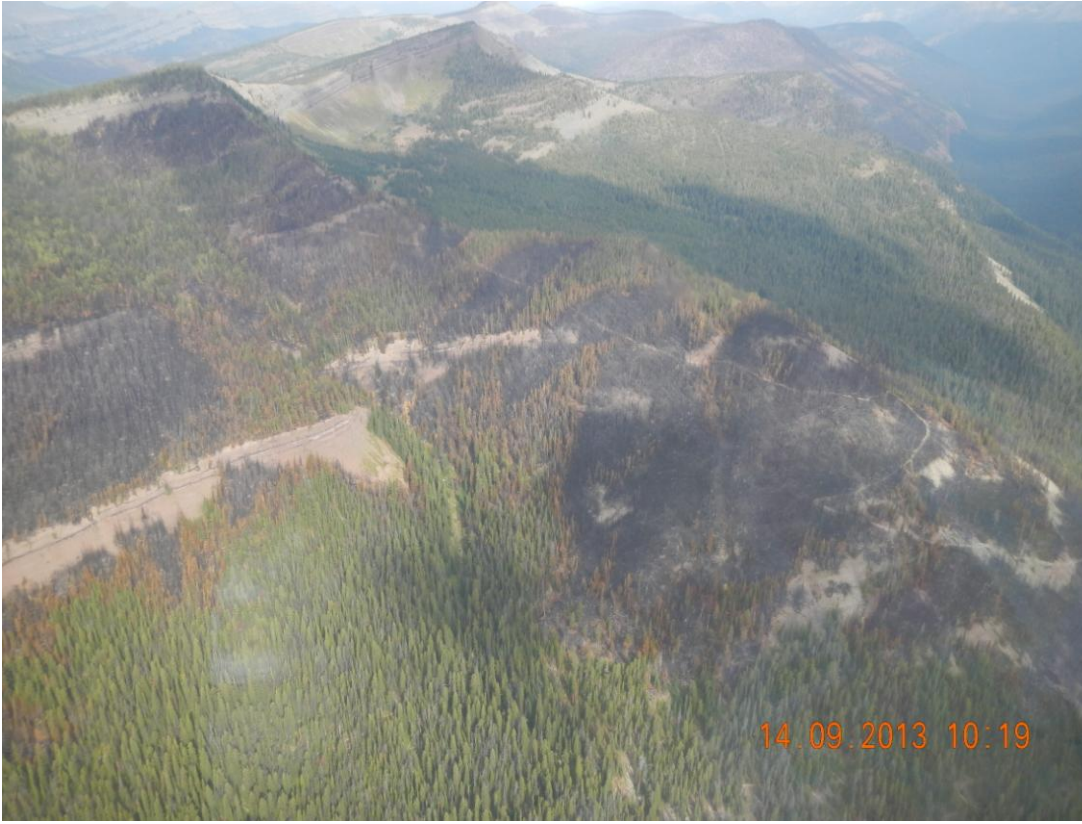
The Rock Creek fire. The soil burn severity in the fire perimeter was mosaic and was judged to be predominantly moderate with pockets of high severity. Steep trail segments (Trial 194) as seen in the photo within the fire perimeter within heavily burned areas comprise the majority of the Values at Risk – predominantly trail segments.

Trail stabilization work is proposed for trails #176 and #194 to protect 0.95 miles of trails. Both trails were previously recorded as historic linear sites, no additional mitigation will be required. **However, cultural stipulations will require the trails to be rehabbed to their original character and the puncheon bridges be replaced in-kind.**

The treatment is to stabilize 0.95 miles of trails in order to minimize erosion and stream sedimentation from post-fire runoff and protect the trails as a historic heritage resource. Protection for crews trail work is facilitated by removing hazard trees that threaten the worksites of the crews. Long sections of the travel routes pass through riparian areas that are wet for most of the year and will require the reconstruction of puncheon bridges through these sensitive areas. Treatment also includes reconstruction of 20 feet of Puncheon Bridge to protect riparian wetland and soil resources.

METHODS: Use a mix of waterbar installation, ditching, out-sloping, and puncheon bridge reconstruction to direct water off the trail as quickly as possible while maintaining the overall trail integrity, in order protect wetland areas and prevent sediment from entering streams by minimizing trail erosion that is likely to occur due to fire effects. Work will be in accordance with EM-7720-102, Forest Service Standard Specifications for Construction of Trails and conform to wilderness standards based on a minimum tools analysis.

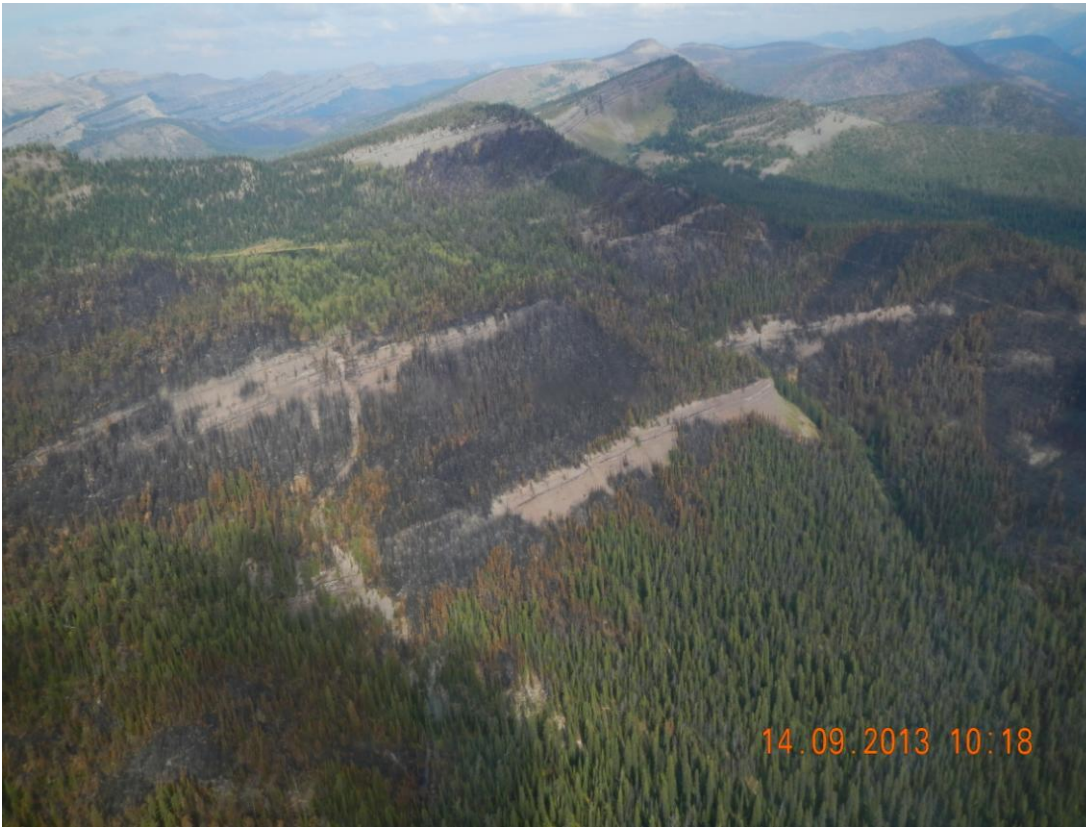
Aerial photograph illustrating the mosaic and steep nature of the Rock Creek Fire.
