# Rock Mountain Fire December 2016

**BURNED-AREA REPORT**  
(Reference FSH 2509.13)**PART I - TYPE OF REQUEST****A. Type of Report**

**PART II - BURNED-AREA DESCRIPTION****A. Fire Name:** Rock Mountain**B. Fire Number:** GA-CHF-160079**C. State:** Georgia and North Carolina**D. Counties:** Clay and Macon (North Carolina), Rabun and Towns (Georgia)**E. Region:** 8**F. Forest:** Chattahoochee-Oconee, Nantahala**G. Districts:** Chatooga River, Nantahala, and Tusquitee**H. Fire Incident Job Code:** P8KTE7 0803**I. Date Fire Started:** 11/09/2016**J. Date Fire Contained:** Unknown**K. Suppression Cost:** \$11.7 million**L. Fire Suppression Damages Repaired with Suppression Funds:****Chattahoochee NF:**

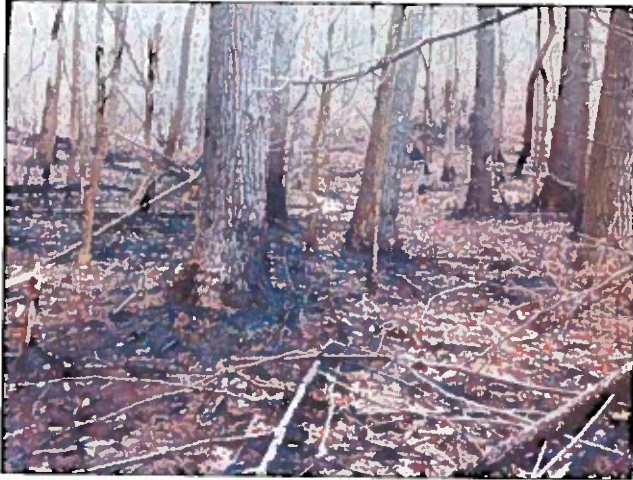
The following photographs on the left show charred but not consumed ground cover, minimally impacted forest duff and fine roots and minimal, if any, impacts on the soil. The following photographs on the right show high consumption of ground cover and forest duff. Impacts on the top ¼ to ½ inch of soil were also observed.

Example of low burn severity effects on landscape (above)

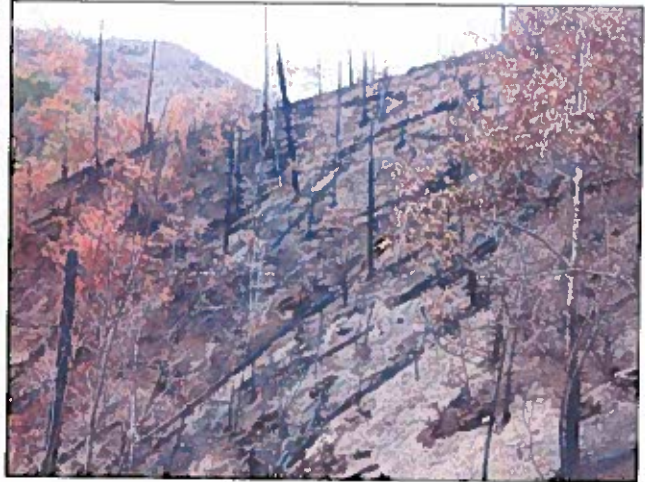
Example of moderate to high burn severity effects on the landscape (above)

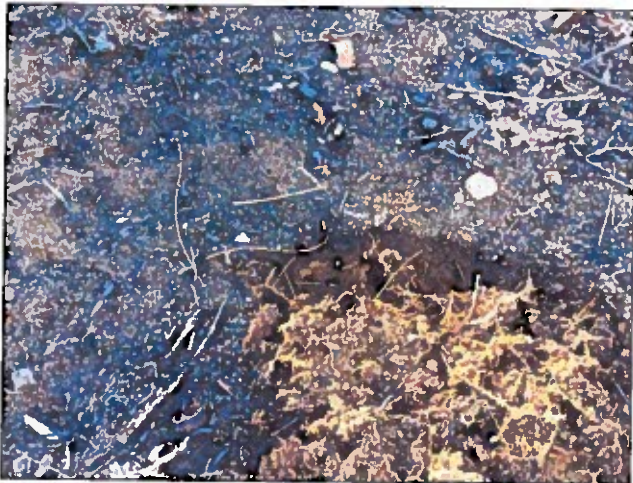
Example of low burn severity effects on the soil (above)

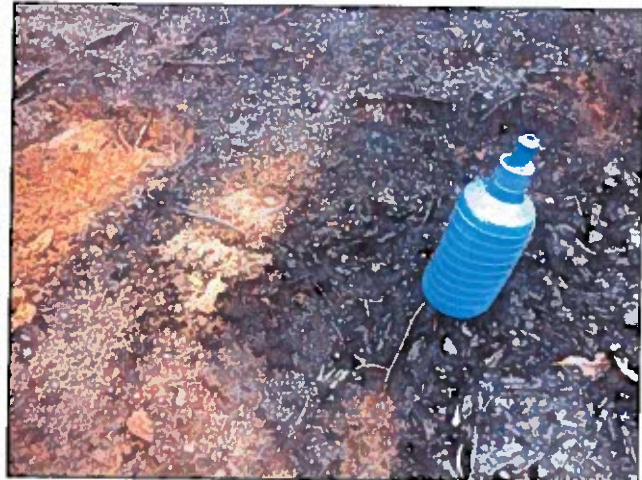
Example of moderate to high burn severity effects on the soil (above)

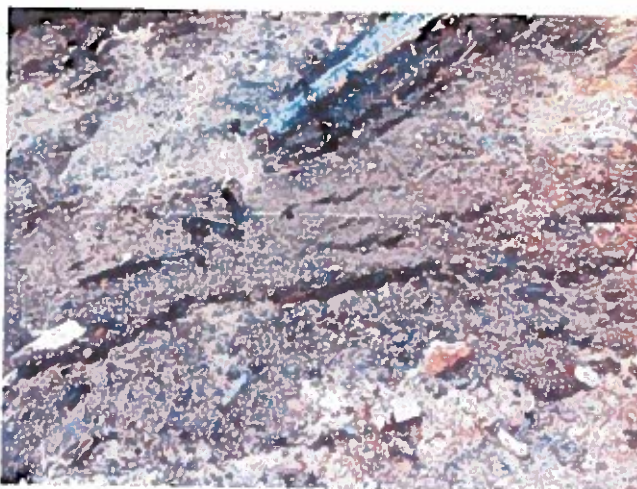
Example of rills in one localized high severity burn area

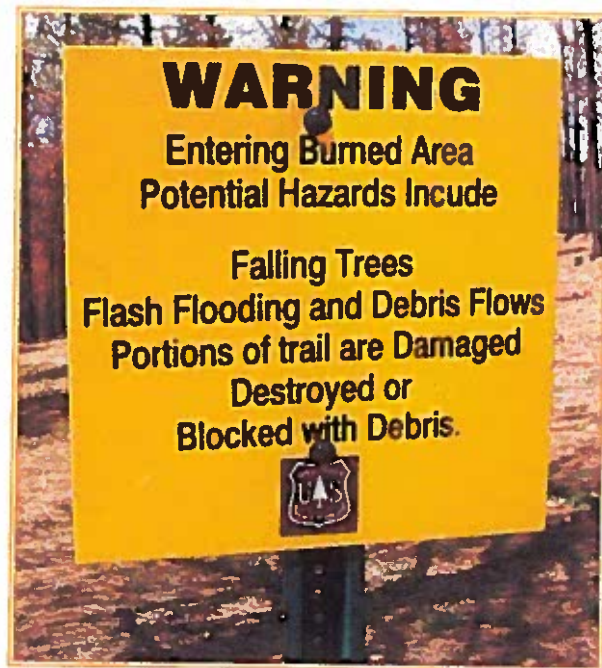
Costs include sign replacement due to weather and/or vandalism. Insert information on trail hazards on the Forest Public facing website and/or press releases. A picture of an example sign is provided below:

**Other Trails - Hazard signs and public (website) information:** Place Burned Area hazard signs at trailheads for the other trails outlined above that enter the fire area. Insert information on trail hazards on the Forest public facing website Approximately 8 signs are needed.

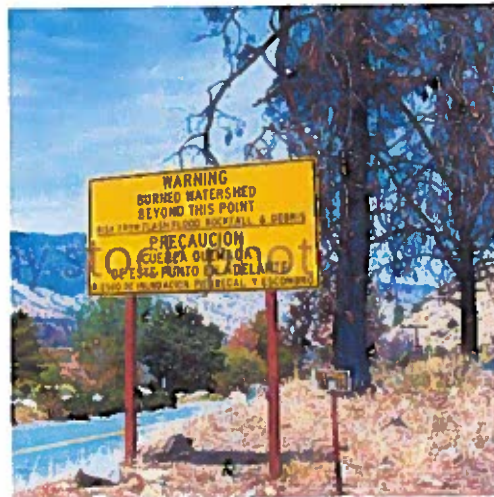
**Roads - Hazard signs and public (website) information:** Place an appropriate sign on two (2) Forest Roads when entering the fire area. See an example of road hazard sign below:
