BURNED-AREA REPORT

PART II - BURNED-AREA DESCRIPTIONA. Fire Name: AnnabellaB. Fire Number: UT-FIF-0055 (Wildland Fire)C. State: UtahD. County: SevierE. Region: Intermountain - 04F. Forest: Fishlake National ForestG. District: Richfield - D4H. Fire Incident Job Code: P4CPU8I. Date Fire Started: 06-07-2006J. Date Fire Contained: 06-14-2006 @ 1800 HoursK. Suppression Cost: \$ 1,500,000 ... Type I - Incident Summary / 06-15-2006 (Estimated Final Cost)

Watershed Condition Summary

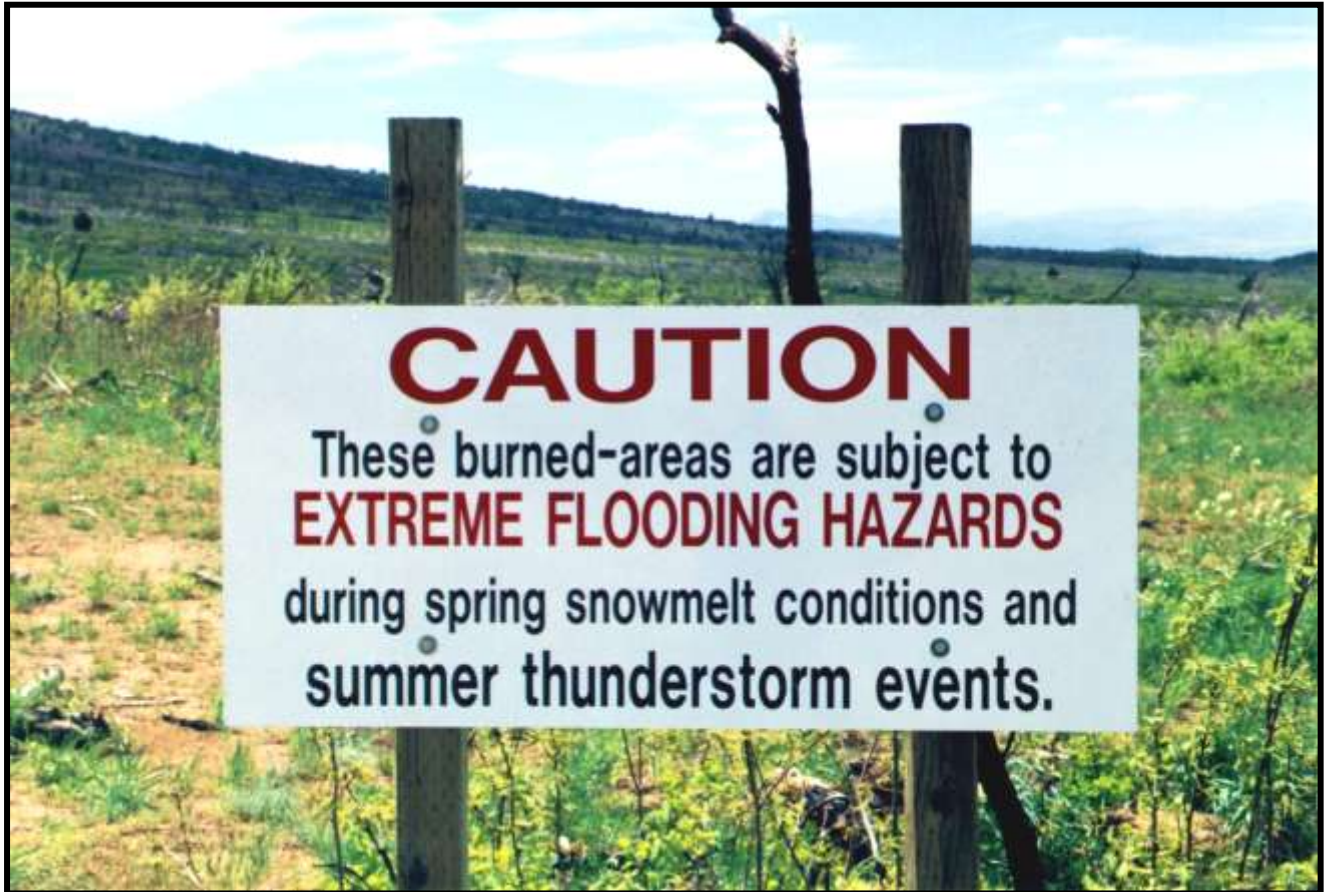
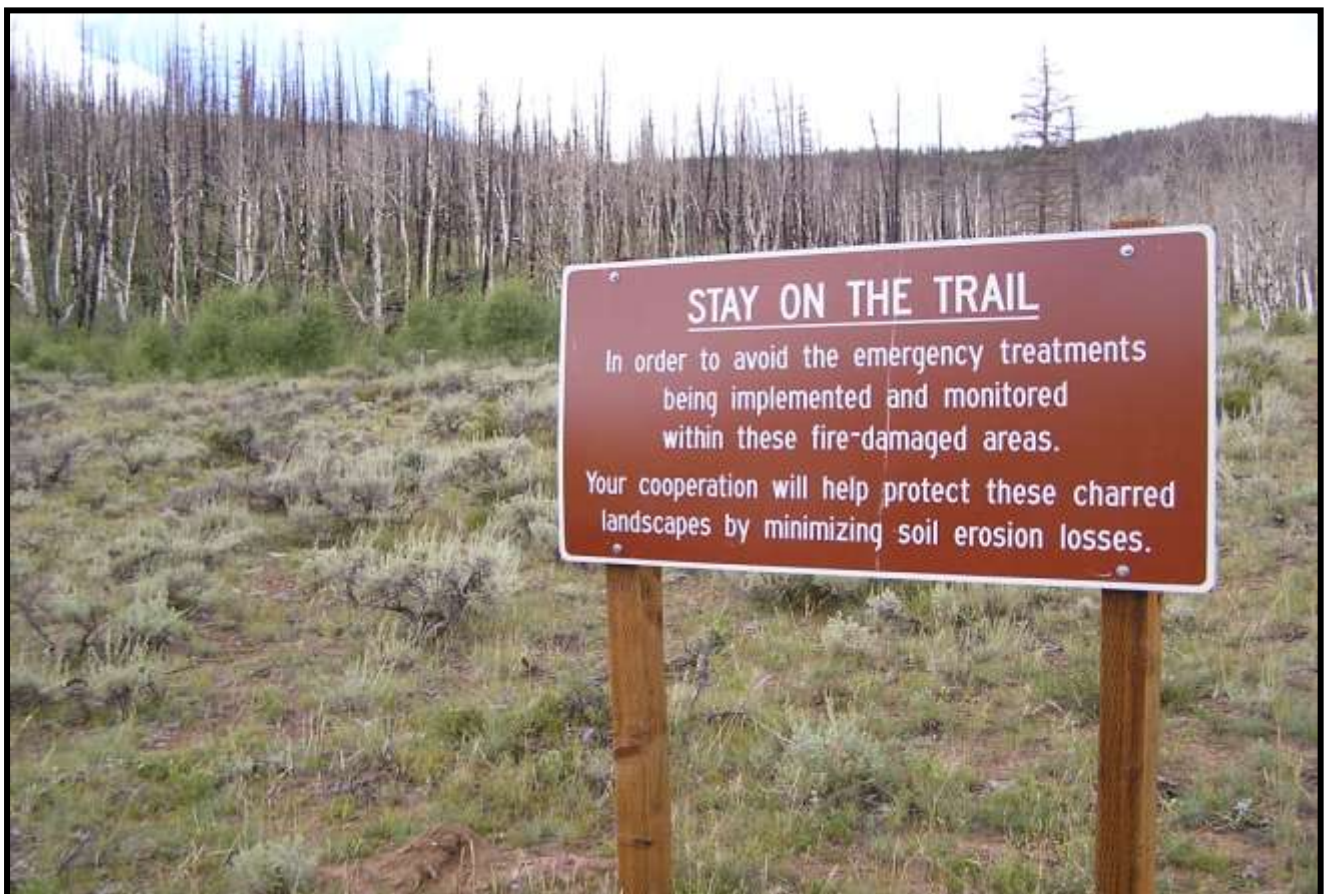
(examples of two explanatory signs used by the Forest Service on wildfires)

④ Protection and Safety Treatments: Two metal gates will be used as temporary barriers for road closure purposes in order to keep the general public away from the burn and off the dirt road leading through the fire incident into Circle Flat. The cost of these new gates is expected to be about \$ 1800 each – which would include the installation by the Fishlake NF / Engineering Crew. Secondly, we would purchase four new explanatory signs to warn the general public about the inherent dangers of walking through a recently burned-area – especially, during inclement weather conditions. The signs would be useful in keeping folks away from our BAER treatment areas too. The cost of the new signs is expected to be about \$ 400 / each. The signs would be placed near Circle Flat, in Henries Hollow and the two remaining signs would be put along an OHV trail located along the Forest Service boundary near Lower Cliff Canyon. The signs would remain in place for a period of at least 3 years –
