**BURNED-AREA REPORT**  
(Reference FSH 2509.13)**PART I - TYPE OF REQUEST**

- A. Fire Name: Tanner B. Fire Number: AZ-TNF-109  
C. State: Arizona D. County: Gila  
E. Region: 3 F. Forest: Tonto  
G. District: Pleasant Valley, Tonto Basin H. Fire Incident Job Code: P3GBY5  
I. Date Fire Started: 8/20/2011 J. Date Fire Contained: 10/12/2011  
K. Suppression Cost: \$2.8 million  
L. Fire Suppression Damages Repaired with Suppression Funds  
1. Fireline waterbarred (miles): 0  
2. Fireline seeded (miles): 0  
3. Other (identify):  
M. Watershed Number: 1506010308  
N. Total Acres Burned: 5,456  
NFS Acres(5,456 ) Other Federal ( ) State ( ) Private ( )  
O. Vegetation Types: Mixed Conifer, Ponderosa Pine, Chaparral, Riparian  
P. Dominant Soils: Typic Argiudolls, Udic Paleustalfs, Lithic Haplustalfs, Udertic Haplustalfs.  
Q. Geologic Types: Diabase, Dripping Springs Quartzite, Troy Quartzite, Mescal Limestone.

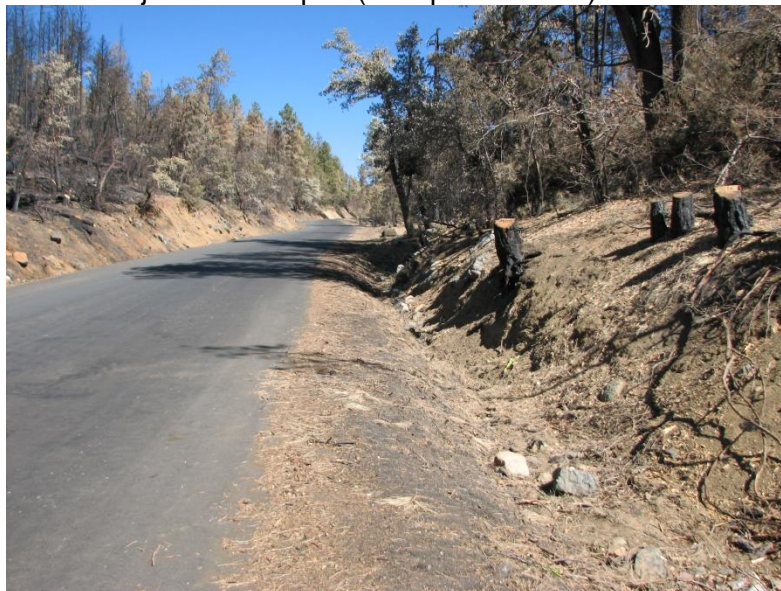
Highway 288 Conner Canyon – The mainstem of Conner Canyon flows along the edge of Highway 288 until it crosses beneath the highway in a 30 inch culvert. The channel and highway are confined to a narrow passage between the adjacent hillslopes ( see photo below).

The channel has been bermed with a small rock and soil berm along part of its length to keep flows in the channel off the highway. ADOT stated that even with the berm they have to remove debris from the roadway following larger storms. Most of the watershed above the culverted crossing has burned with moderate to high intensity (71%) and peak flows will increase dramatically. The table below displays the modeled changes in peak flows for the one hour storm. The storm that would have produced the 2 year flood under prefire conditions now results in a flow greater than the prefire 100 year flood.

Seed and mulch 110 acres of high burn severity areas above Highway 288 in the Connor Canyon Area and along the portion of Highway 288 that drops down to Workman Creek.

Remove floatable debris from the channel and floodplains upstream of culverted crossings of Highway 288 for a distance of 300 yards.
