WELDING REPORT

Model = BASIC 355(V0)/COMPACT 355

Job site = sec 15 MERIMon-dummy

Standard  
UNI10520(06/09) DUAL

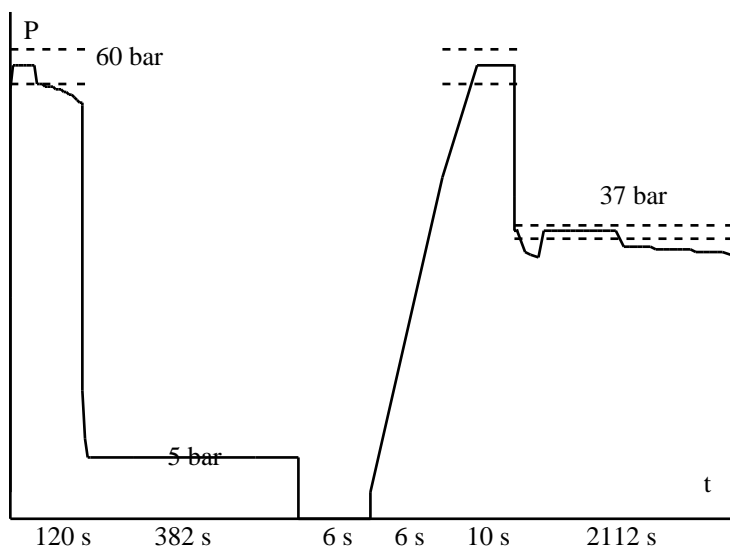
## PRESSURE GRAPH

NO ERROR

$p_1 + p_t = 60\text{ bar}, t_1 = 120\text{ s}$

$p_2 = 5\text{ bar}, t_2 = 382\text{ s}$

$p_3 + p_t = 60\text{ bar}, t_5 = 10\text{ s}$

$p_4 + p_t = 37\text{ bar}, t_6 = 2112\text{ s}$

$t_{\text{total}} = 2636\text{ s}$
