## 1. INTRODUCTION

Case 1: Nitika Pharmaceuticals, a G+2 storied building damaged by extreme fire.

#### 4.2.1 CASE 1: 'Nitika Pharmaceuticals'

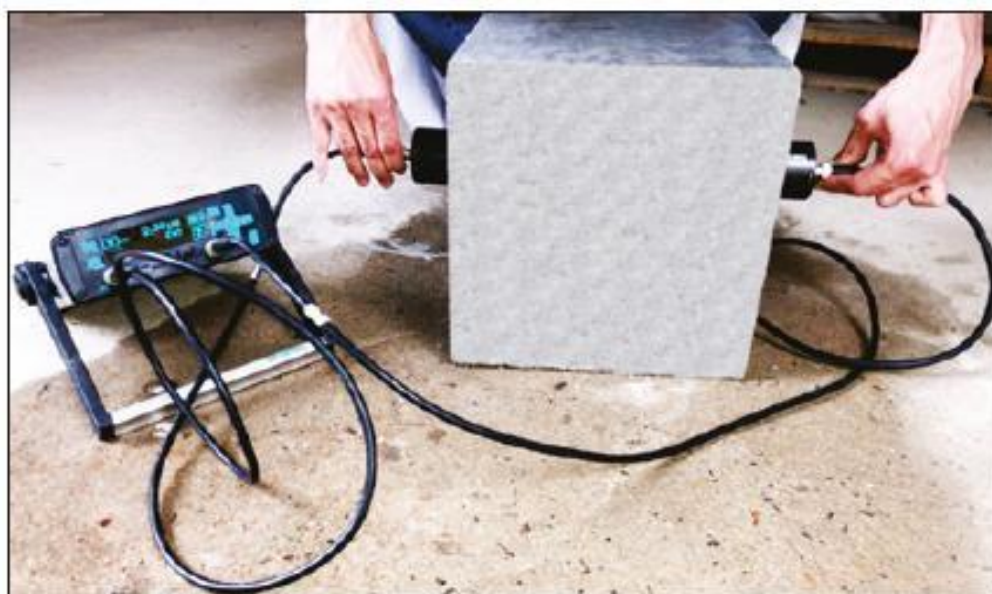
**Fig 3.1 Ultrasonic Pulse Velocities Test.**

This test is done to assess the quality of concrete by ultrasonic pulse velocity method as per IS: 13311 (Part 1): 1992 and IS 516( Part 5/Sec 1) : 2018. The underlying principle of this test is The method consists of measuring the time of travel of an ultrasonic pulse passing through the concrete being tested. Comparatively higher velocity is obtained when concrete quality is good in terms of density, uniformity, homogeneity etc.

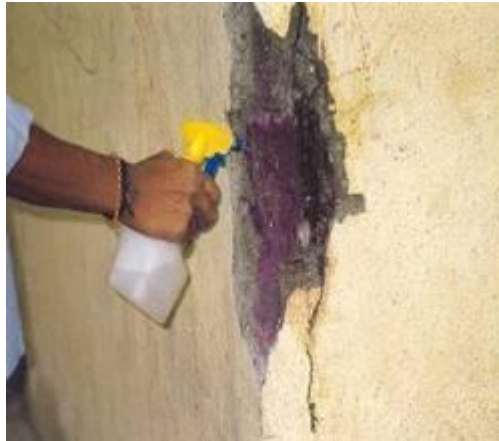
The reaction of concrete with carbon dioxide reduces the pH in the concrete. ... When phenolphthalein comes into contact with high pH ( $>10$ ) concrete the solution shows as bright pink. When the solution comes into contact with low pH ( $<10$ ) the solution shows no color change and the concrete can be considered carbonated.

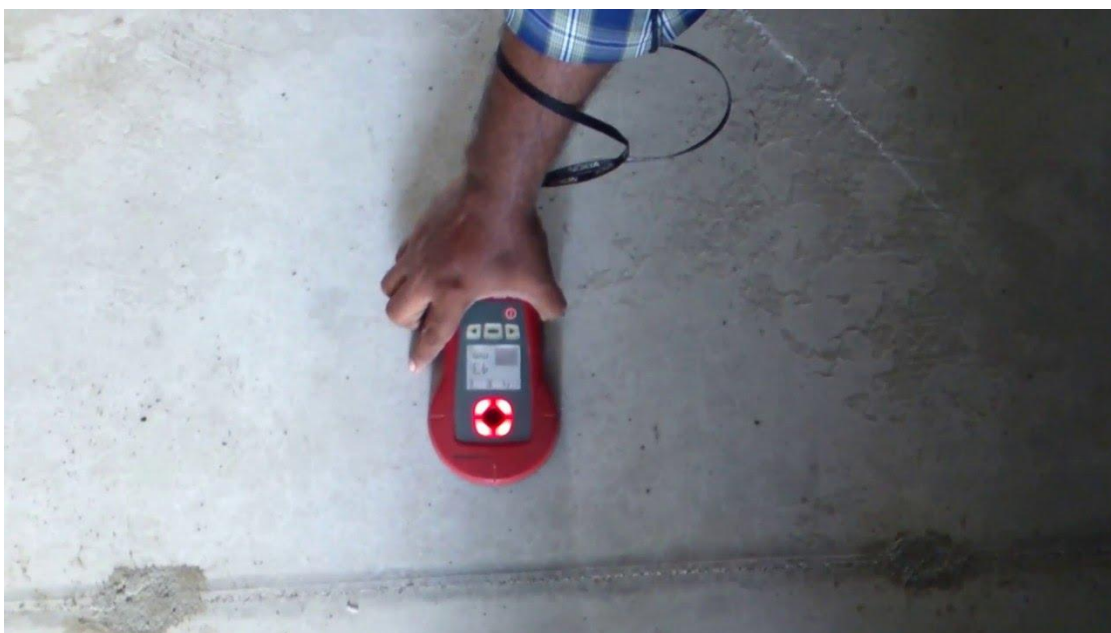
A cover meter is an instrument to locate rebars and measure the exact concrete cover. Rebar detectors are less sophisticated devices that can only locate metallic objects below the surface. Due to the cost-effective design, the pulse-induction method is one of the most commonly used solutions.

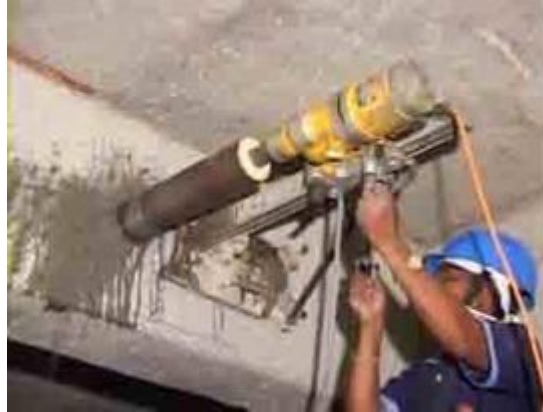
This test is used to determine the compressive strength of a concrete core, which has usually been extracted from an existing structure. The value of compressive strength can then be used in conjunction with other measured properties to assess the condition of the concrete.
