## **CAED Temperature and Humidity Data Sensing**

50095 Advanced Technology Applications in Construction

Ruoxin Xiong

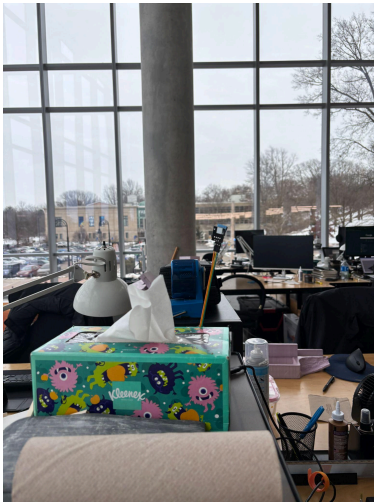
*Second Floor Location 1*

This location experiences the most daylighting, as it was positioned in close proximity to the large floor to ceiling windows, likely causing significant temperature and humidity fluctuations due to solar gains and heat loss. In Ohio, during the month of February, temperatures are low, and the quality of the window's insulation could greatly impact the indoor temperature. Additionally, the heated concrete floor can create a localized thermal environment, influencing the temperature readings at desk height. Finally, the minimal foot traffic nearby ensures consistent environmental conditions.

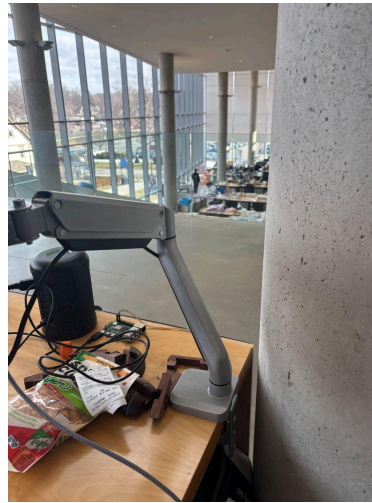
*Third Floor Location 2*

For this location, the sensor was placed in the middle of the room to provide a baseline for ambient conditions, as it is distanced from direct environmental influences like windows or heating sources. This location receives natural light but lacks direct solar exposure, allowing data collection for temperature and humidity reflective of the general room climate. Moderate foot traffic introduces variable heat from occupants, providing insights as to how human activity is affected by the building's thermal environment.
