Truss Design Project

Using engineering theory in a clear iterative process our team was tasked to develop three truss designs that result in defined performance improvements in strength between the initial and final design geometries of each truss. We chose one of the three trusses to build, then loaded it to failure. We then Compared the results to the projected failures from the design simulation using the Truss Analyzer. Each truss design must begin with a significantly different initial geometry and include at least four iterative steps leading from initial to final geometry

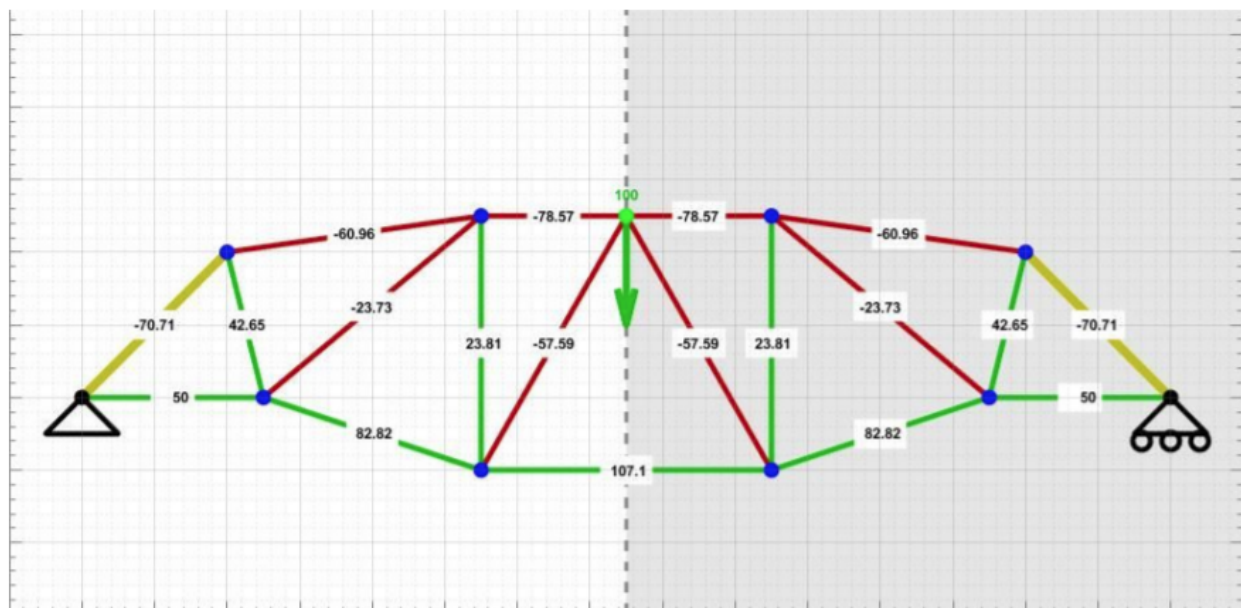
Compression vs Tension

The material used in the project was brass, which can support tensile stress (green) more efficiently compared to compressive strength (red). Zero force members (yellow) are beneficial because they reduce stress by splitting a compressive force as the truss fails. This diagram is a screenshot of the Truss Analyzer software for the final truss design.

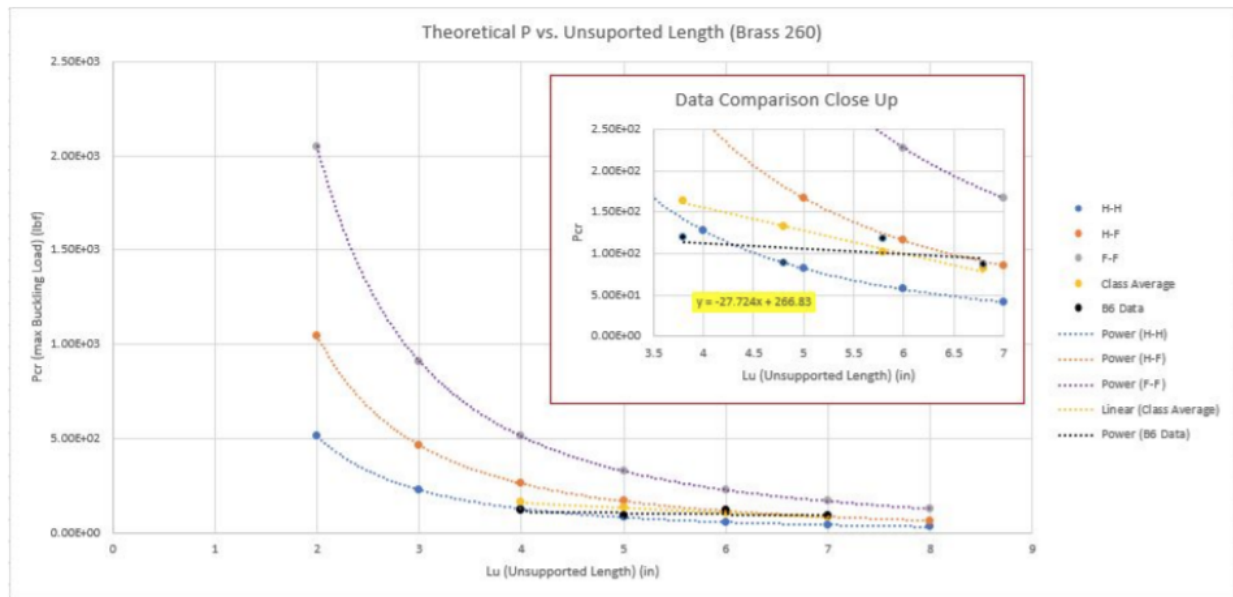
Theoretical Pcr vs Unsupported Length

Shorter members are more ideal, and buckle at a higher load.

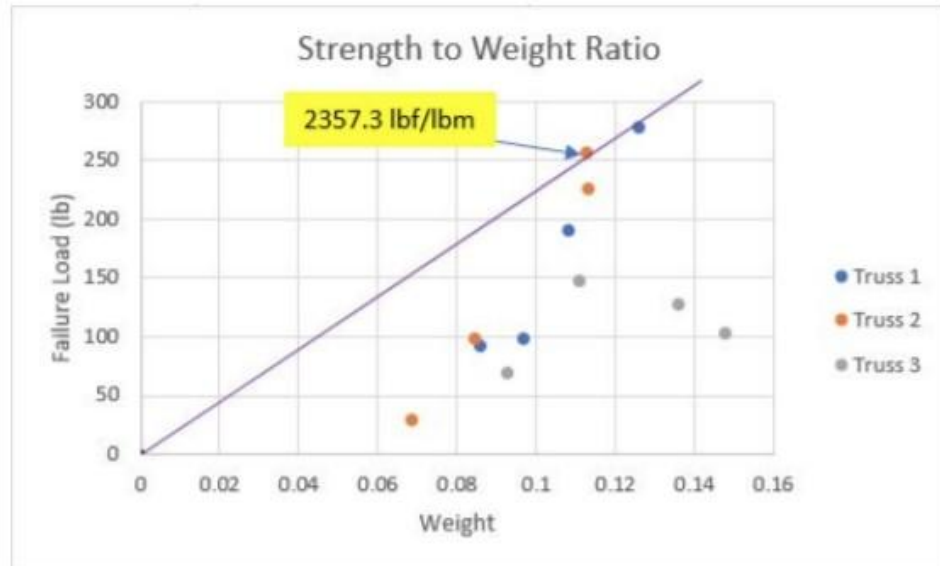
Failure Load Prediction

Using the calculated information from the tests as indicated above, the team designed 3 trusses, and optimized each one with 4 iterations. The last iteration of Truss 2 moved forward because it had the highest strength to weight ratio. Theoretically with a final weight of 0.114 lbm, our truss should fail at 269 lbf.

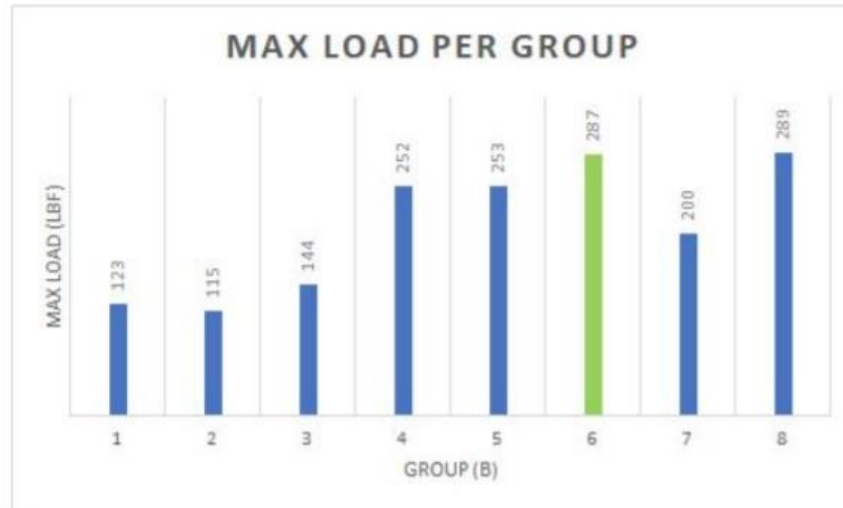
Team Results

Our team had the second highest max load in the class at 287 lb. This was 18 lbf off from our theoretical prediction, with an error of 6.27%

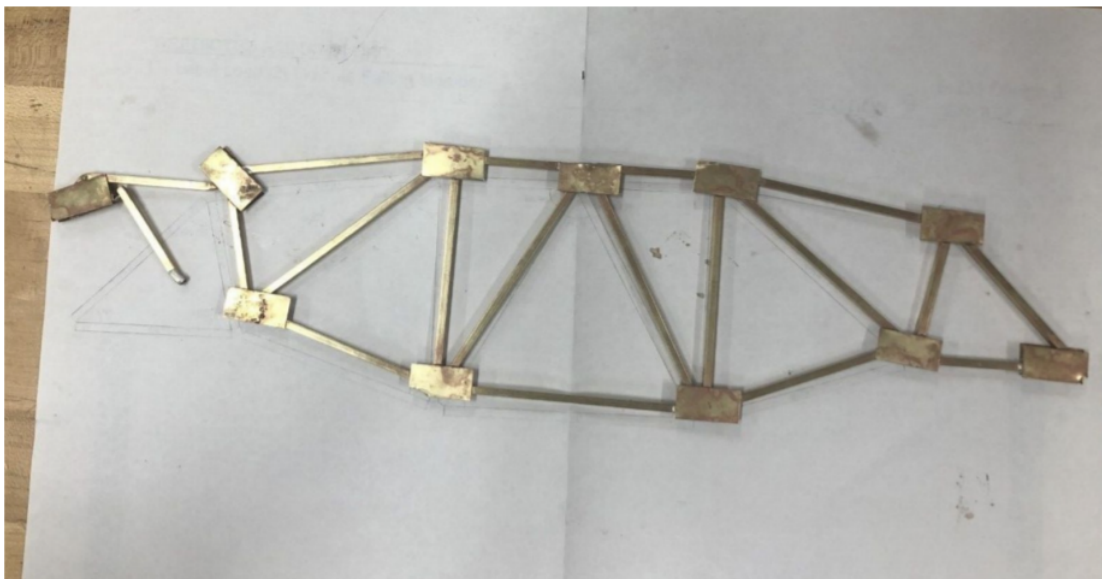
Final Truss Failure Point

The truss member that ended up failing was the bottom left member. While this was not the member indicated in the Truss Analyzer, the group realized this was because the thickness of the brass increased the total length of the truss to an additional inch which was unaccounted for in the Truss Analyzer. This caused the load to be concentrated on the member instead of being distributed to the joint as planned.
