The vulnerability of solar panels to hail

The vulnerability of solar panels to hail.

Climate-KIC project: *'1 million near-zero energy homes in 2023'*

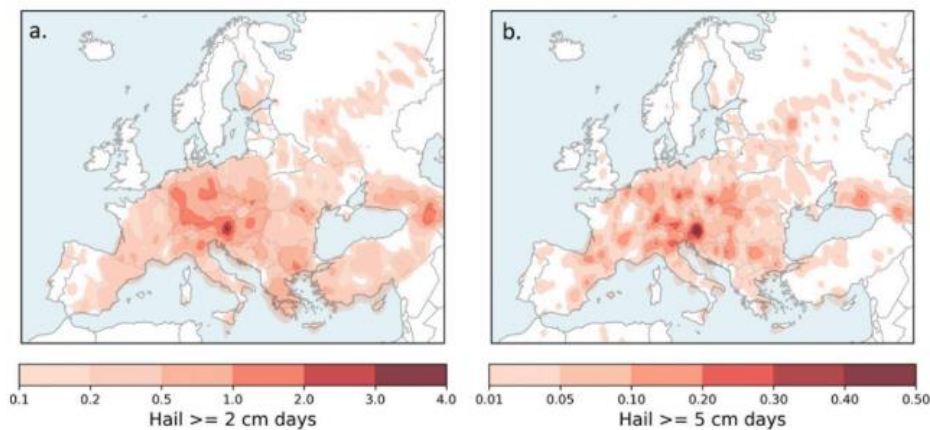
Figure 1: Mean annual number of days with (a) large & (b) very large hail (from the research of Pucik et al. (2019)).

Pucik et al. (2019) shows that large hail (≥ 2 cm) occurs in similar spatial patterns but less frequent than very large hail (≥ 5 cm), as can be seen in Figure 1. The highest frequencies can be found in the southeast of Austria. This area experiences large hail around three to four days a year and very large hail every two years. Other areas with a high frequency of hail are in southwestern Germany, the Po Valley in Italy, over the Ore Mountains on the border of the Czech Republic and Germany, and on the border of the Czech Republic and Poland. (Pucik, et al., 2019). Punge & Kunz (2016) also show an overview of hail event frequency in Europe. According to that study, central Europe, like Germany, Switzerland, and Austria, are highly exposed to hail hazard.

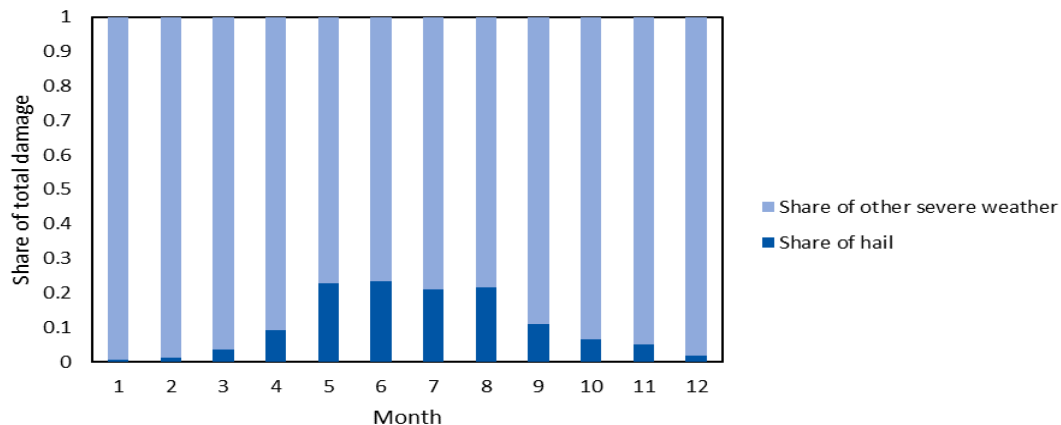
Figure 5: Average share of damage due to hail from all damage by severe weather per month from 1990 to 2016 (data from Achmea data (2019)).

Figure 5 shows the largest share of insured damage due to hail per month, averaged over the years 1990 to 2017. Hail damage occurs the most in the summer months from May to August. This is also in agreement with the findings of Pucik et al. (2019) who show that the Netherlands experiences most hailstorms in June and July. This indicates that damage is in relation to hailstone sizes, as the largest hailstones are found in summer as well, as can be read in the research of Wouters et al. (2019)).

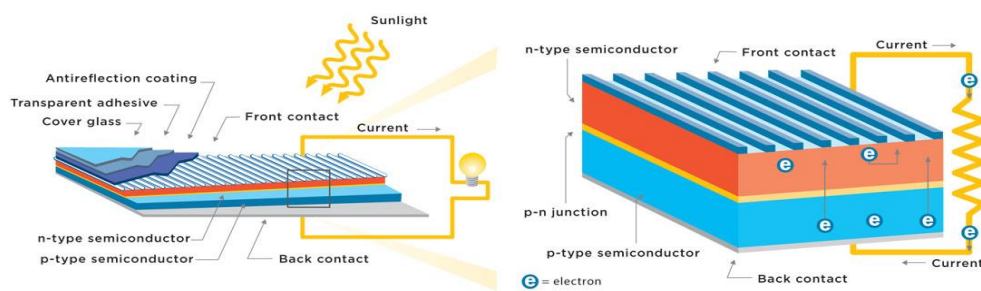
Figure 7: Fundamentals of a solar panel and solar cell (Alpine Solar, 2019).

Solar panels are boards of solar cells. The solar cells use light energy to generate electrical energy. The mechanism behind this conversion is called photovoltaic energy conversion (Soga, 2006). While the materials used in solar cells differ, the structure of solar cells remains the same (Fonash, Ashok, & Fonash, 2018). The structure of a solar panel and cell can be seen in Figure 8 (Fonash et al., 2018).

Sunlight first encounters the antireflection layer. This layer has an optical coating, which is made to minimise the loss of light and retain the light as best as possible. In order to do this, the transmission of the light to subsequent layers is promoted. Those subsequent layers convert energy. They consist of a top-junction layer, an absorber layer, and a back-junction layer. These three layers, together with the antireflection layer, are situated between two electrical contact layers. The front electrical contact layer consists of very thin and widely spaced grid lines. Those grid lines are made to be as small as possible, in order to minimise the blockage of light. The back electrical contact layer does not have any restrictions on its surface area and therefore covers the entire back of the solar cell (Fonash et al., 2018).
