Restoration of juniper woodland-steppe ecosystems: Effects on water capture and release

Michael Fisher, COCC Forest Resources Technology
Tim Deboodt, OSU Crook County Extension

Camp Creek Paired Watershed Study

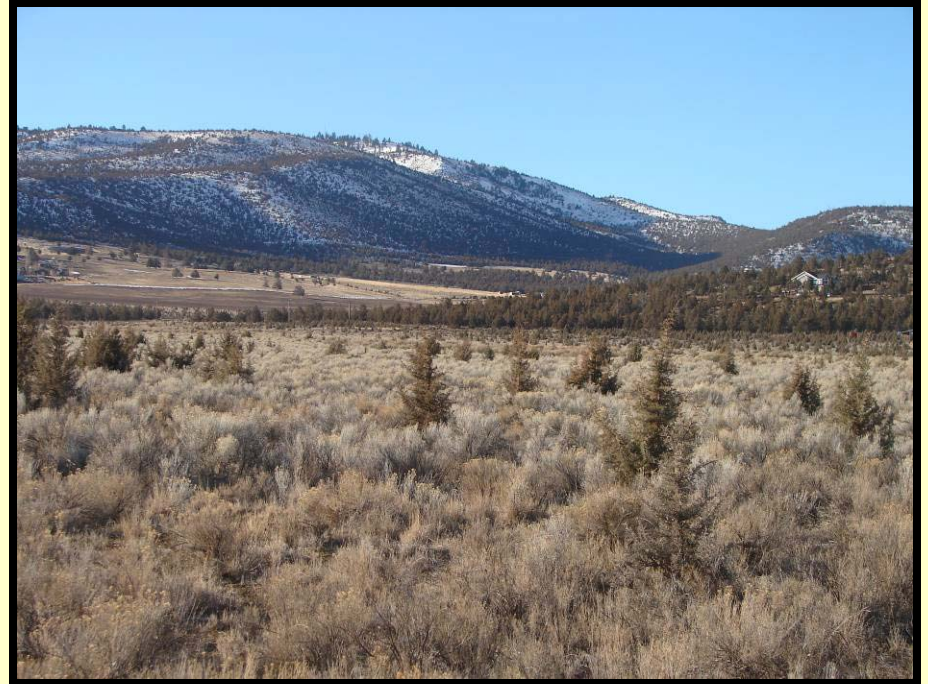
Phase 1:

The Invasion Begins

- Juniper is present
- Small juniper become visible
- Grasses, shrubs and forbs are unaffected
- Little or no change in ground cover

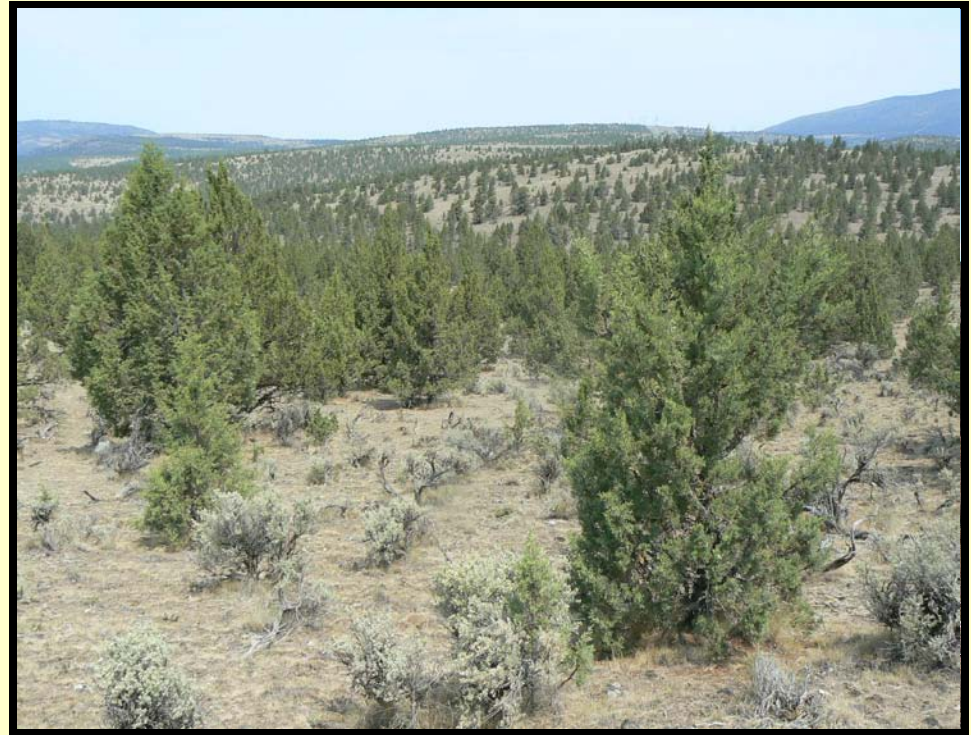
Phase 2:

The Invasion Advances

- Juniper trees throughout the site
- Some shrub die-off possible
- Loss of ground cover

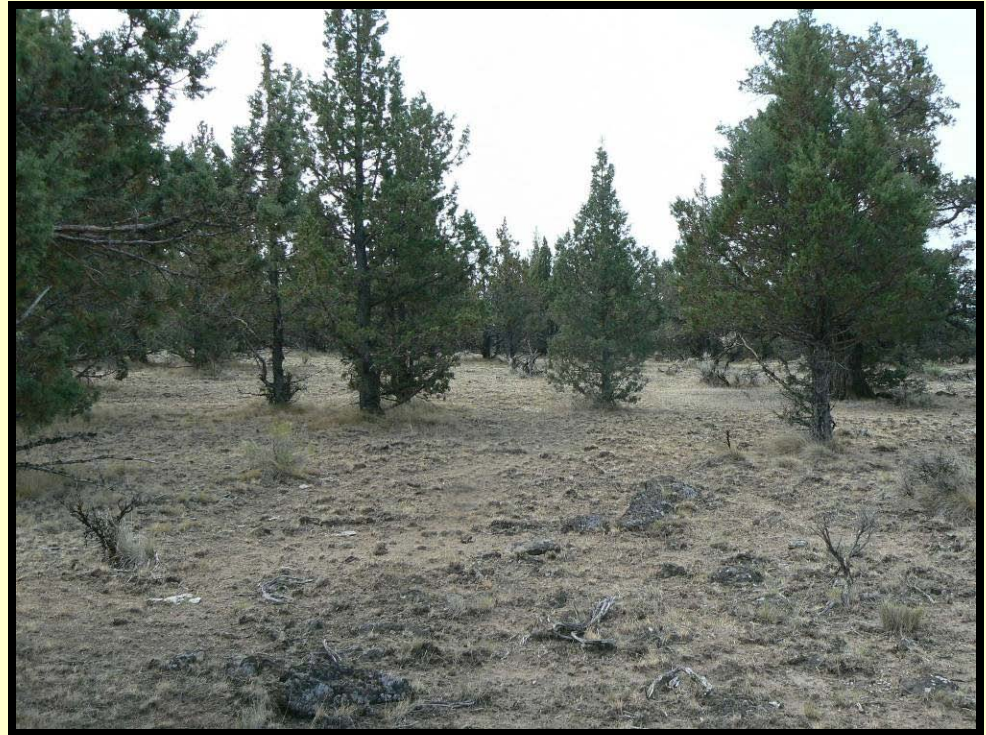
Phase 3:

The Invasion Takes Over

- Juniper canopy closes
- Shrub die-off up to 75%
- Loss of understory vegetation
- Large areas of bare soil
- Overland water flow common

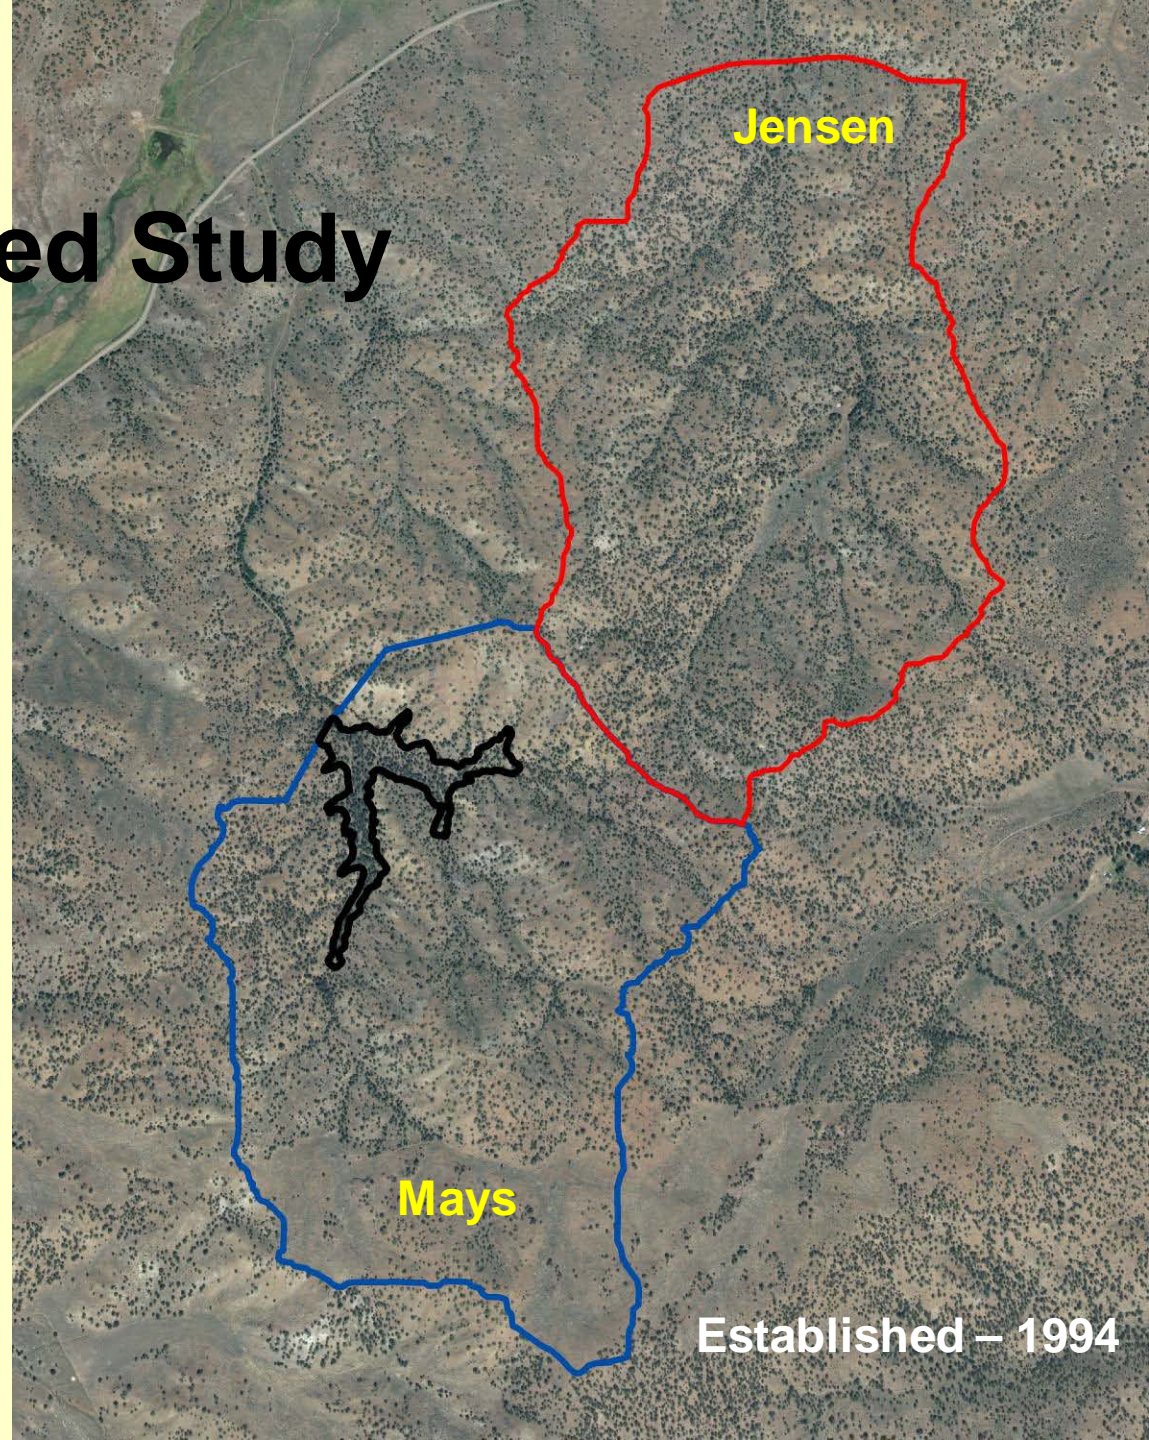
Area Description

Mays – 279 acres

Jensen – 261 acres

4500 – 5000 ft elevation

Sagebrush/bunchgrass
steppe

13 inches precipitation

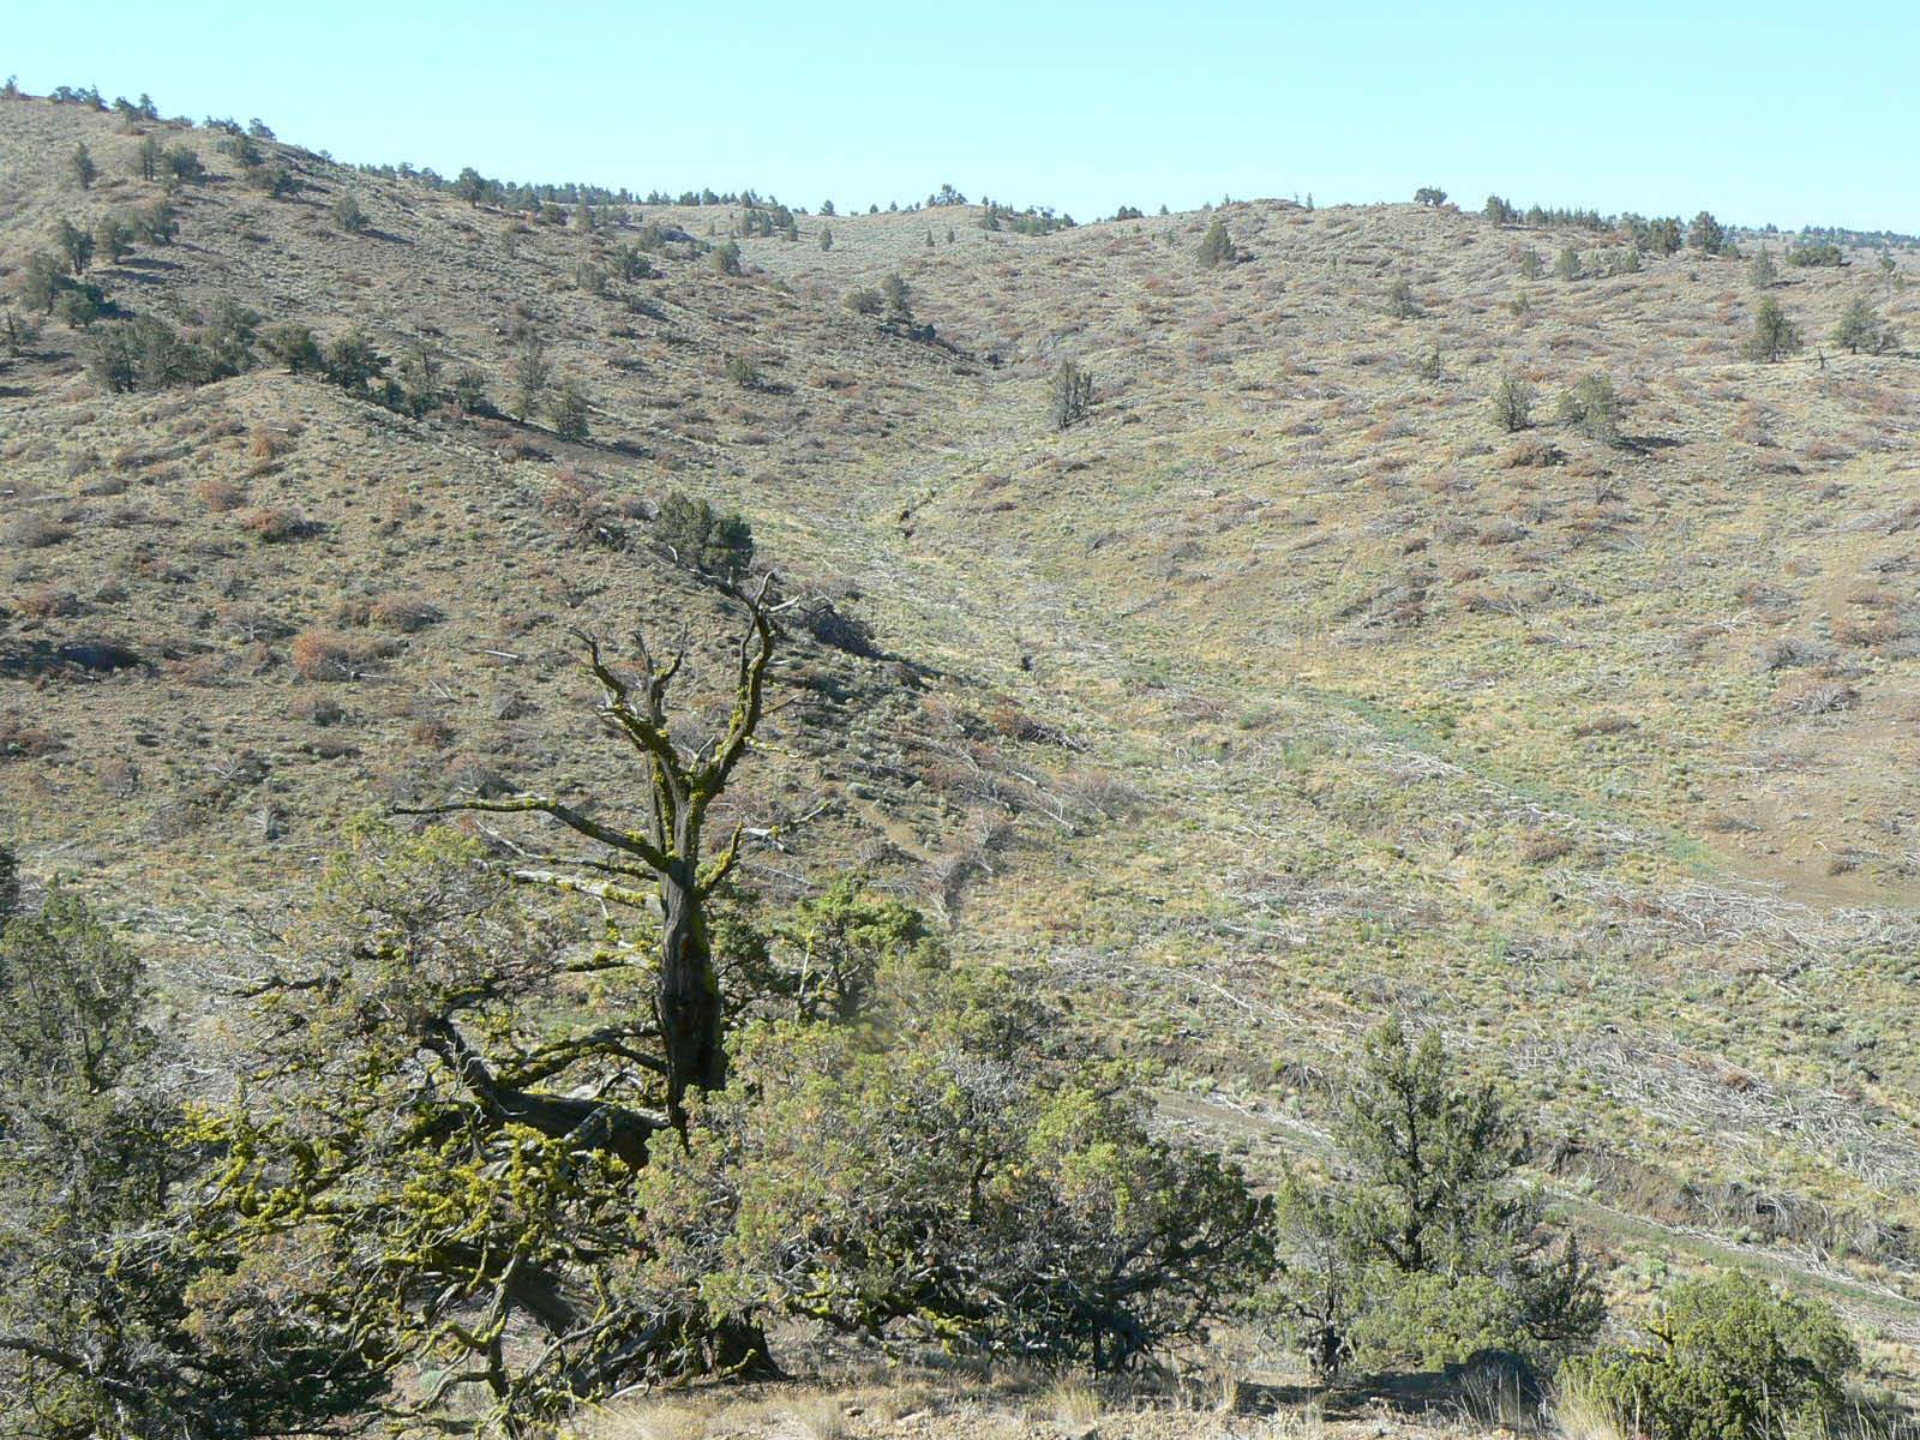
What we know:

- Late season spring flow increased 225%
- Ground water days has increased 41 days
- Late season soil moisture increased
- Increase in ground cover
