## Big Park Allotment Adaptive Management Strategy (2020)

### Rangeland Management in the Park Range Analysis Area EA

The purpose of this document is to I) summarize the Park Range EA (2012) II) provide the current status of Rangeland grazing administration and monitoring results (2010-2019), III) outline adaptive management action items, and IV) ensure specialists and line officers concur that next steps for adaptive management action items, and were adequately covered by the Park Range EA.

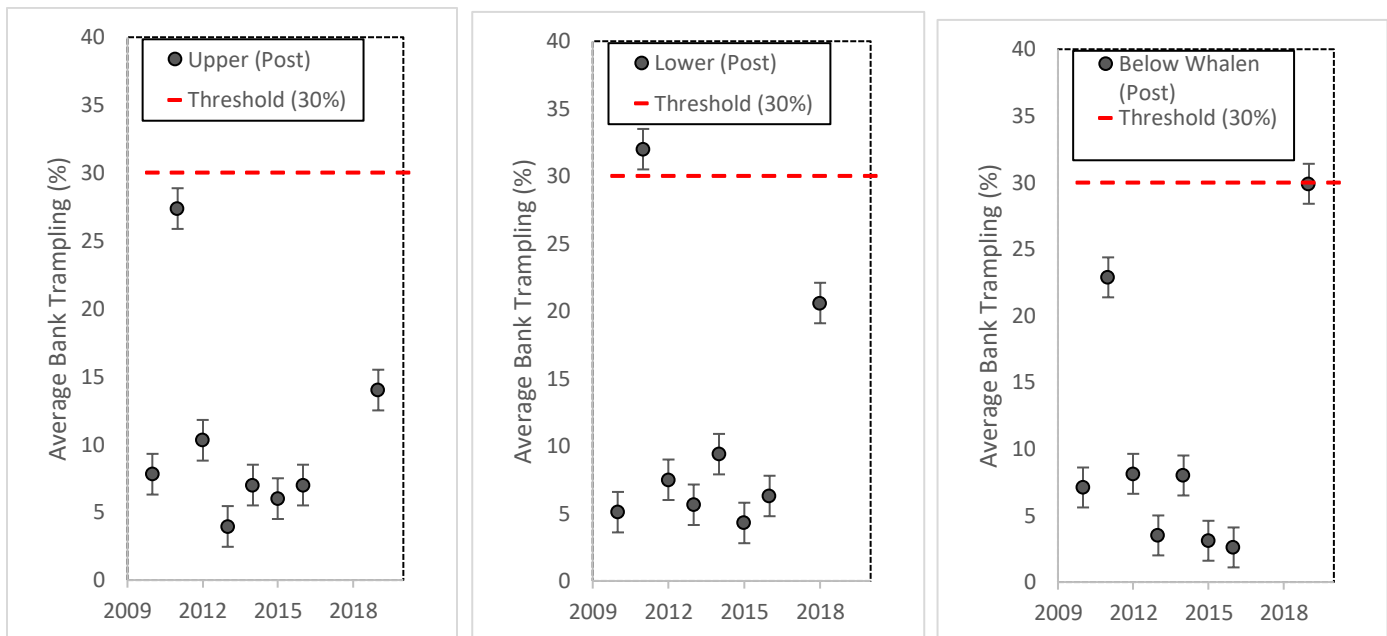
- Post-Grazing Bank Trampling and Sedge Heights indicate some of the desirable stream and riparian conditions are not being met. In 2011, all sites exceeded the Bank Trampling and Sedge Height thresholds (Fig. 3).
- Thresholds were established from best available data and the Watershed Conservation Practices Handbook (FSH 2509.25).

**Figure 3:** Bank Trampling and Sedge Heights for Upper, Lower, and \*Below Whalen Creek (\*formerly the Reference) at Newcomb Creek. The red lines are bank trampling and sedge height thresholds

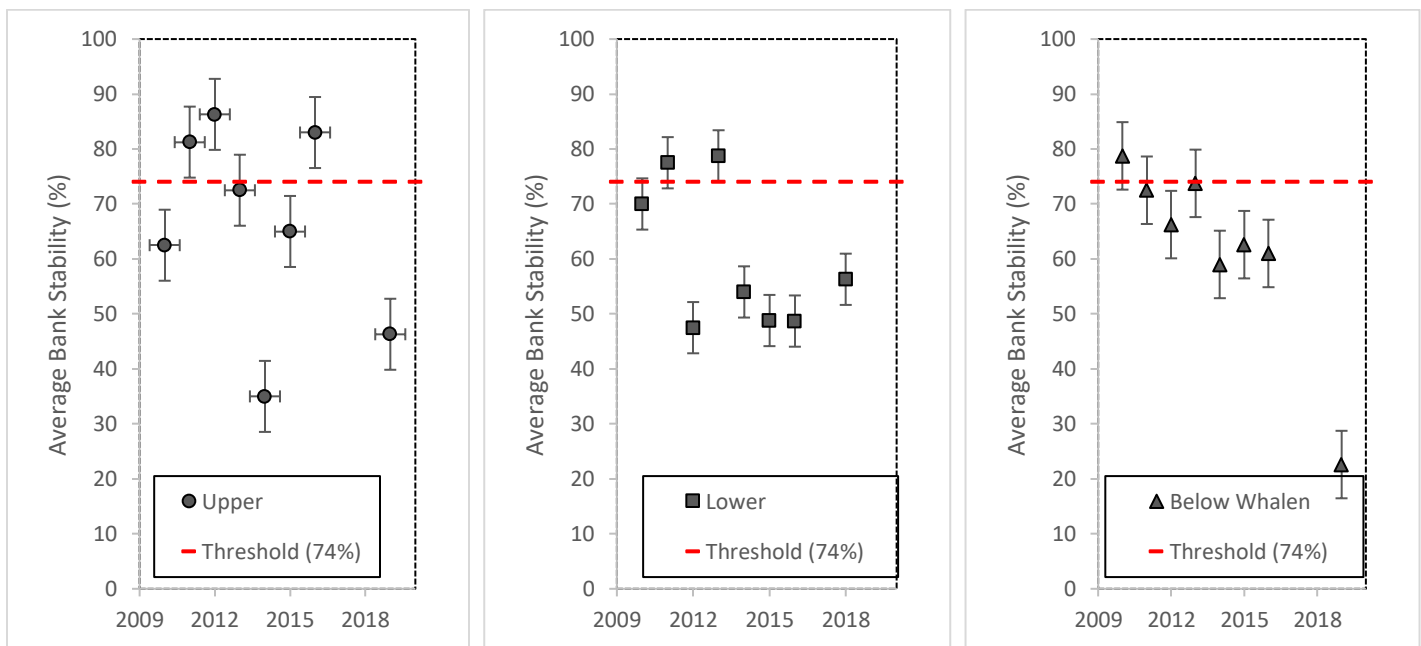
- Bank Stability Ratings indicate some of the desirable stream and riparian conditions are not being met. The Bank Stability threshold was exceeded for all 3 sites in 2014 and 2015 (Fig. 4).
- Greenline Stability Ratings indicate some of the desirable stream and riparian conditions are not being met. Greenline Stability Ratings at the Upper and Lower sites have a downward trend. The Greenline Stability Rating at the Lower site has been below its threshold for 2 consecutive surveys.

Figure 4 - Bank Stability and Greenline Stability for Upper, Lower, and \*Below Whalen Creek (\*formerly the Reference) at Newcomb Creek. The red lines are Bank Stability and Greenline Stability thresholds. Greenline Stability thresholds are based on the 2010 surveys

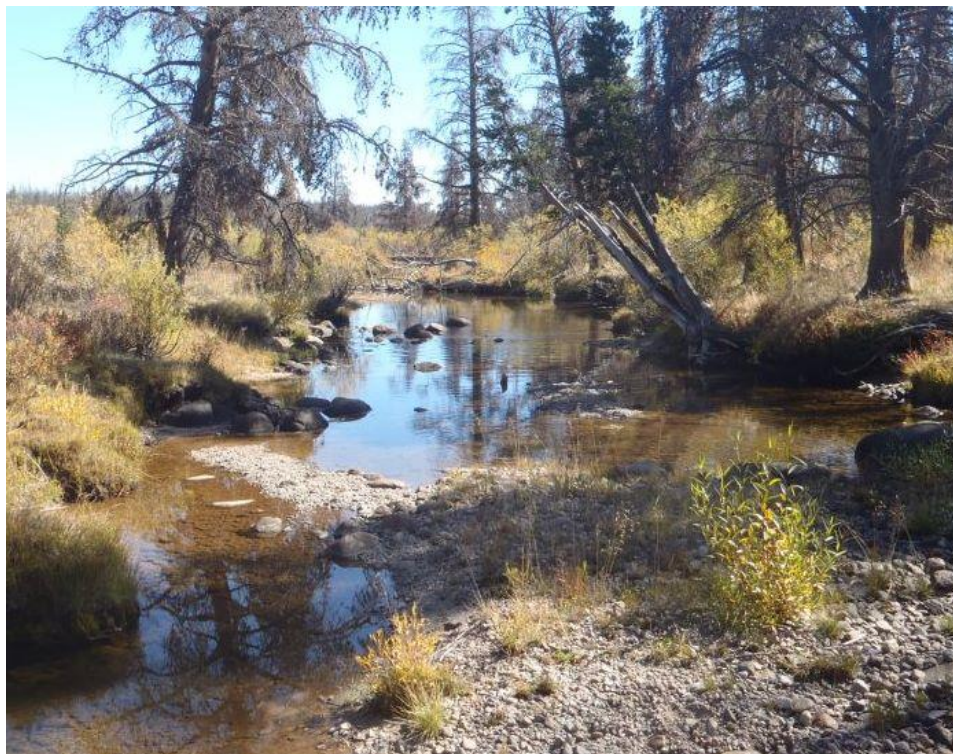
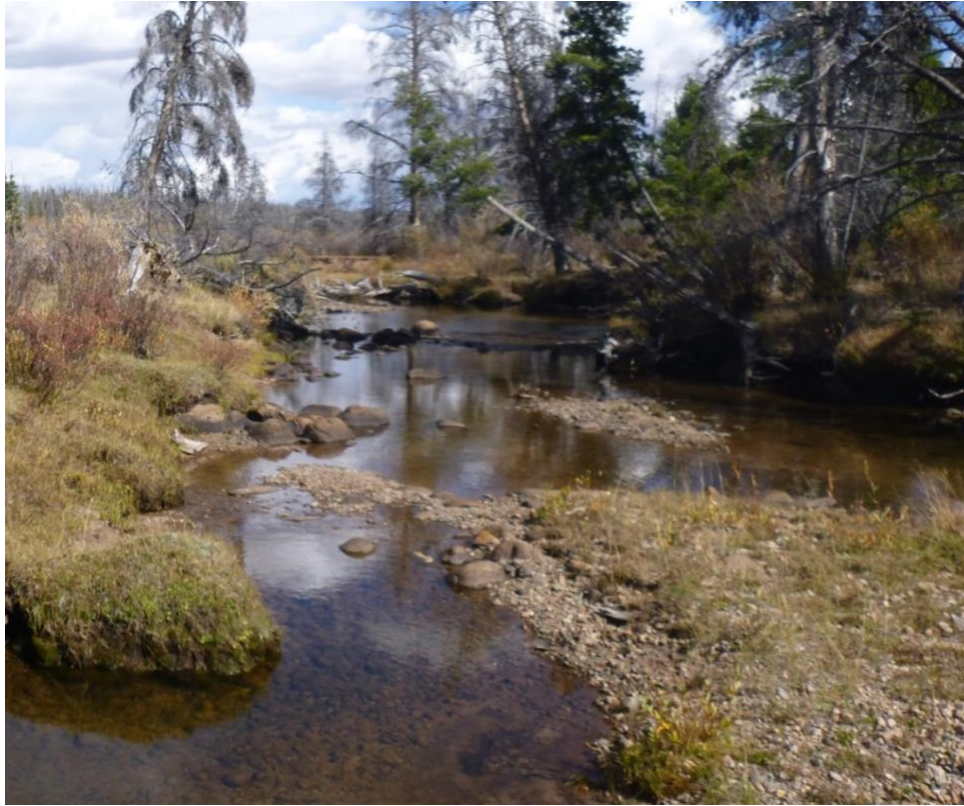
*Figure 5: Newcomb Creek Lower MIMS reach (looking downstream) taken at similar times of the year.*

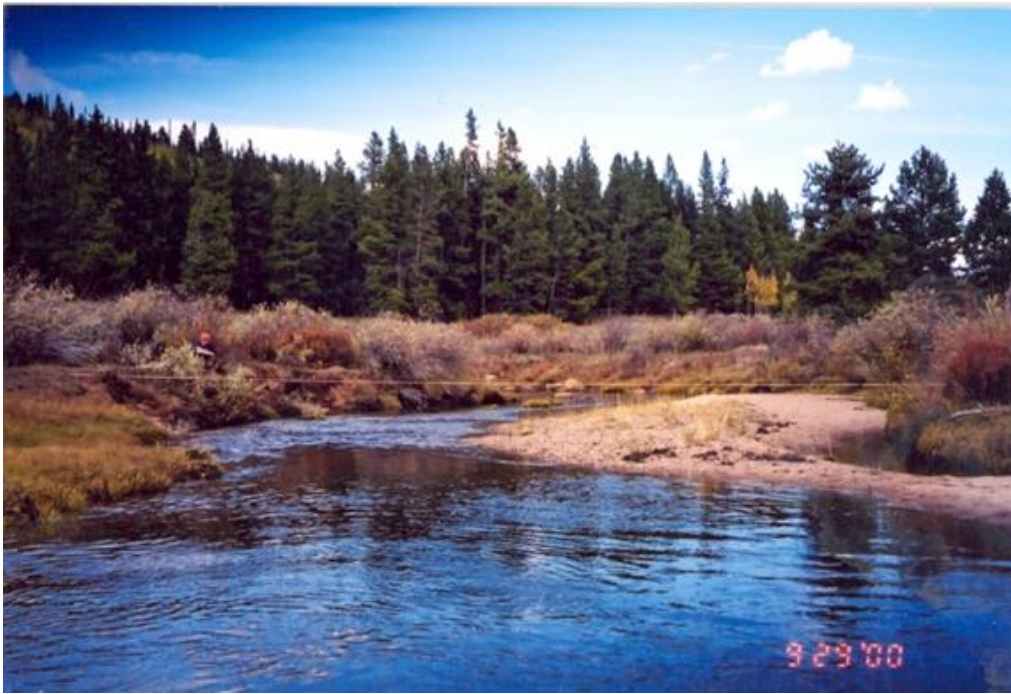
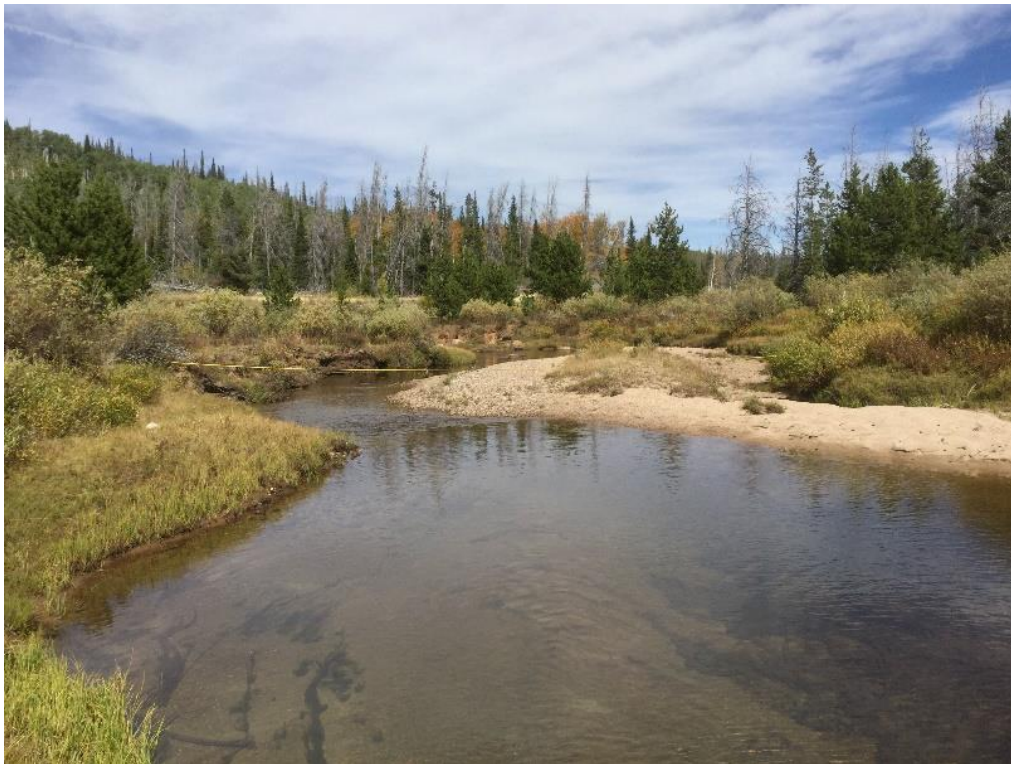
*Figure 6: Newcomb Creek Lower Riffle Cross Section #1 Photo Comparison (looking downstream). Photos taken at similar time of year show high Width to Depth ratio. Point bar is growing suggesting excess sediment from slumping banks cannot be flushed by flows so point bar grows, flows are then constricted by growing point bar and additional velocity is pointed toward already slumping bank causing the cycle to repeat.*

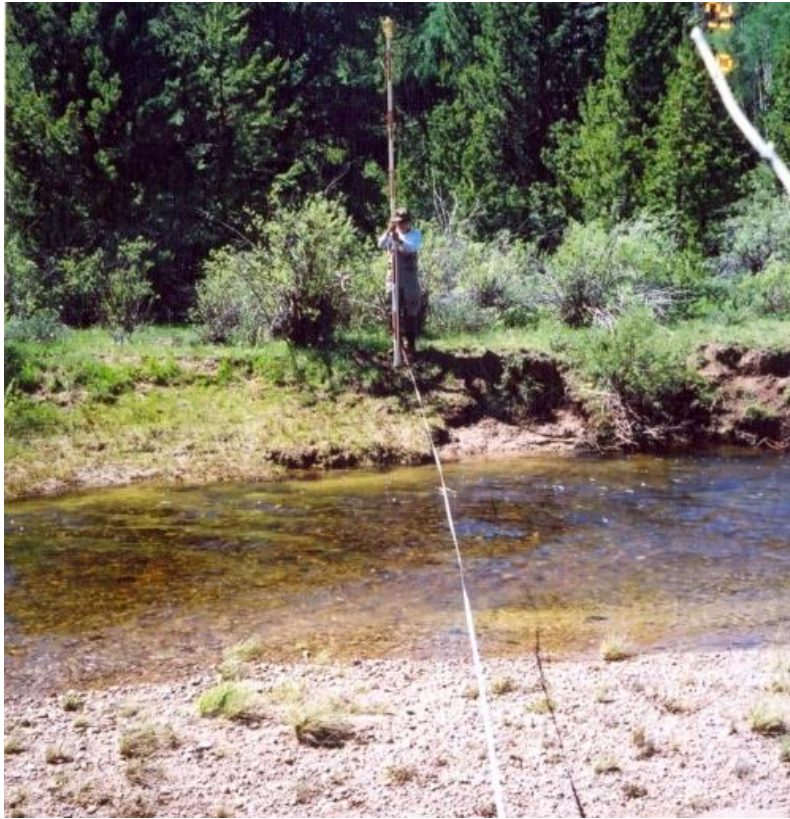
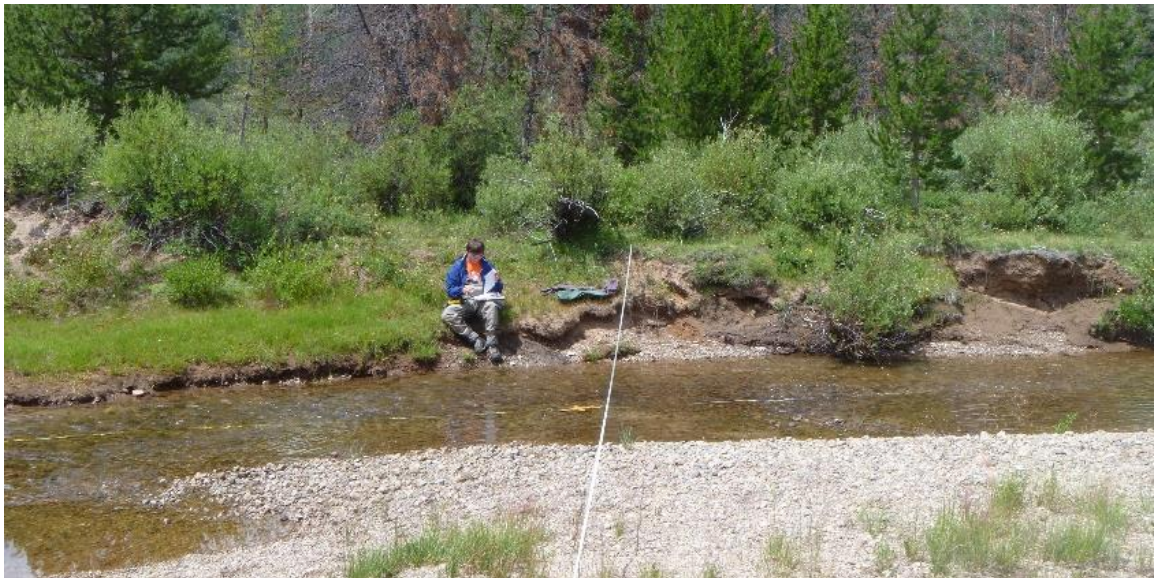
*Figure 7: Newcomb Creek Lower Riffle Cross Section #1 Photo Comparison (looking at left bank). Note how the raw, slumping bank is growing in size.*

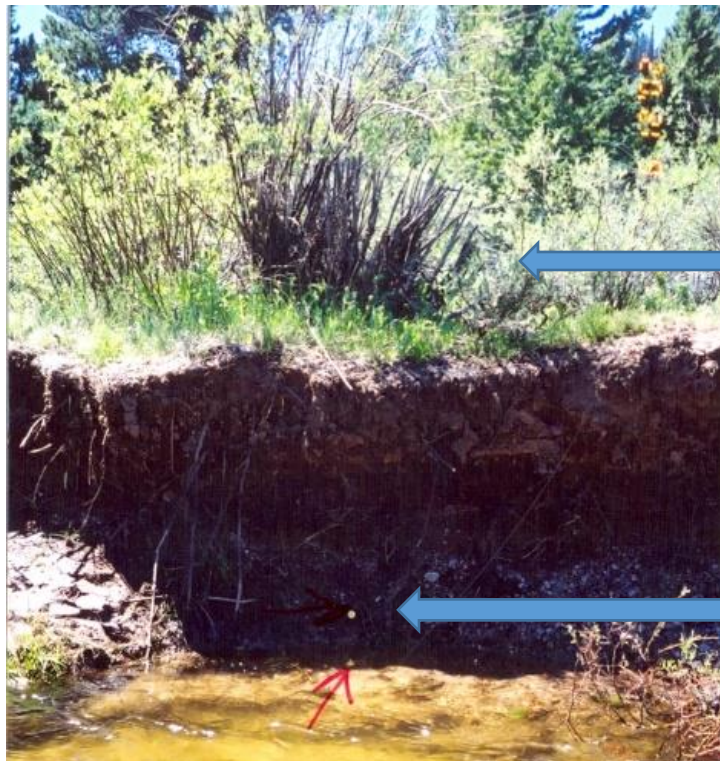
Stabilizing willow in 2002

Stabilizing  
willow from  
picture above  
has slumped  
into creek.

Figure 8: Newcomb Creek Erosion Pin (Lower Erosion Pin Site just below riffle #1 cross section) Photo Comparison (looking at left bank).

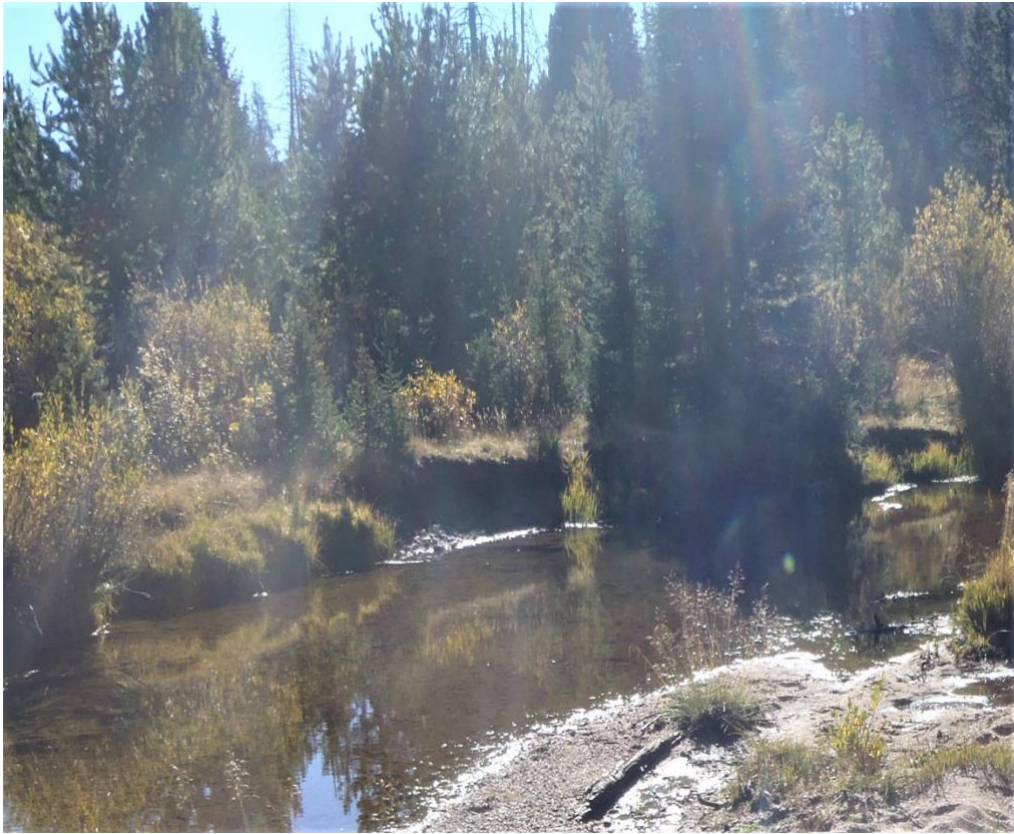
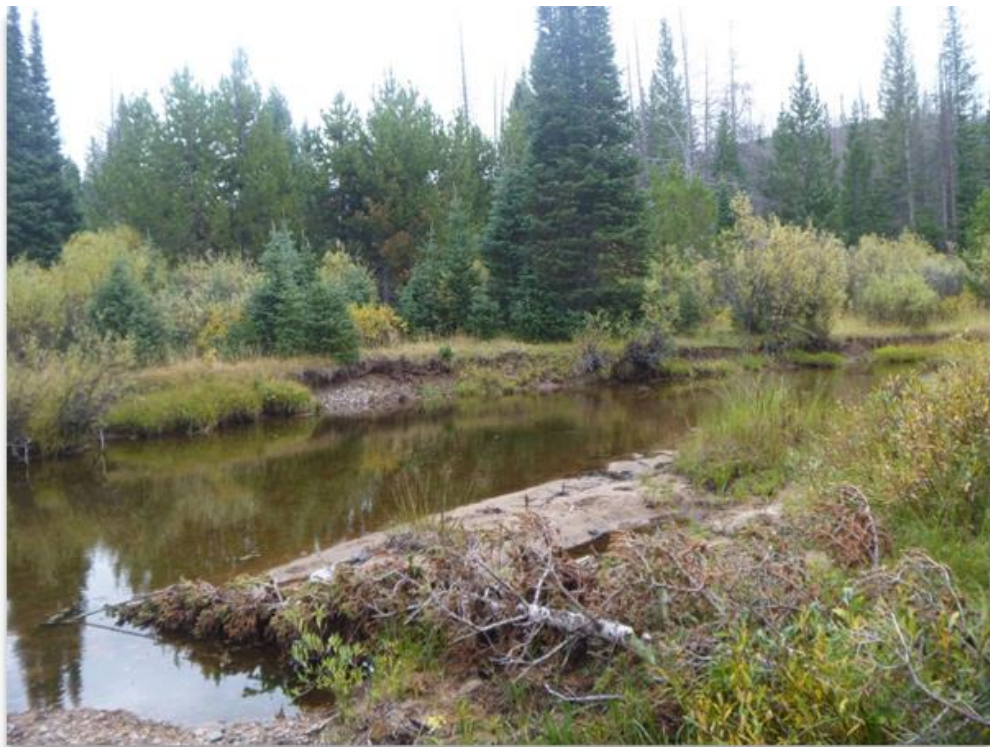
*Figure 8: Newcomb Creek Upper MIM site.*

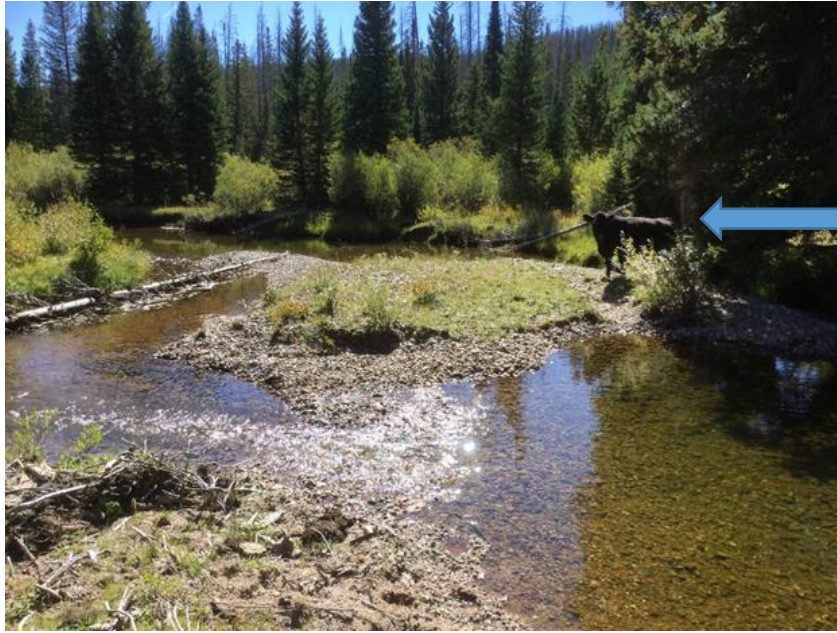
Cow in creek  
Upper site

*Figure 9: Newcomb Creek Upper MIM site.*
